## WESTCOUNTRY RIVERS TRUST CITIZEN SCIENCE

### MONITORING OF THE PAR RIVER AND ITS TRIBUTARIES

**APRIL 2022**

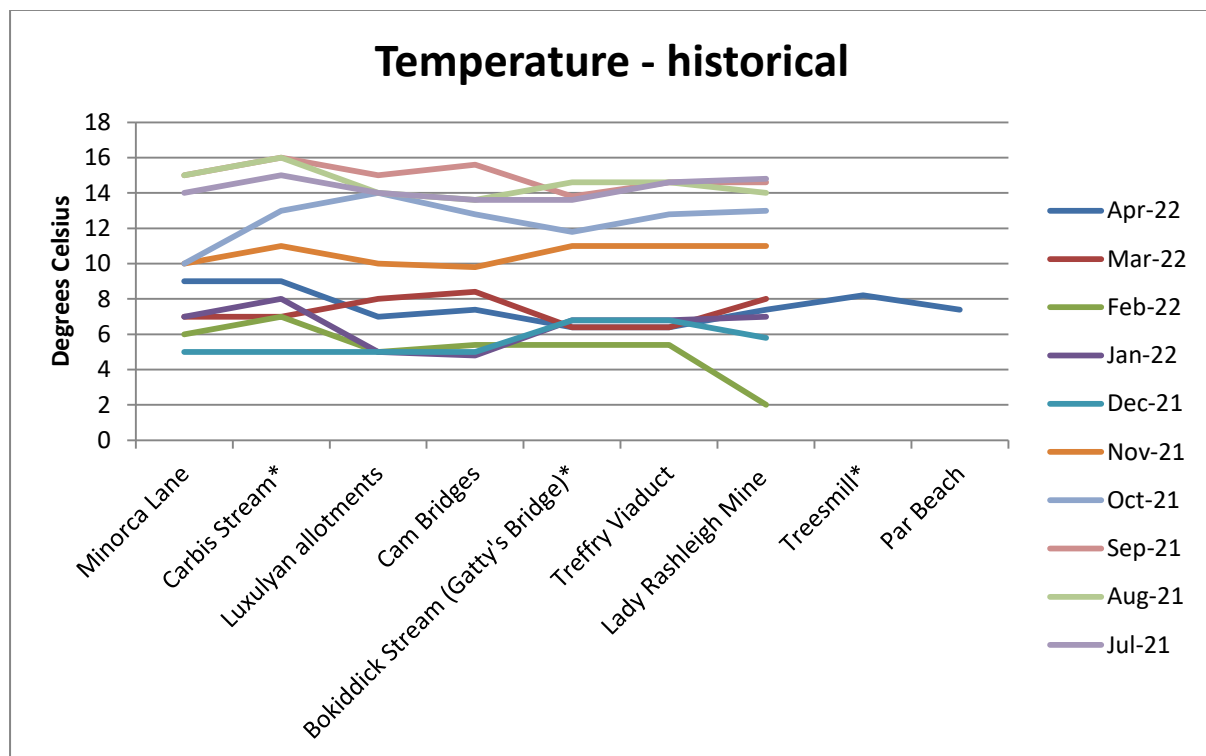
The thermometer used at Treesmill and Par Beach was giving inaccurate readings. These have been deleted and the new reading is in line with other readings.

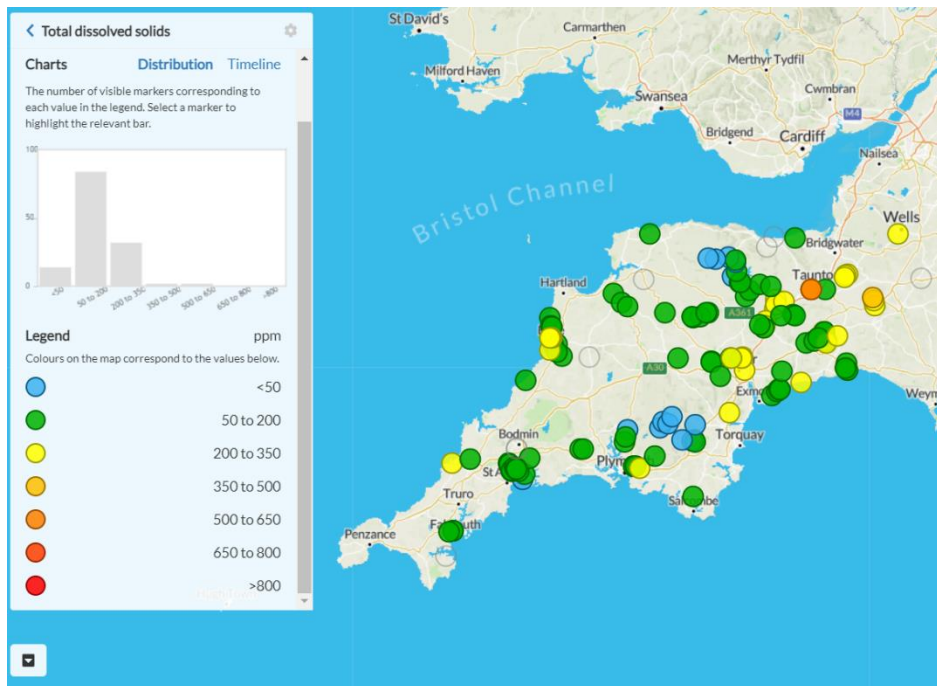
The reading of zero ppm at Par Beach is a surprise but is not the only such result in the region as this map shows:

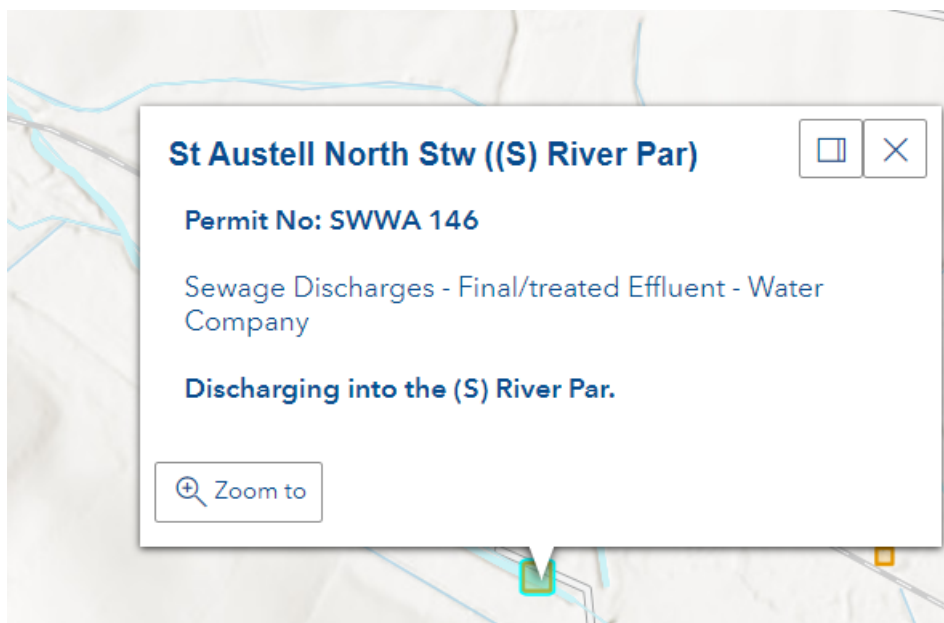
The outfall marked with a square was operating when the samples were taken. Small clusters of foam and a very slight smell were noticeable.

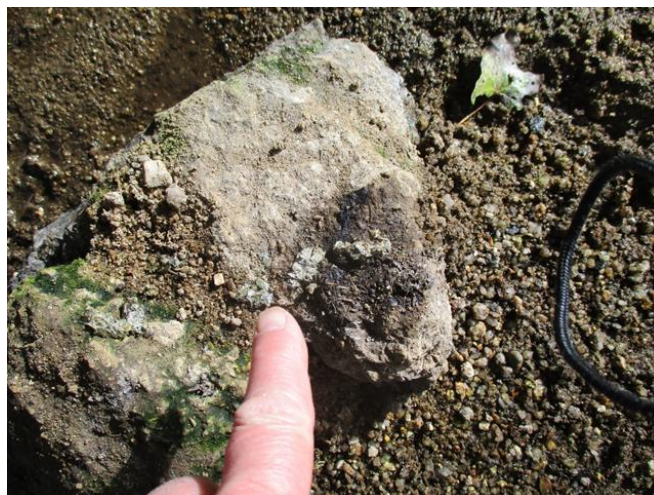
1. Old spraint (from March?) under canal bridge at Ponto Mill (SX 07312 56164).

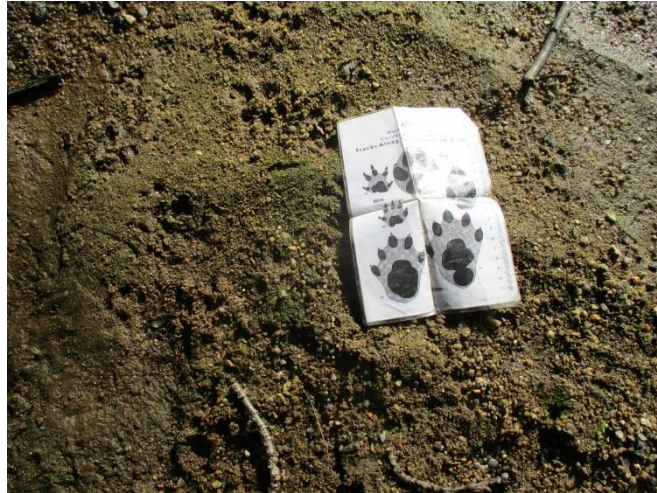
2. Indistinct footprints under canal bridge at Ponto Mill (SX 07312 56164).

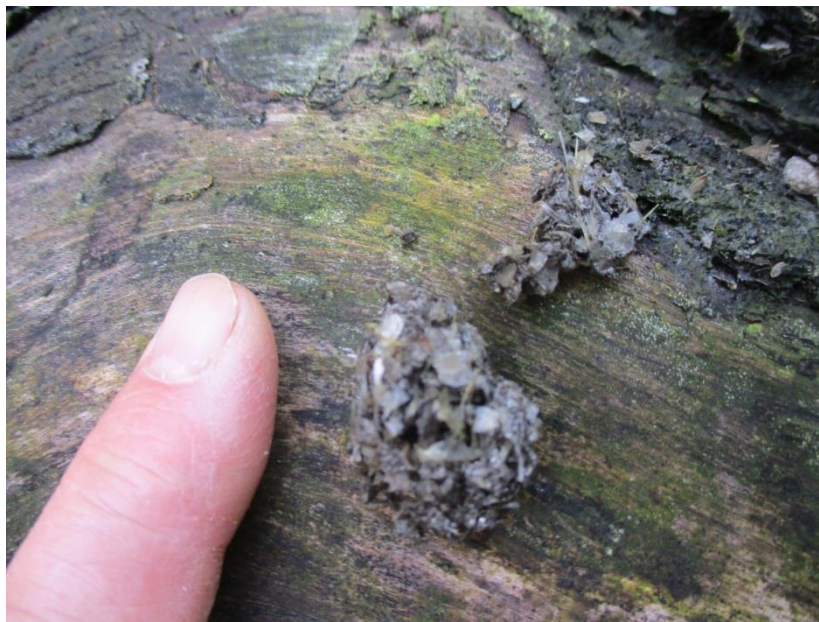
3. Old spraint on log downstream from Ponto Mill sluice (SX 0733 5577).

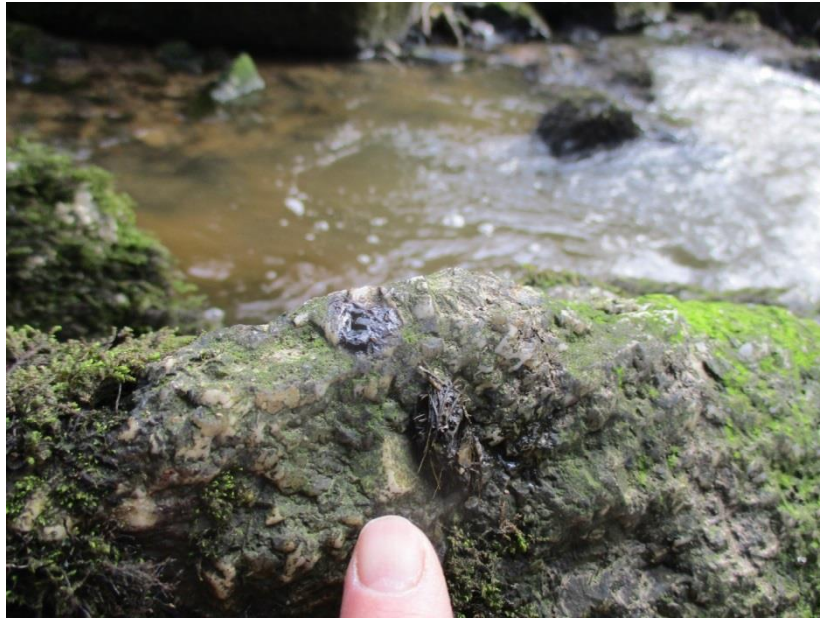
4. Upriver from point where Carmears Wood stream crosses Lower Tramway and joins Par River. Fresh spraint with fish bones and scales (SX 0687 5622).

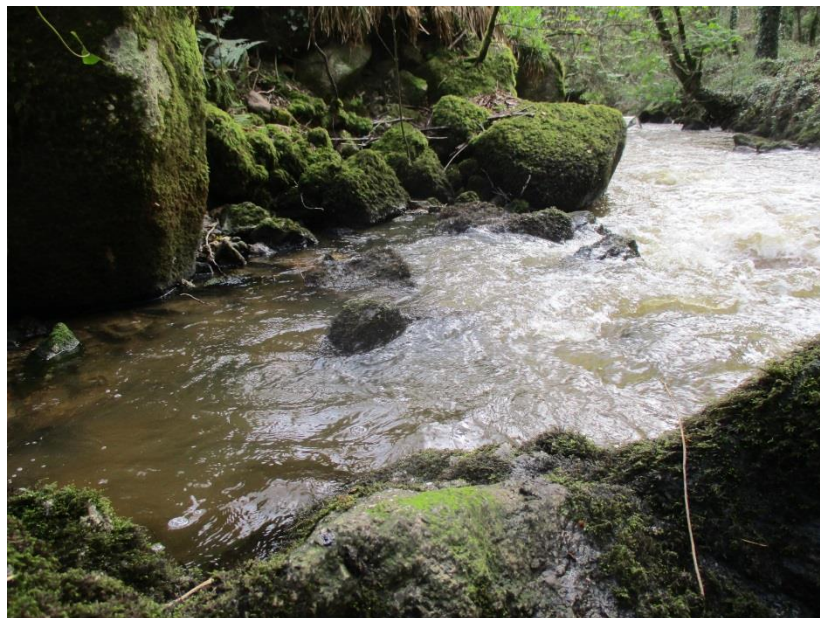
5. The stream from Carmears enters on the left. This is a fast flowing, boulder-strewn section (SX 0687 5622).

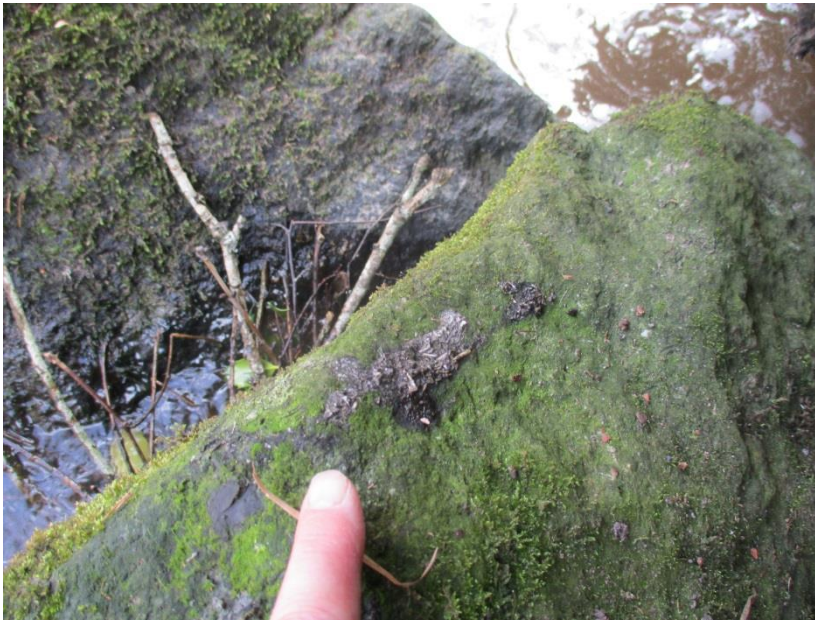
6. Old spraint on boulder at Lady Rashleigh Mine (SX 06456 56498) may be from last month so has not been recorded on ORKS.

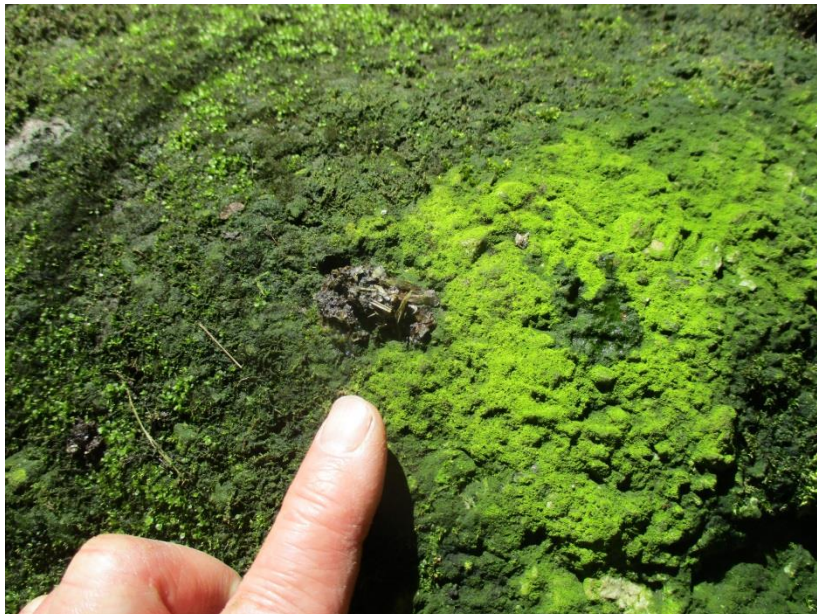
7. Recent spraint on boulder downstream from bridge at Lady Rashleigh Mine (SX 06471 56497).

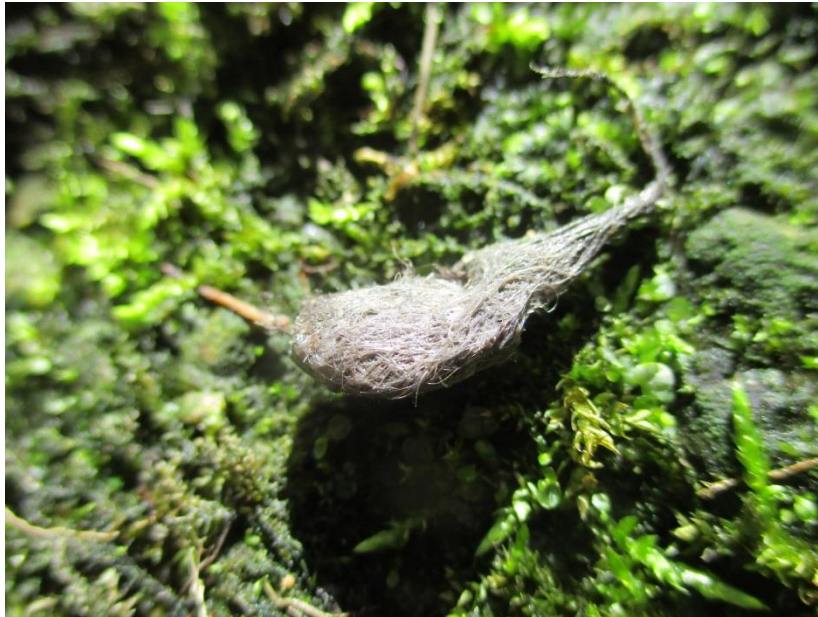
8. Unidentified, odourless dropping containing fur on boulder downstream from bridge at Lady Rashleigh Mine (SX 06471 56497).

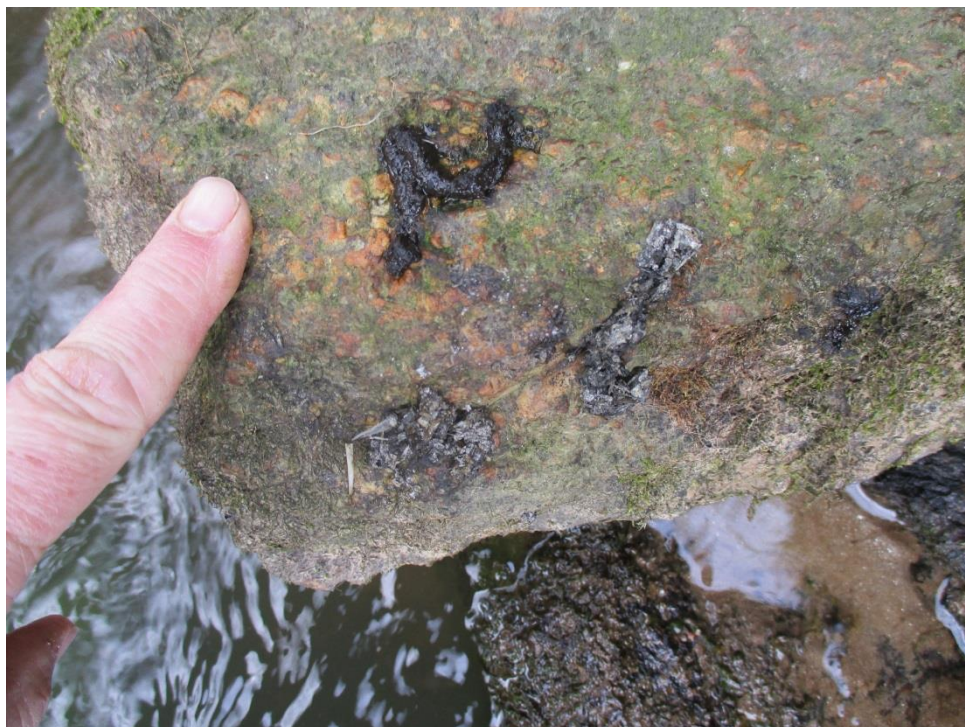
9. Fresh and old spraint on boulder on far side of river from Luxulyan allotments (SX 04747 58056). Old spraint not seen in March survey so can be recorded on ORKS.

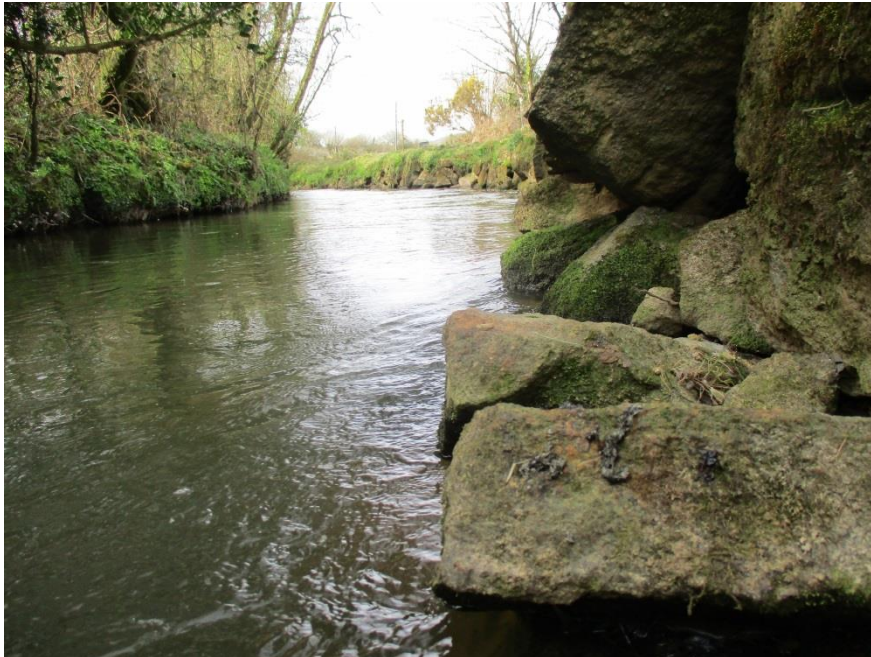
10. Looking upstream from sprainting spot near Luxulyan allotments (SX 04747 58056).
