## WESTCOUNTRY RIVERS TRUST CITIZEN SCIENCE

### MONITORING OF THE PAR RIVER AND ITS TRIBUTARIES

OCTOBER 2021

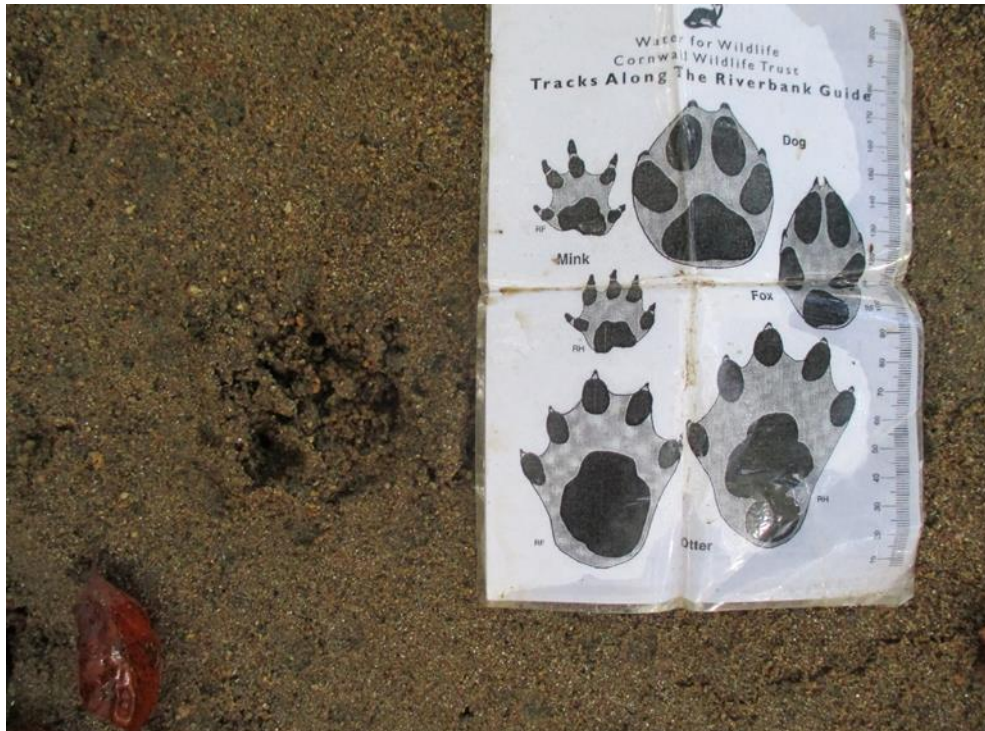
Possible footprint SX 05802 56860 near Rock Mill Quarry

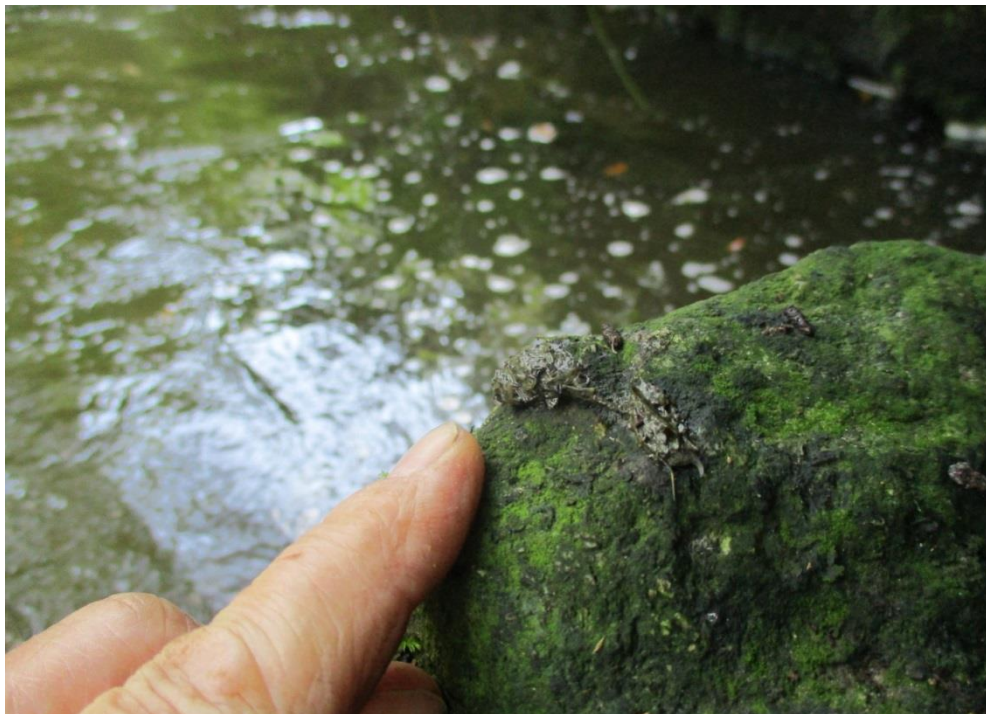
Fresh spraint on boulder near Lady Rashleigh Mine, SX 06456 56498

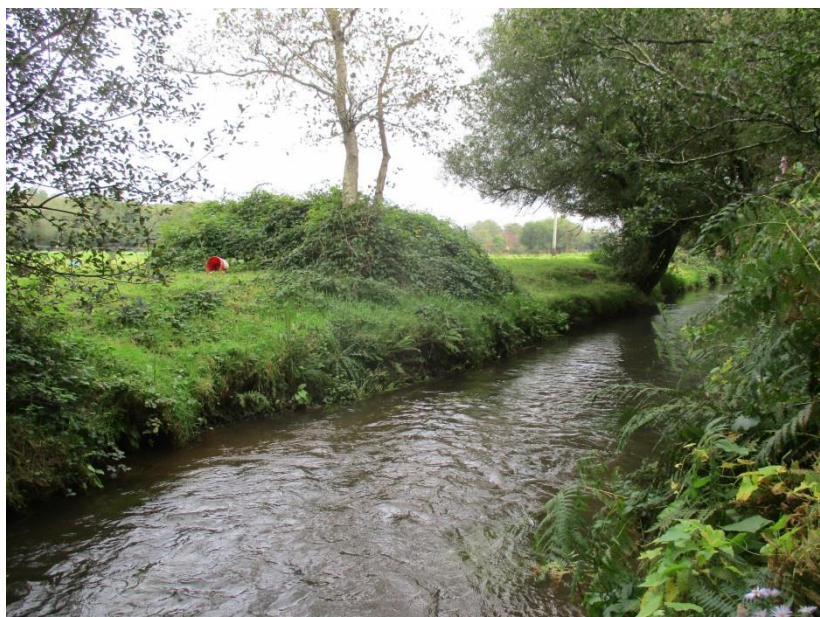
This time the maximum possible reading using our kit was made: 2500 ppb. The next photo is looking from the usual monitoring spot in the direction of the place where the mid-river sample was taken. No tributaries enter in this stretch. On one side is a field and on the other a belt of bushes and trees. In other words, there was no obvious source of contamination.

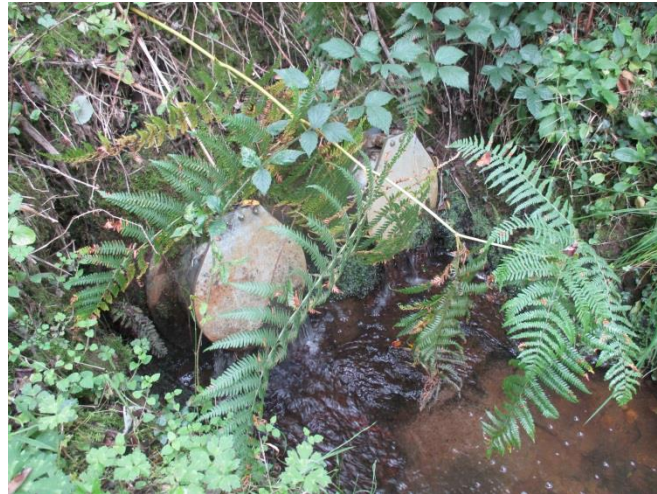
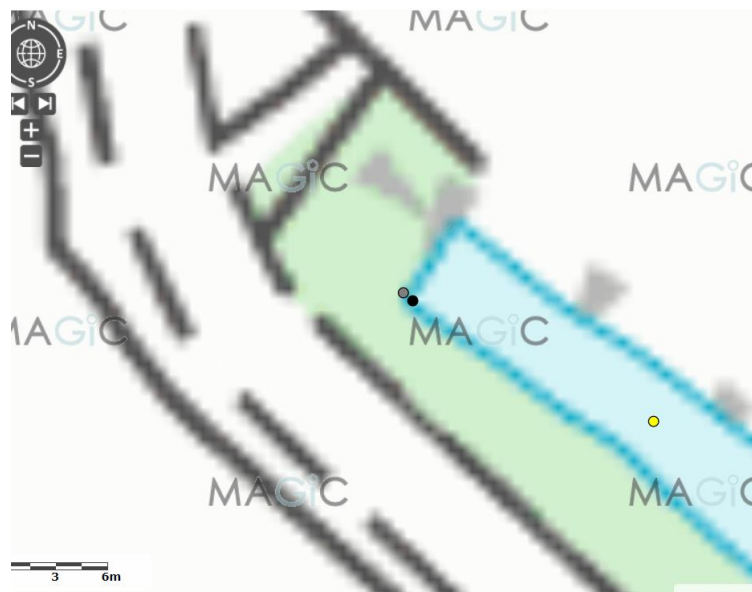
6. At first we couldn't understand how the readings went from 300 ppb to 2500 ppb in such a short stretch but then realised that readings at our usual spot might have been diluted by water from 2 small outfalls draining local fields entering the river a metre from our position. This is shown in the photo and by the grey dot in the map below.

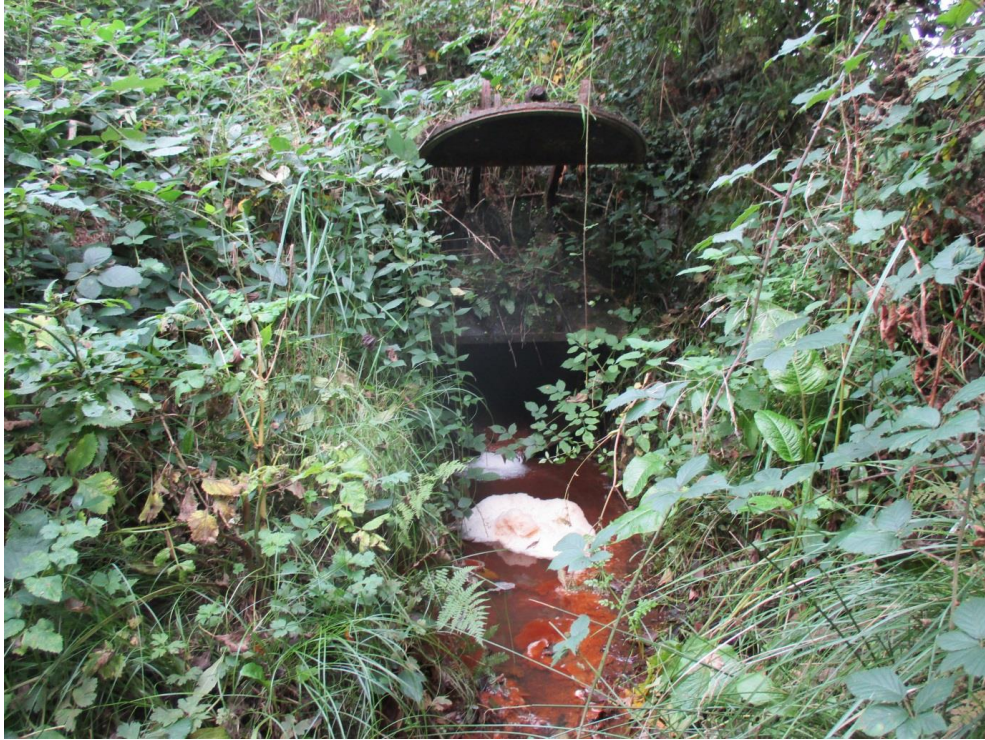
This outfall has a metal hinged flap that is permanently open. We have never observed large volumes of water emerging from it, although sometimes, as was the case on this occasion, small amounts of foam and a reddish tinged liquid emerges. We don't know its purpose but its position suggests it is the outfall from a water channel that flows around the northern perimeter of the STW (see map in section 5 above).

**The mystery outfall pipe. Note flap that is always up, the foam and reddish liquid emerging.**

8. It seemed as if the high phosphate level was the result of something emerging from the large, unexplained outfall at SX 0447 5811. Given the very high levels the Environment Agency hotline was contacted later on Saturday 9<sup>th</sup> October. Information was also sent by email. Shortly after a very helpful conversation with the official manning the hotline someone from the Cornwall section EA rang me. On Monday 11<sup>th</sup> October the following message was received from the EA:

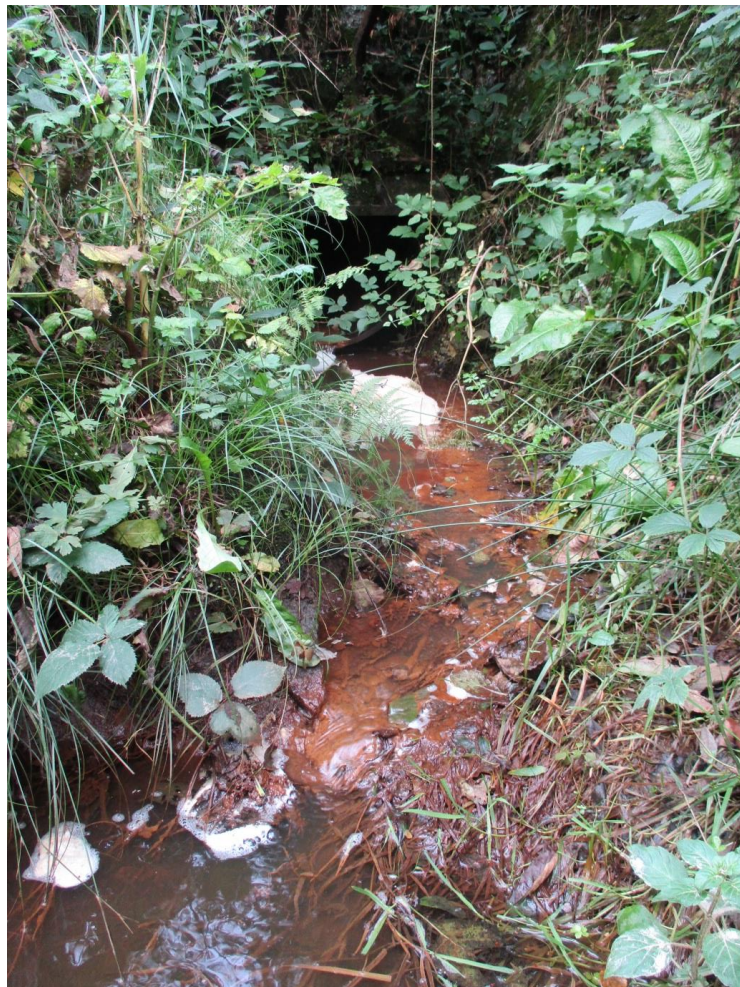
**Liquid flowing from the mystery outfall**
