WESTCOUNTRY RIVERS TRUST CITIZEN SCIENCE

MONITORING OF THE PAR RIVER AND ITS TRIBUTARIES

DECEMBER 2021

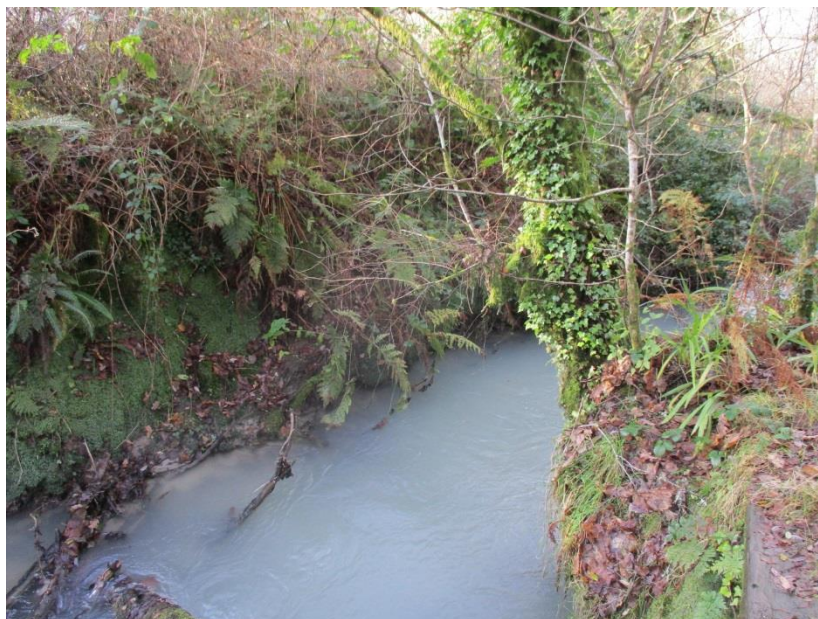
The highest readings were from the Tregarrick Stream at Rosemullion bungalow and the Carbis Stream near Higher Menadue/Lavrean. The former location is a stream containing a thick level of silt believed to have originated from slurry. At the latter, it is quite clearly china clay.

Carbis Stream at SX 02834 59401 running white, presumably with china clay

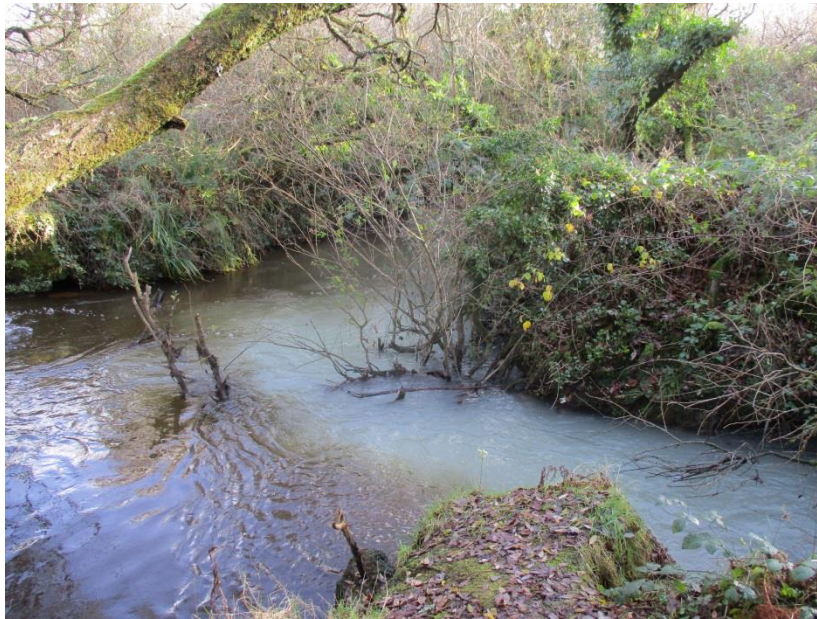
On the right the clay-polluted Carbis Stream meets the Par River

3. The pollution of the Carbis Stream with china clay needs further examination. The source of the china clay could be the banks of the stream, where a higher water level washes previous deposits into the stream, or current discharges, or both. Near the purple dot in the following map, the Carbis Stream can be seen by the road. Often it runs clear; at the monitoring point at SX 02834 59401 (red dot), however, it is more often white than not. This suggests that the clay enters the river closer to Bugle but as the map suggests, there are various watercourses in addition to the Carbis Stream that might act as conduits for pollution. Therefore it cannot yet be said where this china clay is coming from. The impact on fish and other wildlife is unknown.

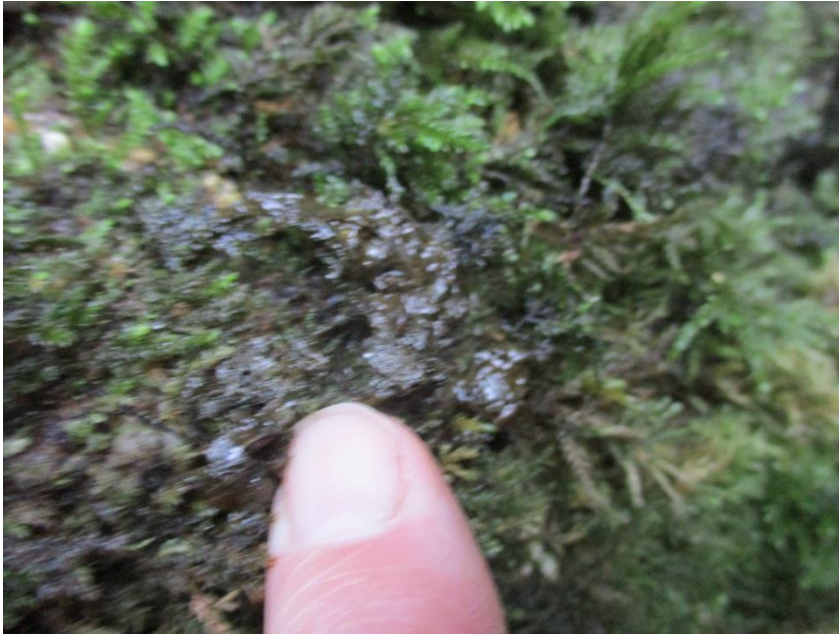
Blurry photograph of spraint on rock below canal bridge at Ponto Mill

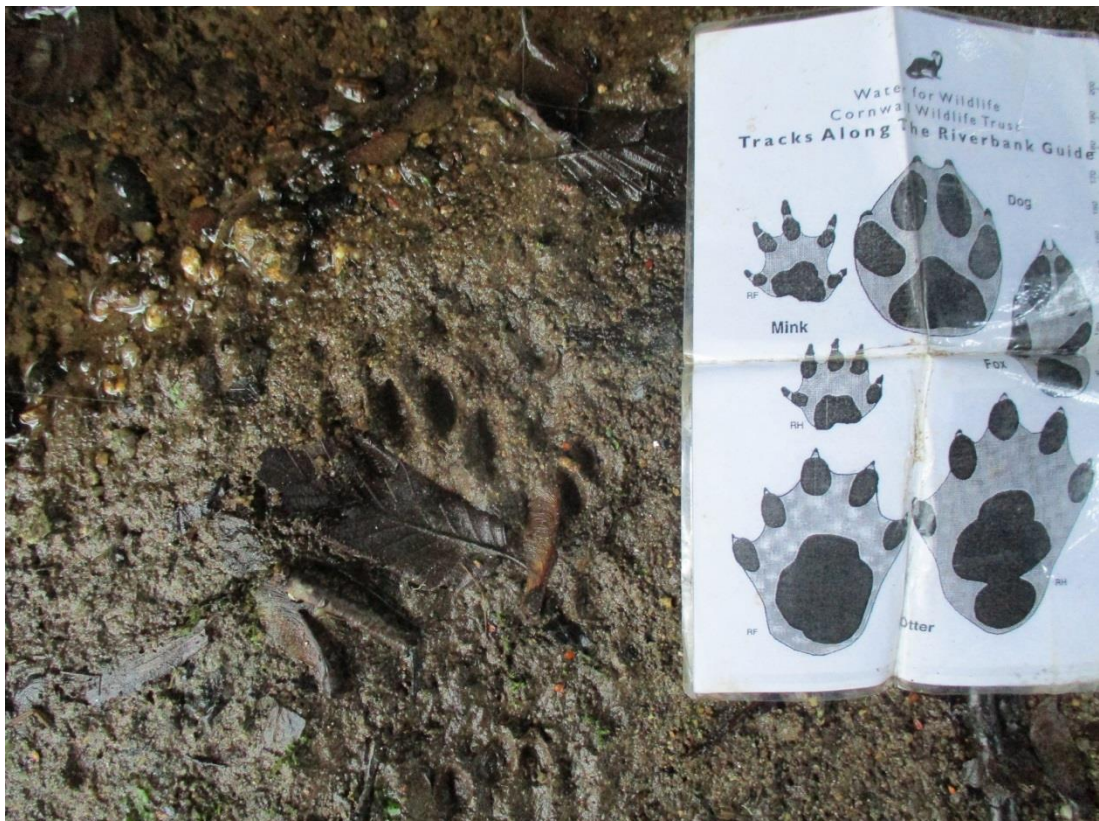
Close inspection suggested five toes in many of the footprints.

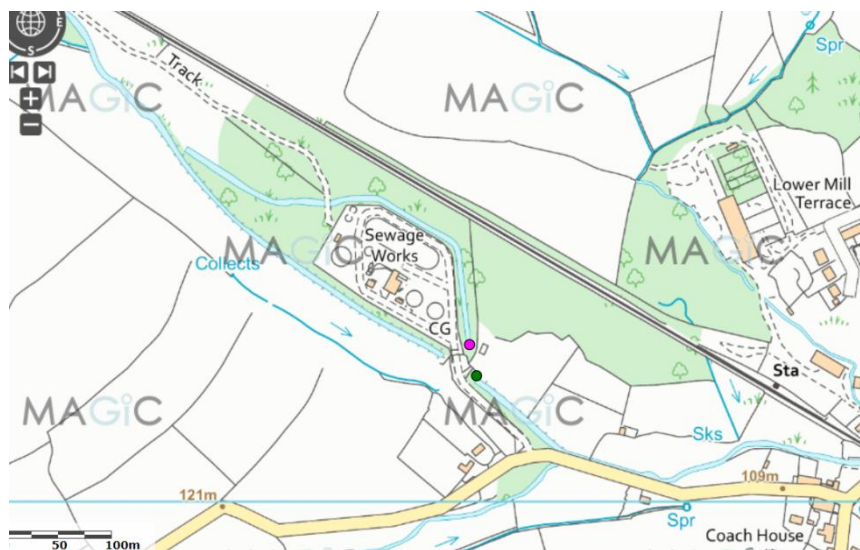
On this occasion, no unpleasant discharge could be seen in or around this outfall.
