WESTCOUNTRY RIVERS TRUST CITIZEN SCIENCE

MONITORING OF THE PAR RIVER AND ITS TRIBUTARIES

OCTOBER 2022

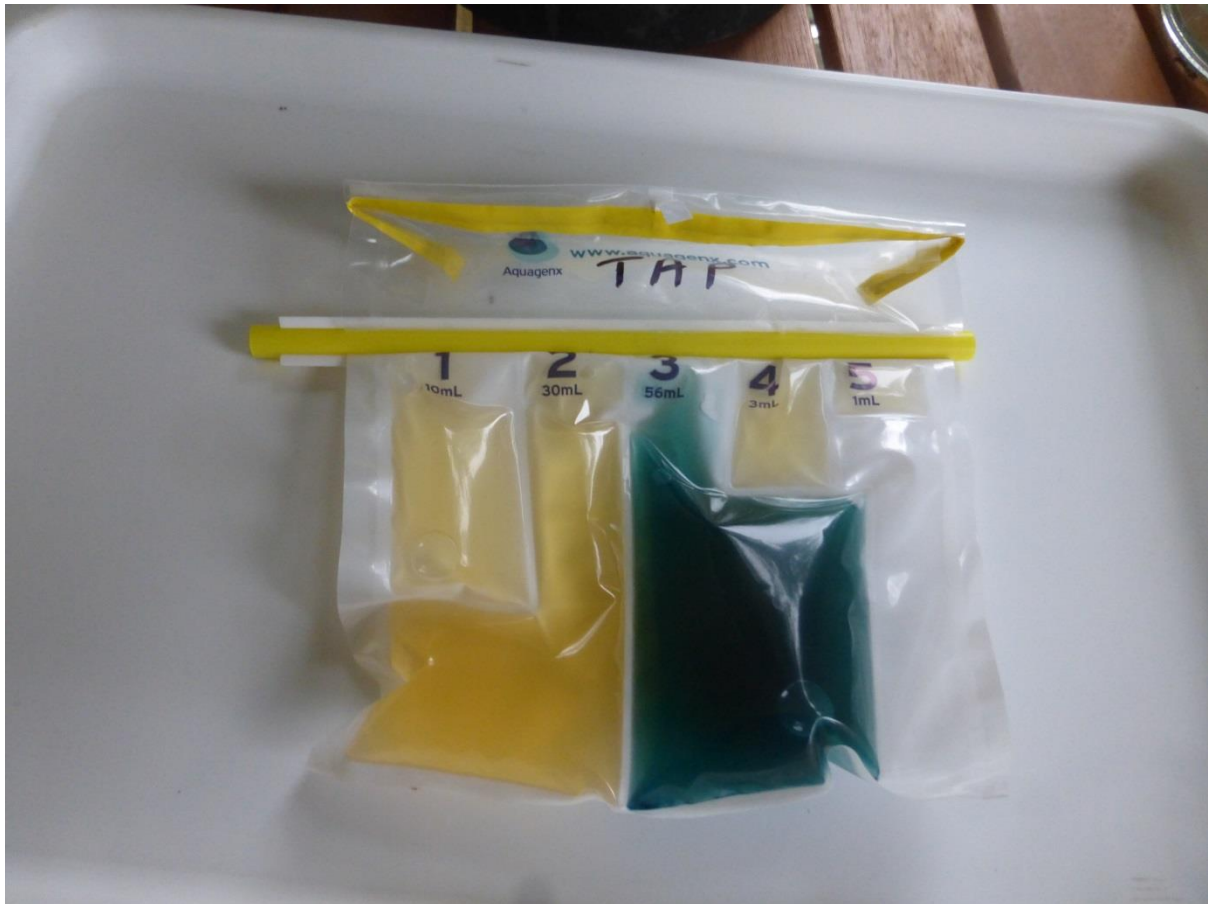
Tap water test

15mpn/ 100ml is Low Risk/Probably Safe for recreational water. However, the result should be 0 for tap water. As it was the first test of the day, there should be no cross contamination so either the equipment was not adequately sterilised, (test tube and syringe for 1:10 solution) or my 90ml of previously boiled tap water for dilution was compromised, or there was indeed e coli and other coliforms in the tap water. In the tap water sample under UV light all compartments except no 2 glowed. It remained a sandy colour, which is not very clear from the photo. In ambient light compartment 3 was quite a dark blue and I used 3 chlorine tablets to neutralize it and turn it a sludgy brown, so it was not a mere trace of bacteria.

I intend to buy some bleach to sterilise all equipment and repeat the tap water test. The tablet present in the 1st bag (where you dilute the sample and add sugars), should remove traces of chlorine from the sample.

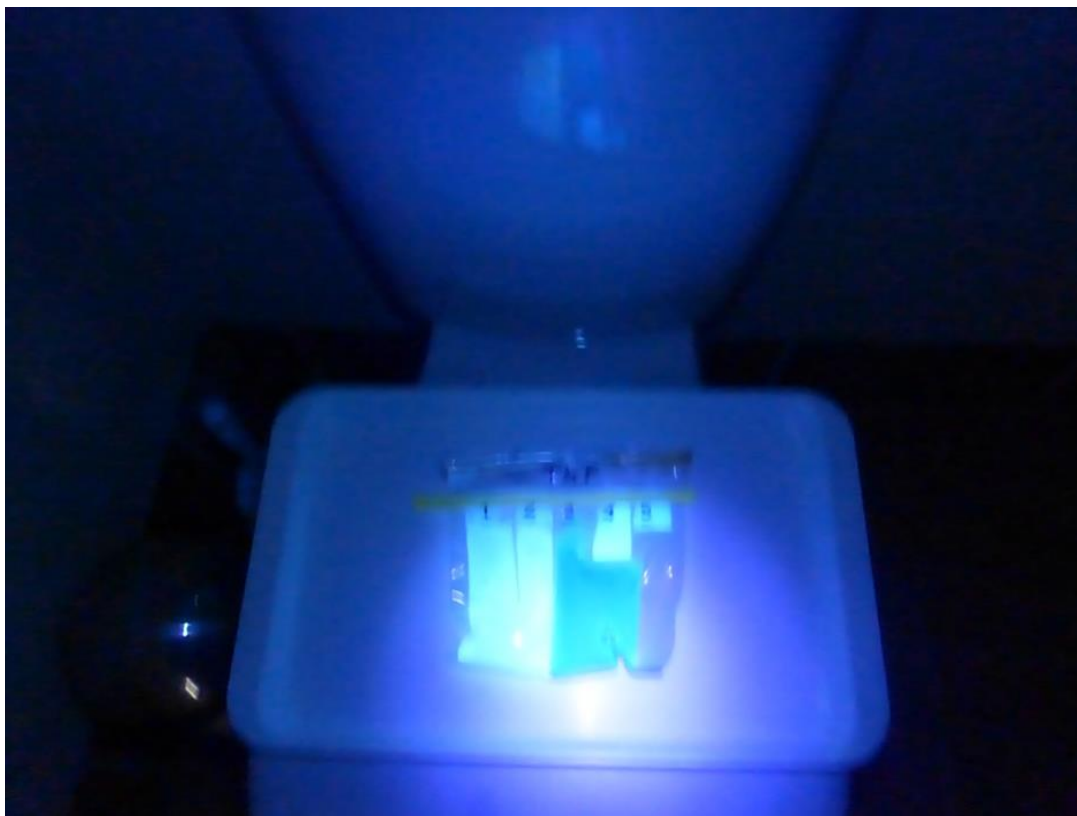
Tap water sample under UV light Photo: Joan Farmer

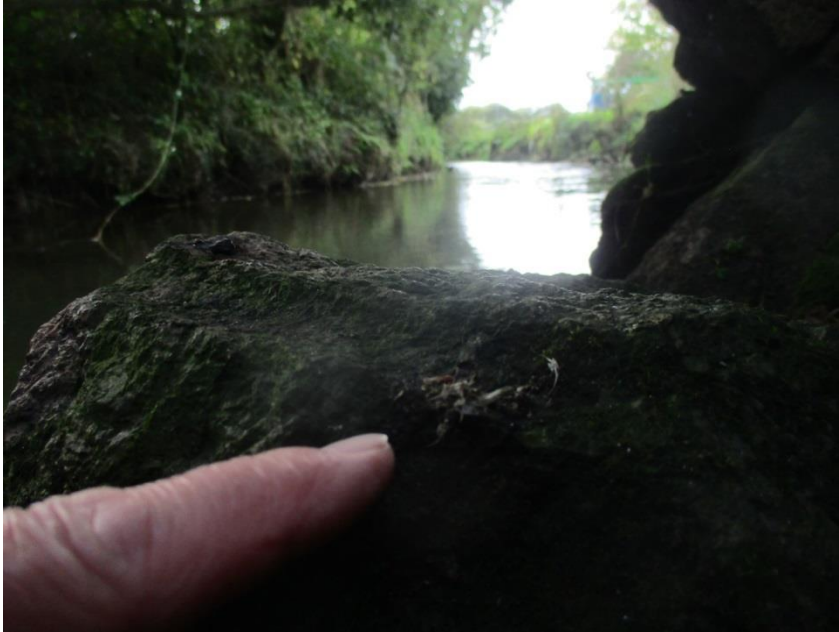
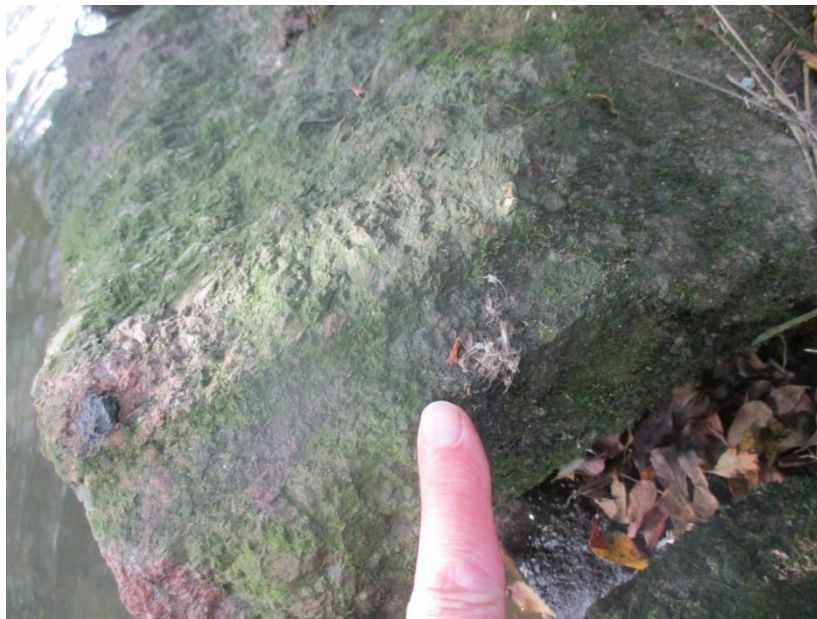
1. Old spraint on boulder near Luxulyan allotments (SX 04747 58056):

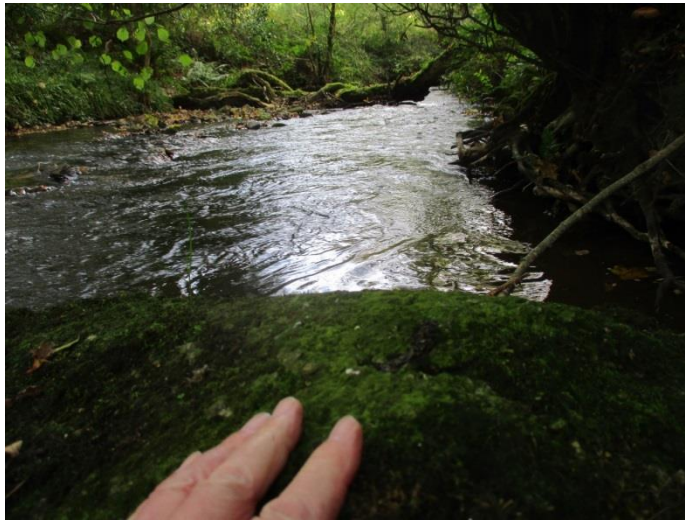
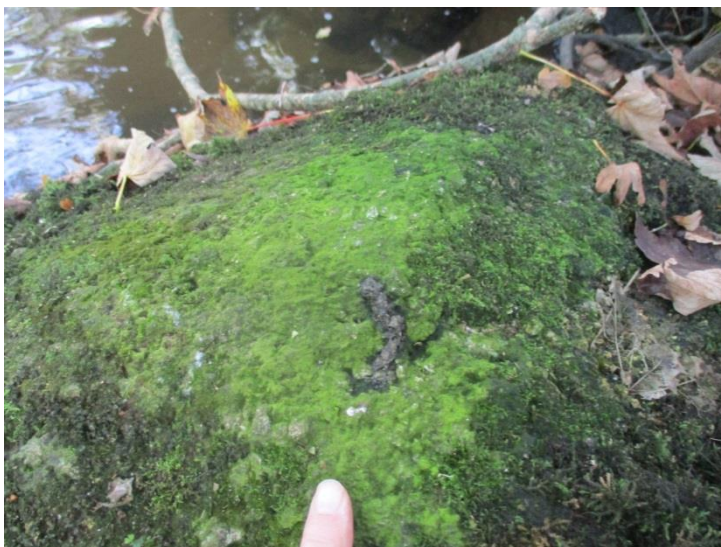
(a) Near west bank:

3. Recent spraint on boulders in river downstream from Lady Rashleigh Mine (SX 06471 56497):

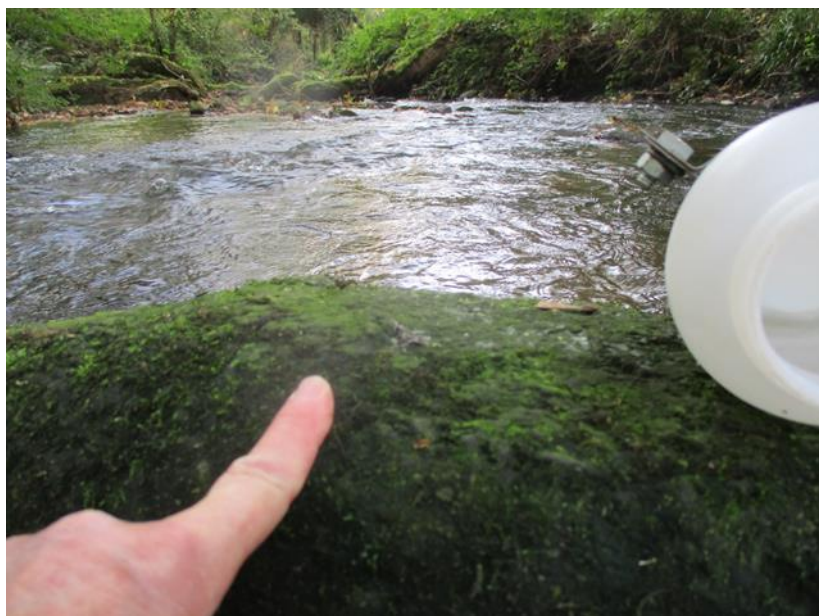
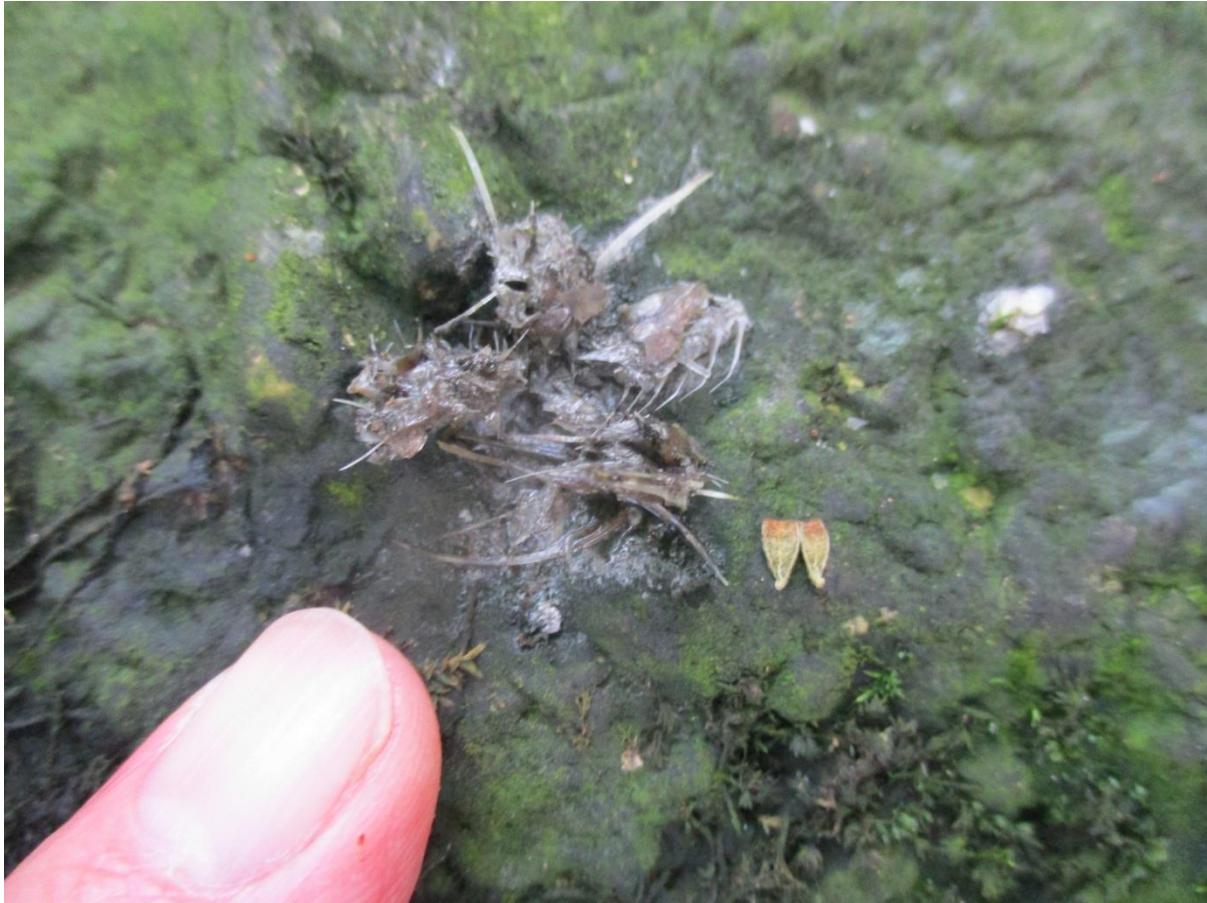
(b) Mid-stream (second photo clearly shows fish bones):

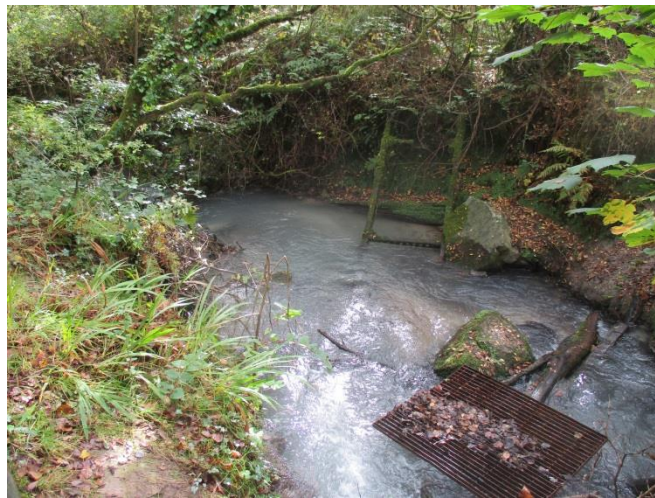
(c) The Carbis Stream was tinged white, probably with china clay and at the confluence with the Par the contrast in water colour was evident once again, although not as stark as it is for most months of the year. As the photo shows, a grating, branches and planks have been placed in the water as a makeshift bridge, which also acts as a barrier for fish. The good news is that the bridge (vandalised years ago) will soon be replaced by Cormac.

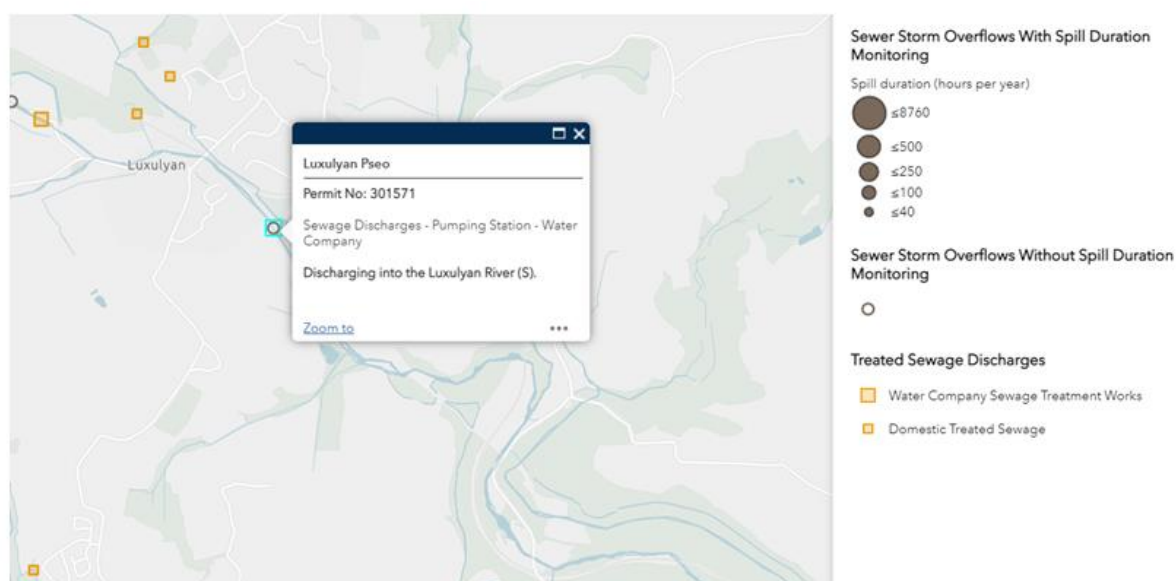
(d) South West Water has recently informed a local landowner of their intention to repair the dilapidated pipe and headwall of their sewage pumping station at SX 0504 5783. Our group was

concerned that this might have been a source of pollution and reported it to the Environment Agency in May 2021. Investigation showed it had not been a source of recent sewage pollution but SWW did say that the pipe and structure would be repaired, as this message received in July 2021 from SWW shows:

The pumping station was shown on The Rivers Trust's sewage map in 2021:

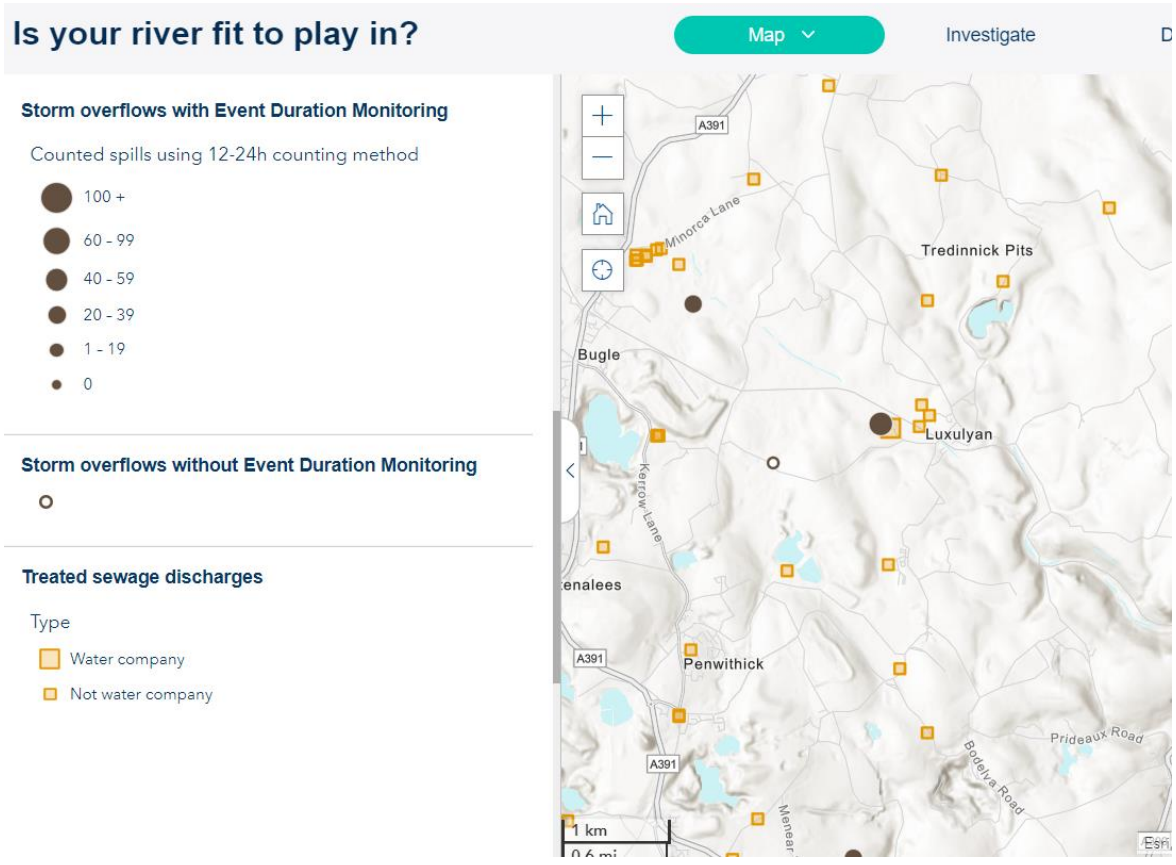
It seems that SWW do not intend to replace the pipe, which raises the question of what will happen should the operation of the pumping station be interrupted, for example by a power cut: where would the sewage go? Also strange is the fact that the pumping station is not shown at all on the current Rivers Trust map:

Does this pumping station still operate?
