WESTCOUNTRY RIVERS TRUST CITIZEN SCIENCE

MONITORING OF THE PAR RIVER AND ITS TRIBUTARIES

FEBRUARY 2022

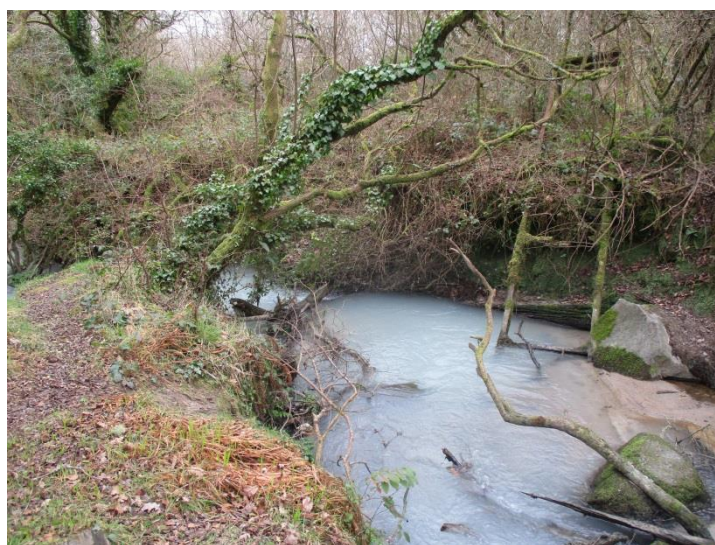
The two highest readings were on the Carbis Stream, where the water was white with china clay, and Par Beach, where, presumably, beach sand had an effect on the reading.

Looking downstream on the Carbis Stream north of the confluence with the Par River.

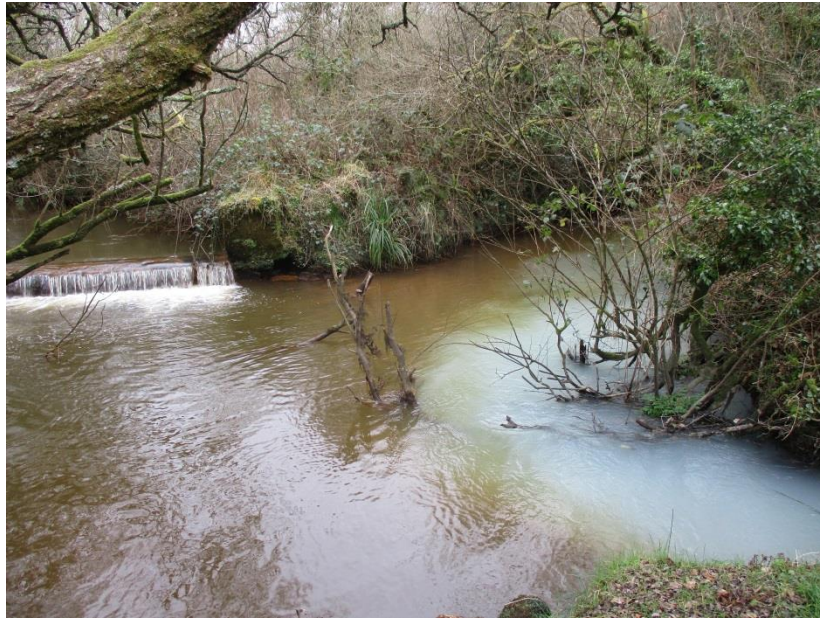
Note the white water of the Carbis Stream as it joins the main Par River near Higher Menadue.

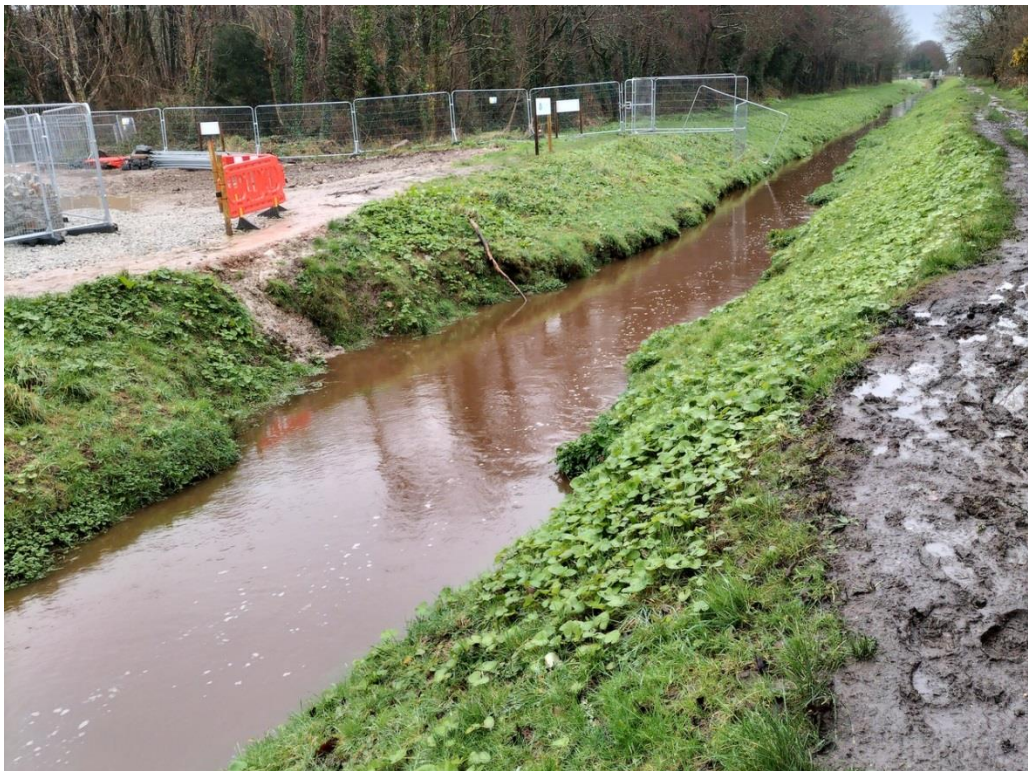
The high figure for Total Dissolved Solids on the Carbis Stream is consistent with the high Turbidity recorded. Those at Treesmill and Middleway (photo below) may be explained by the heavy rain that preceded monitoring.

Par Canal at Middleway. Heavy rain and the StARR engineering work may have contributed to the muddiness of the water.
Photo: Veronica Jones

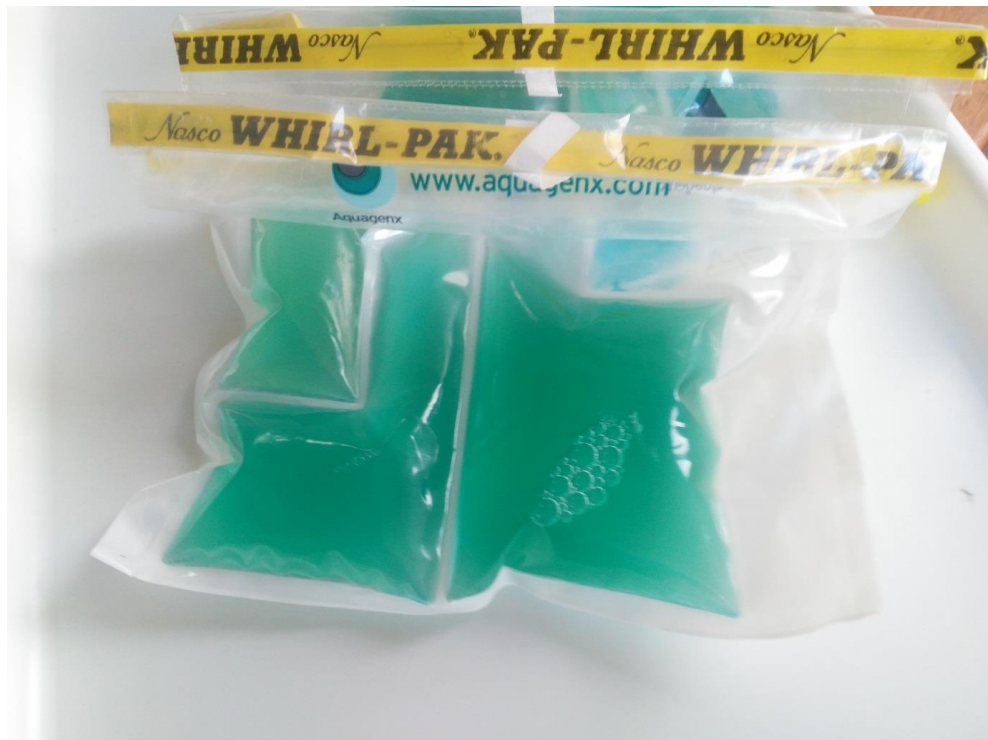
Incubated samples

LOCATION	E.coli (EC) MPN/100mL	EC Risk level	Total coliform (TC) MPN MPN/100mL	TC Risk level
Treffry Viaduct SX 05650 57179	31	Very High Risk/Unsafe	32	Very Unsafe
Lady Rashleigh Mine SX 06451 56509	31	Very High Risk/Unsafe	32	Very Unsafe

(e) The results are extremely worrying. But this was the result of an initial training exercise, with the possibility of errors in testing and incubation. It is also based on testing at 2 sites on one occasion. Therefore we are unsure about informing the Environment Agency Hotline.

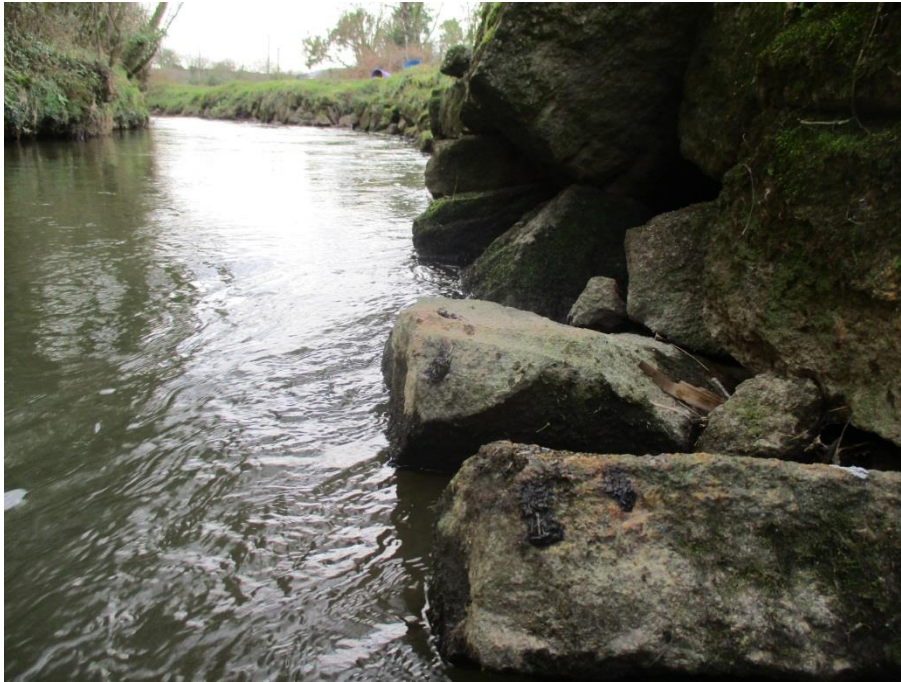
(i) Near Luxulyan allotments, looking upstream.

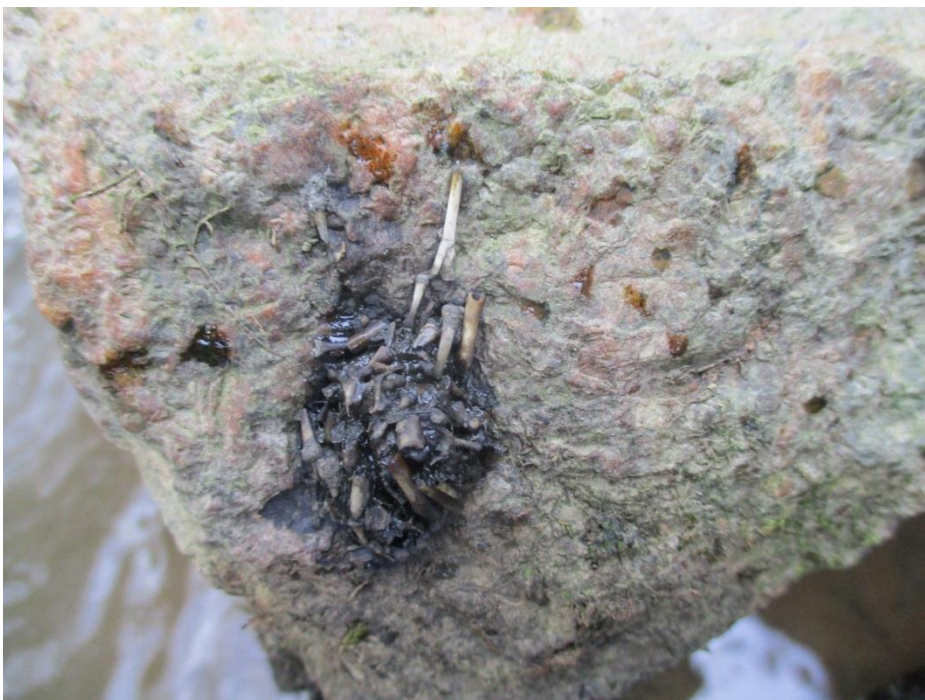
(ii) Fish bones and scales in the spraint near the allotments.
