WESTCOUNTRY RIVERS TRUST CITIZEN SCIENCE

MONITORING OF THE PAR RIVER AND ITS TRIBUTARIES

SEPTEMBER 2022

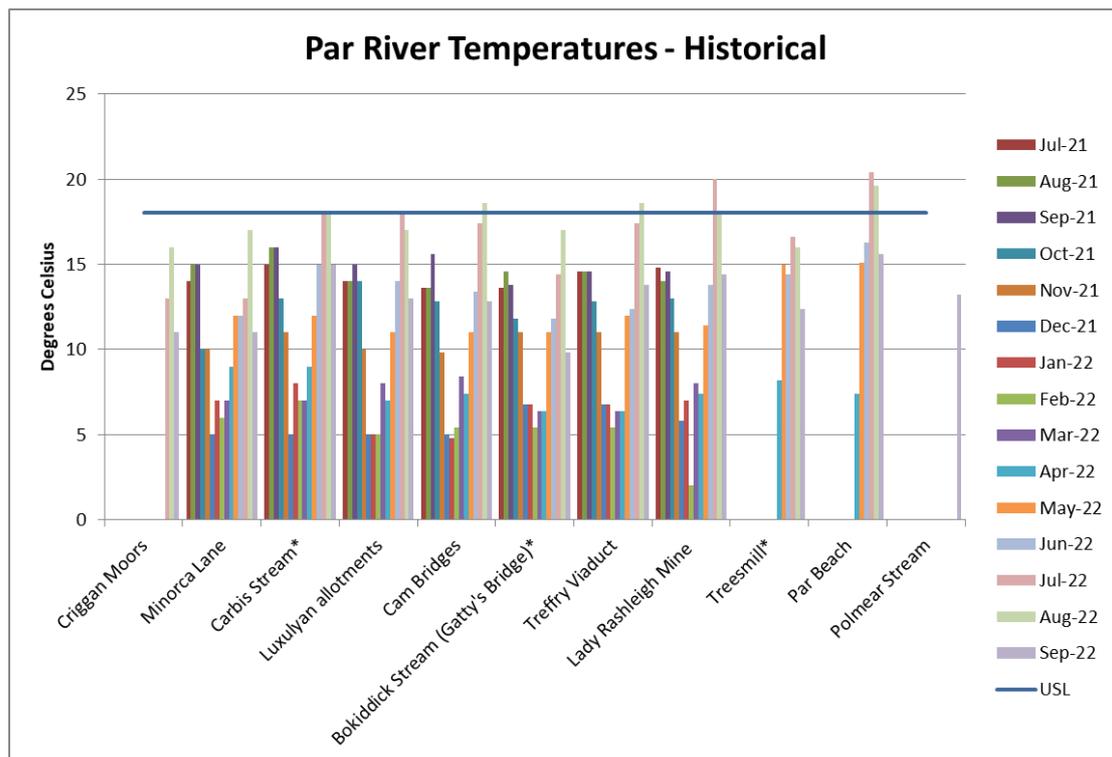
The temperature data is limited, so generalisations will be ill-founded. Even so, it seems that river temperatures on the Carbis Stream and on the main Par River from Luxulyan allotments downstream were worryingly high in summer 2022.

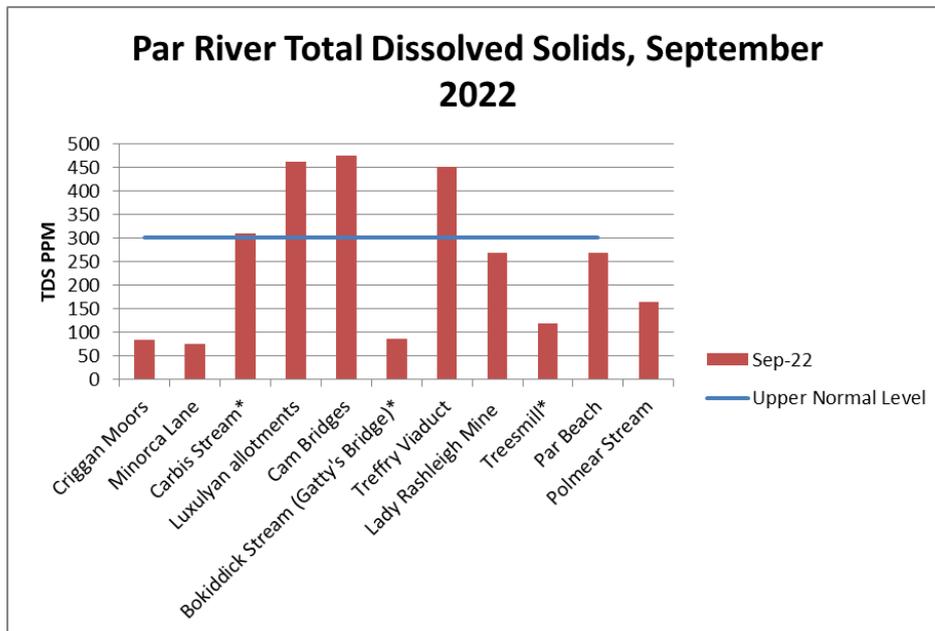
The WRT advice is: 'TDS levels vary between catchments due to natural geology etc. We generally say that after 6 months of sampling you should have an idea of what is 'normal' for your river. Looking at the scorecards for the Lower Par for 2020 and 2021 I would say that anything above 300 ppm is too high.'

N.B. The 'excess' TDS on the Carbis Stream coincides with, or is caused by, the resumption of china clay in the water; however, the markedly excessive readings at 3 locations on the Par River cannot be explained.

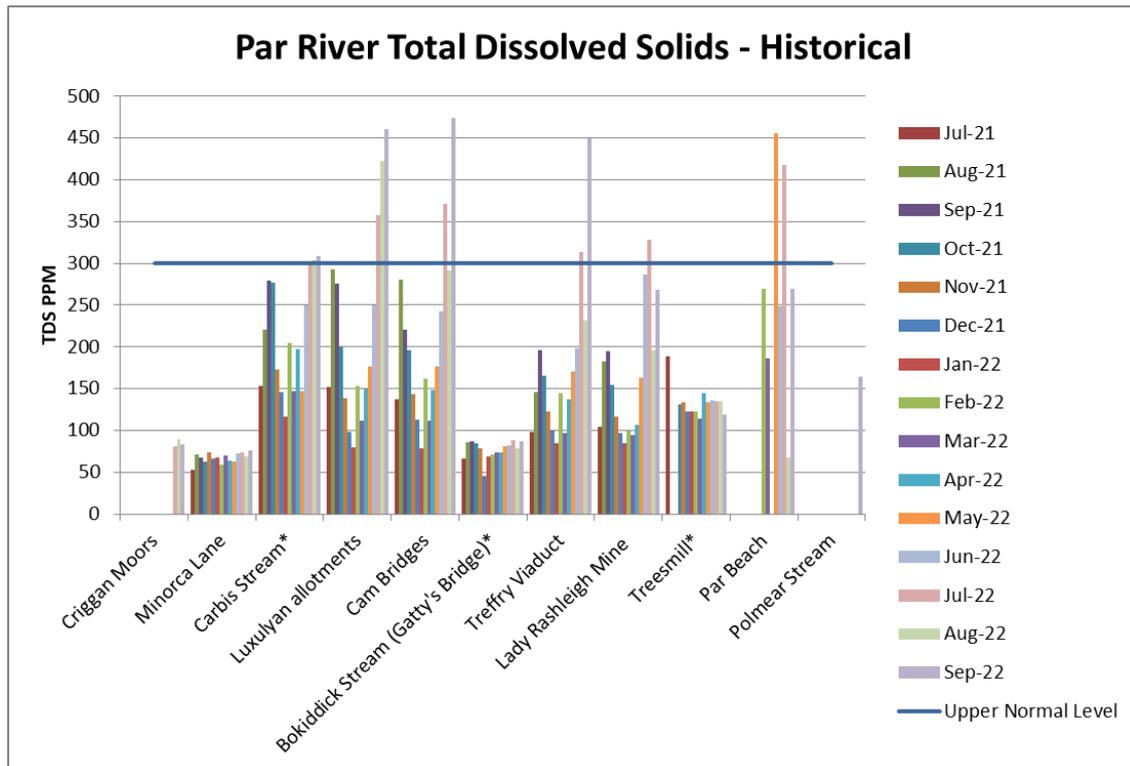
N.B. The sites most frequently exceeding the informally designated Upper Normal Level are downstream from St Austell North STW but correlation does not establish causation. Readings on the Carbis Stream often exceed those elsewhere but only triggered the Upper Normal Level this year. Low water levels might be an explanation of some of these readings if dilution increases the concentration of Total Dissolved Solids.

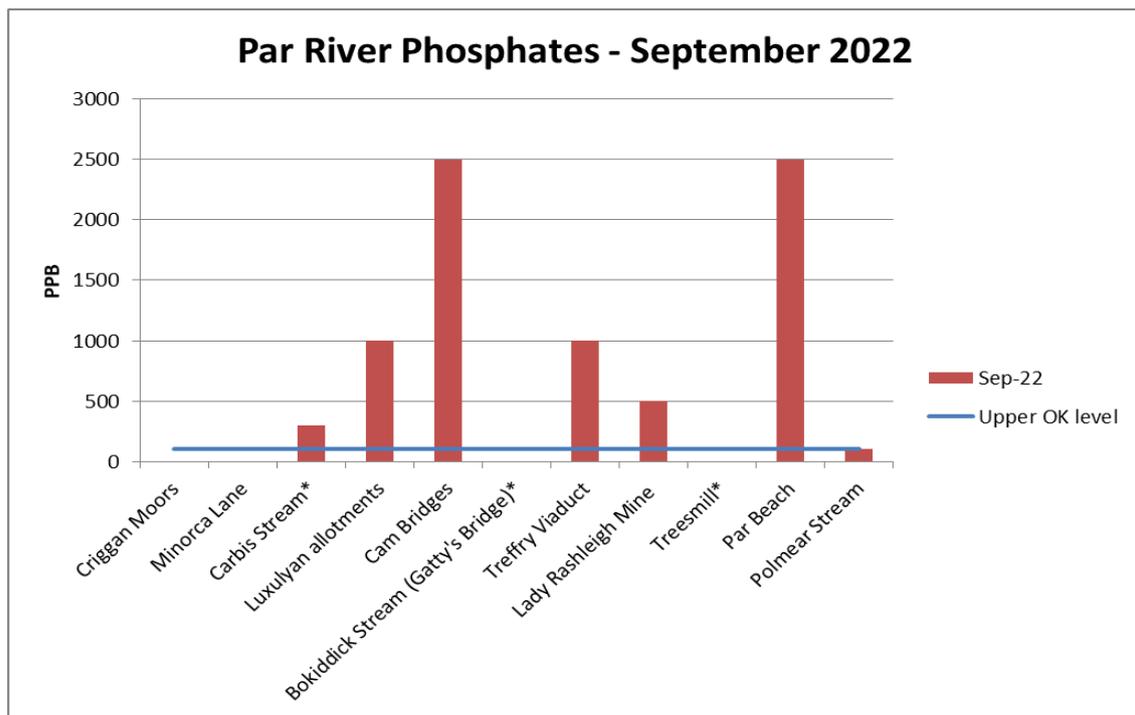
*indicates a tributary of the Par River. USL is 100 Parts Per Billion which, according to WRT, is the Upper Safe Level.

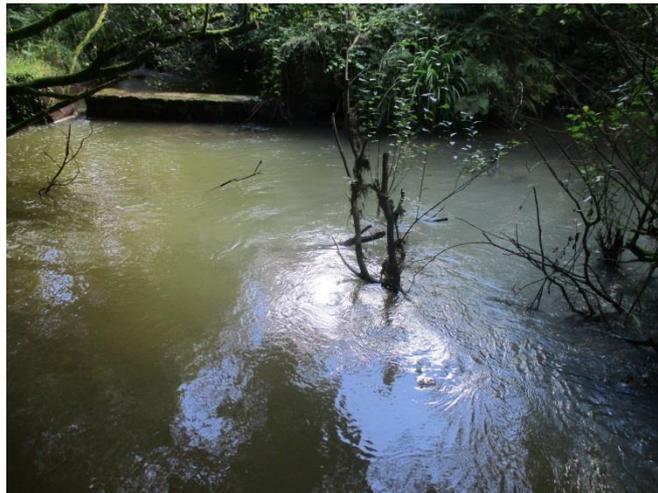
Bottom right – grey water from the Carbis Stream at the confluence with the Par River.
