WESTCOUNTRY RIVERS TRUST CITIZEN SCIENCE

MONITORING OF THE PAR RIVER AND ITS TRIBUTARIES

JULY 2022

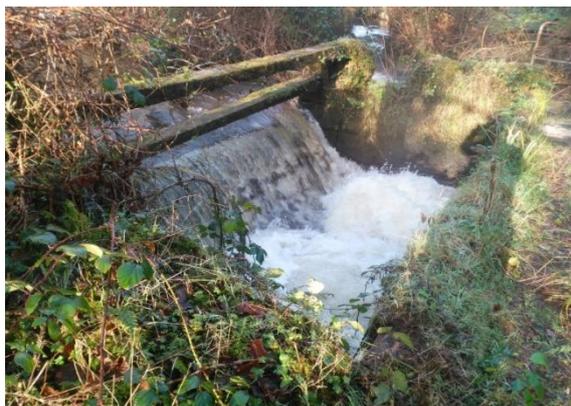
The weir at Cam Bridges: hindrance, historic asset – or both?
Photo: Joan Farmer

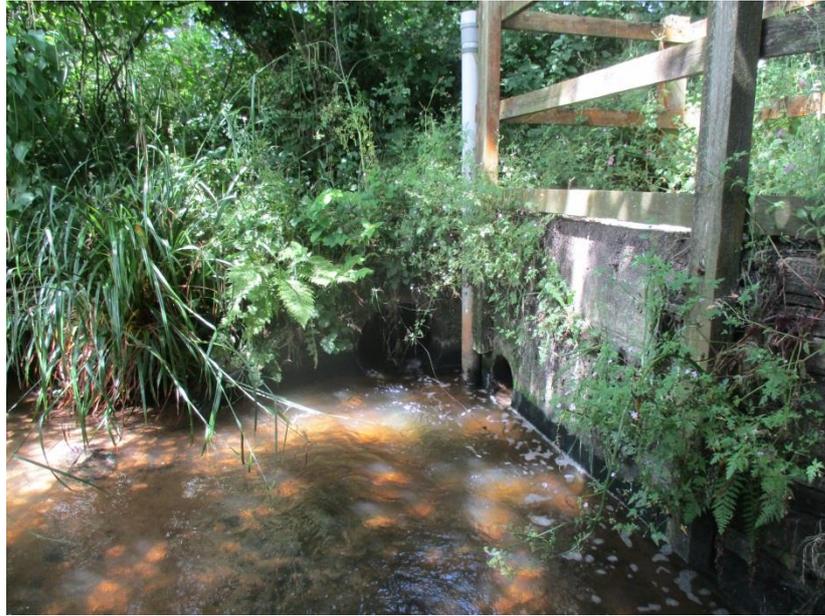
The sample was taken upstream from the STW and so would not have been affected by the two outfalls, one of which is a Combined Sewer Overflow, and was not discharging, and the main one, which was (see photo).

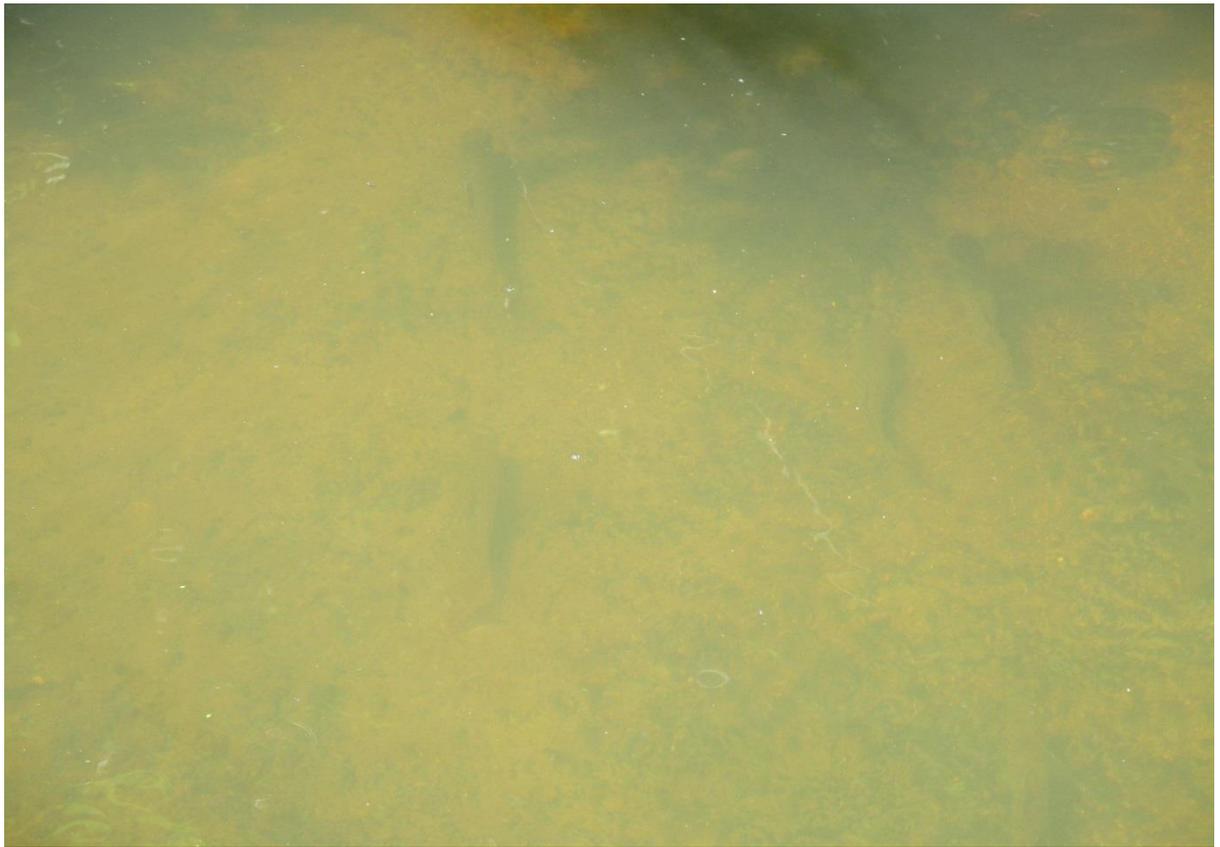
Fish in the Par River near St Austell North STW

The following photograph is not of good quality but shows fish in the Par River downstream from St Austell North STW at Luxulyan. This is not the first time that they have been seen here. It is impossible to give an accurate figure but the number was in double figures. The fish appeared to be about 6" to 8" in length.

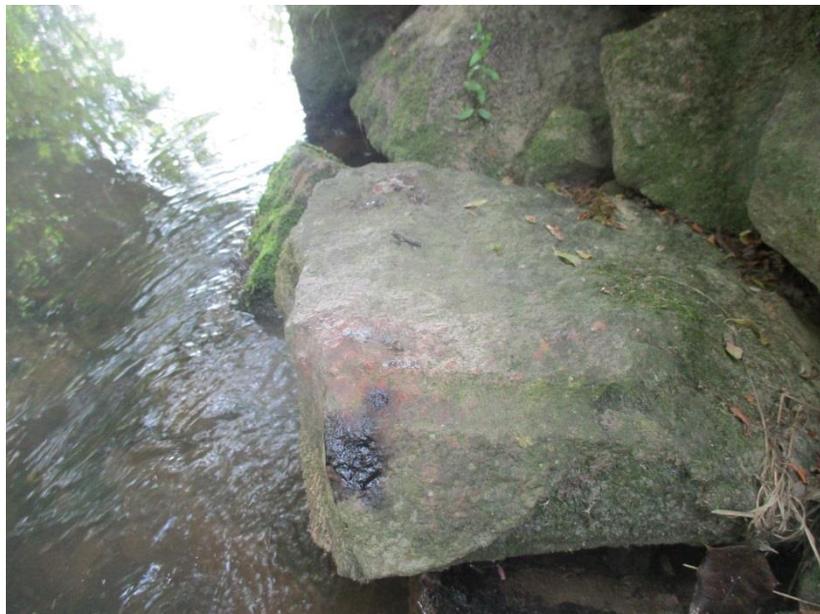
| EVIDENCE | SEEN/ ORKS* | LOCATION | NOTES |
|---|---|--|---|
| Staining | ? | SX 04747 58056 Luxulyan allotments boulder in river | Tarry deposit. Not sure it was from an otter. |

1. Staining (foreground) and old spraint on boulder near Luxulyan allotments (SX 04747 58056).

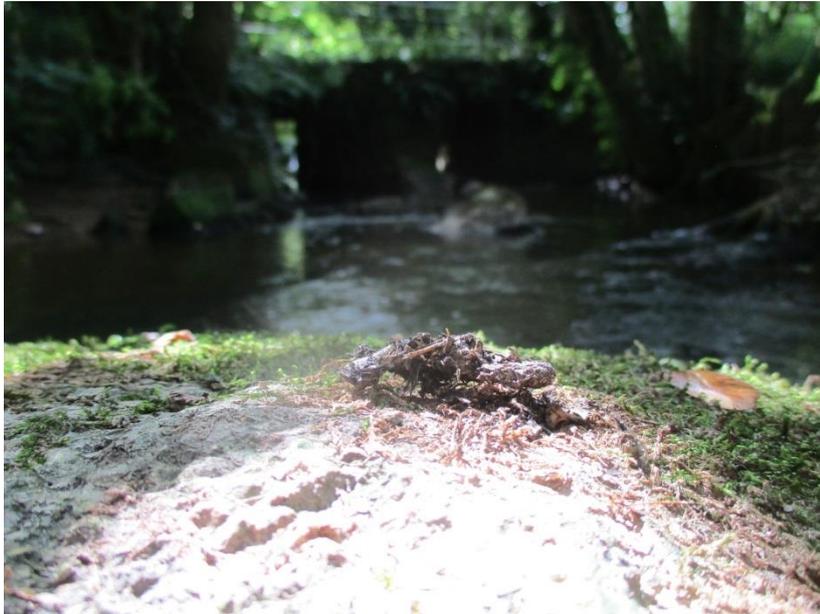
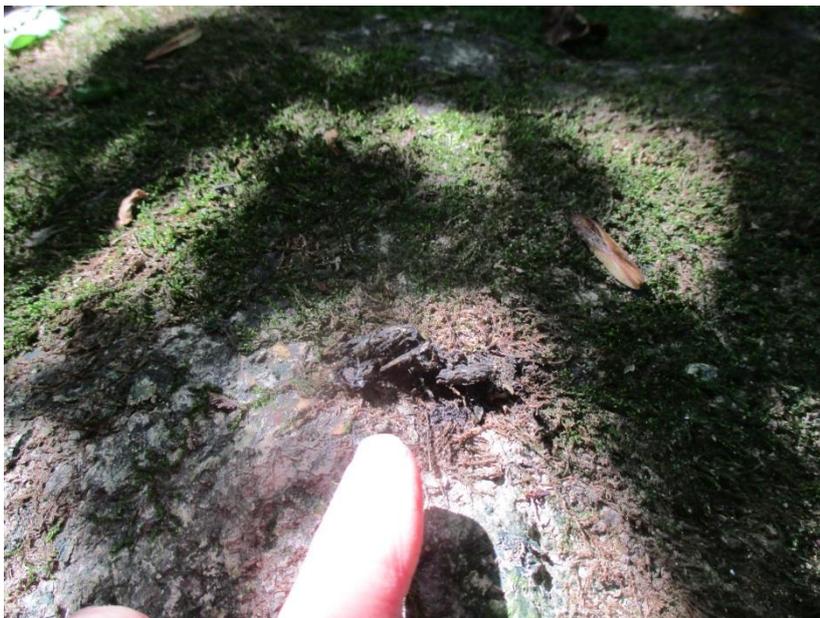
2. Recent spraint on boulder downstream of Cam Bridges (SX 0530 5745). This location has been checked on numerous occasions for the last 20 years or so but this is the first evidence of which I am aware.

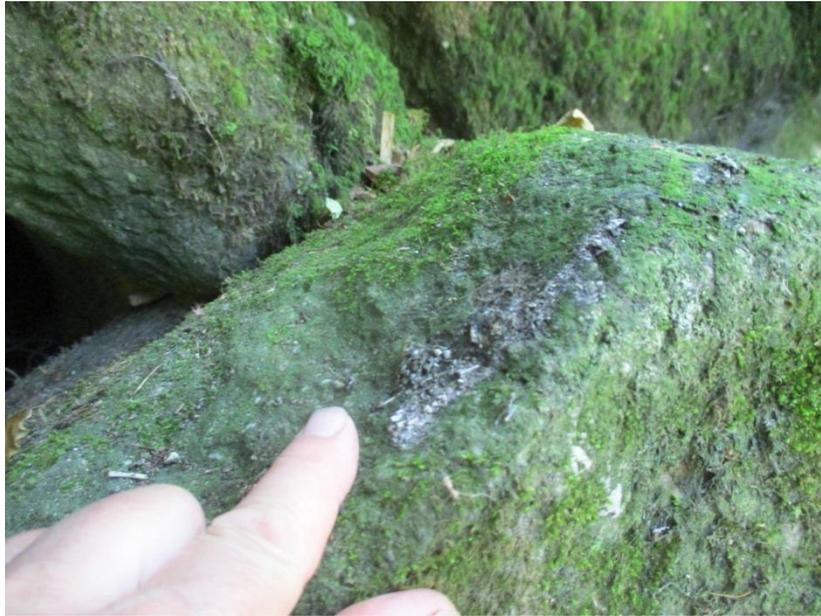
3. Old spraint on boulder near Lady Rashleigh Mine (SX 06456 56498), which is a regular sprainting spot.
