WESTCOUNTRY RIVERS TRUST CITIZEN SCIENCE

MONITORING OF THE PAR RIVER AND ITS TRIBUTARIES

NOVEMBER 2021

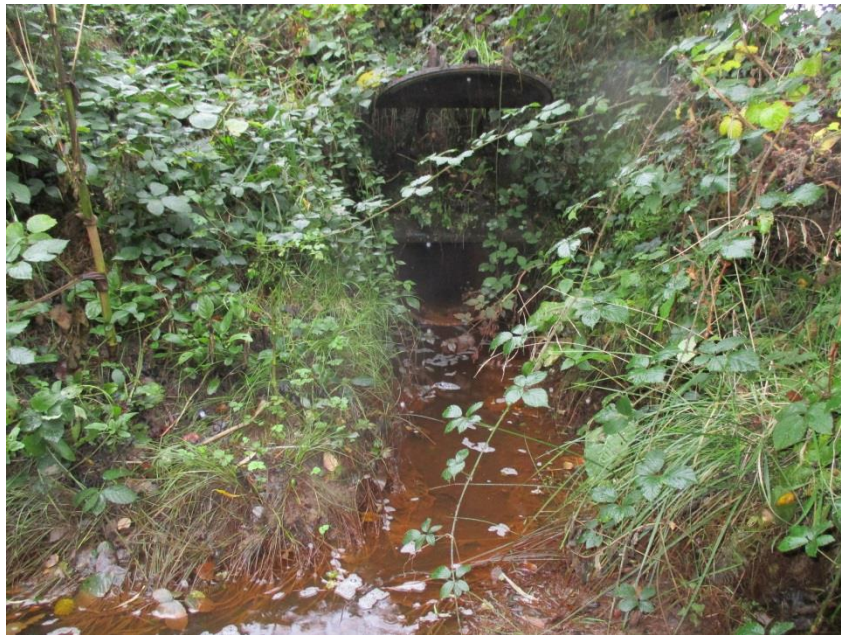
Outfall at SX 0447 5811 near Luxulyan STW: questions remain.

The new monitoring point was selected after very high phosphate levels were detected in October 2021. Two small outfalls from field drains next to the previous monitoring point were thought to have been diluting readings. Two outfalls from the STW are known. An EA investigation has confirmed high phosphate readings in this vicinity. Ammonia levels were recorded but our group does not know if these were significant. The purpose of the outfall at SX 0447 5811 is unknown. On this occasion only a trickle was emerging, yet the red-stained deposit was still evident (see photo on page 1).

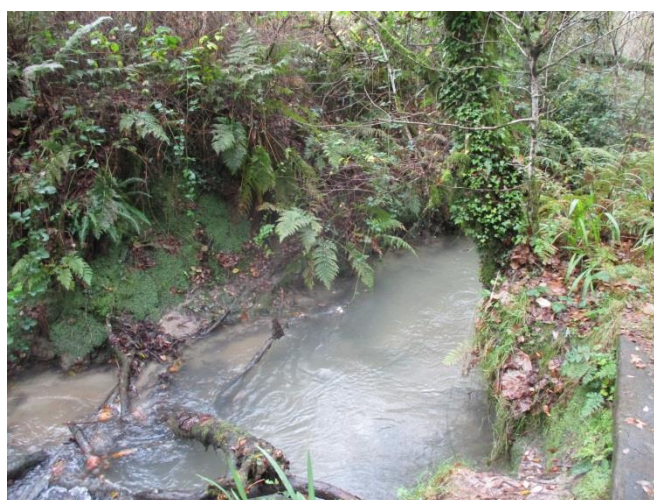
Carbis stream – white with china clay

Historic deposition of china clay is visible in the banks of the Carbis stream. It had been assumed that the clay in the water had eroded from the banks but this is an untested assumption. It has been noticed that this stream, where it runs parallel to the Bugle to Roche Road, also seems white on occasions. Perhaps the source of the clay is not the adjacent banks?

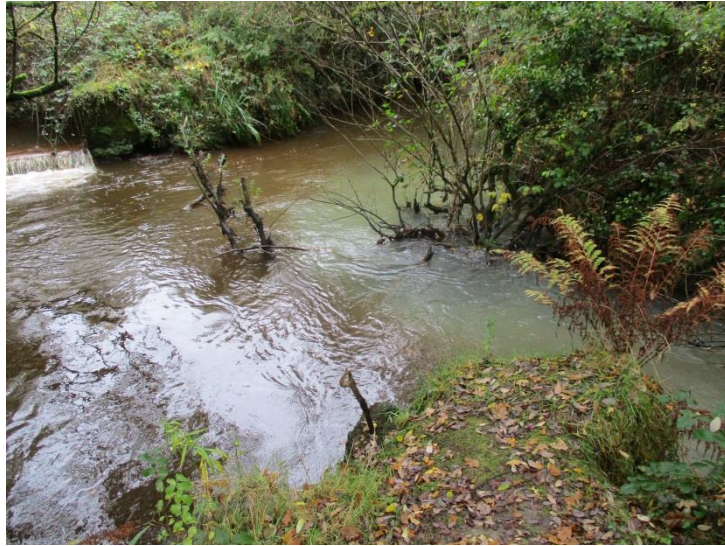
Confluence of the Carbis Stream and Par River – note the contrasting colours of the water

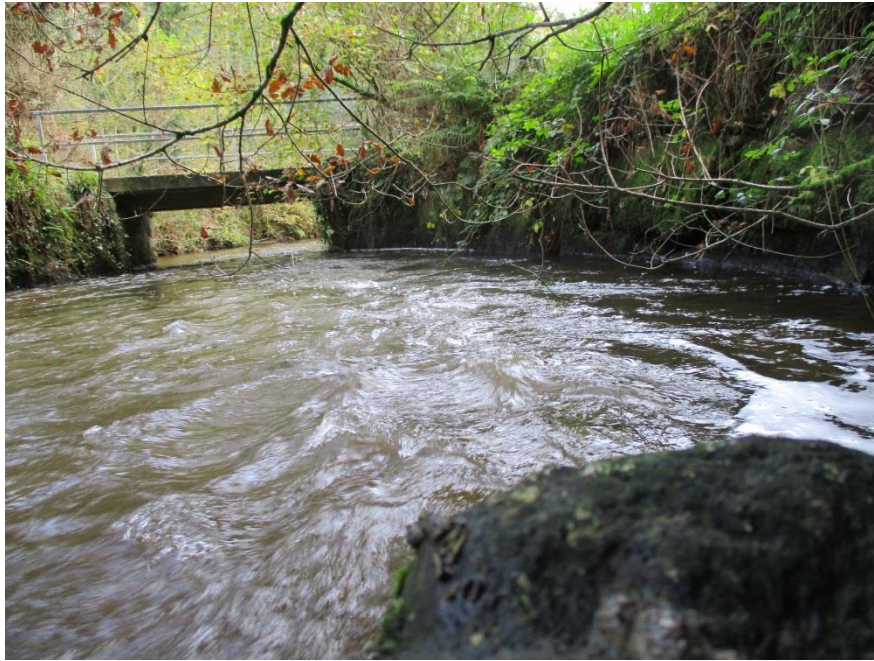
Boulder at Lady Rashleigh Mine (SX 06456 56498) with spraint on the left

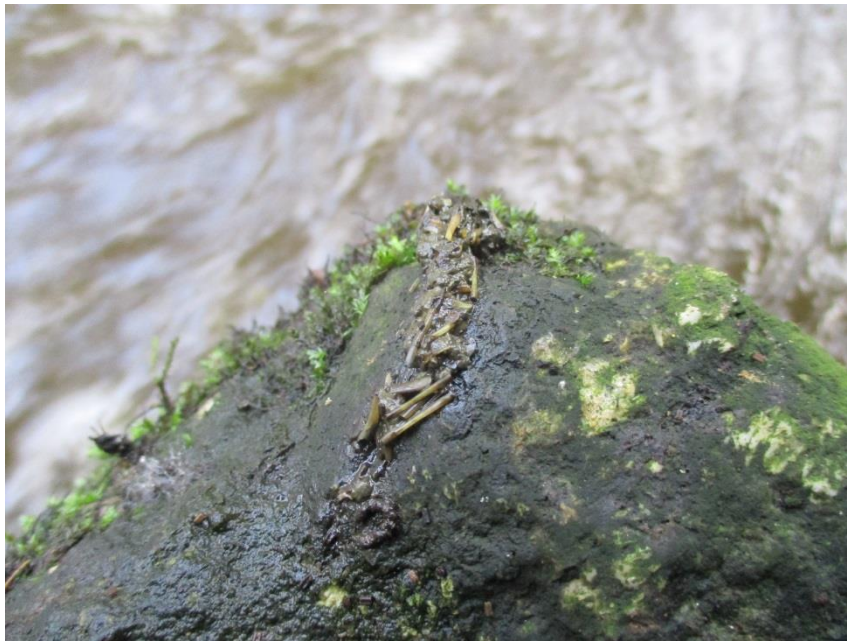
Close-up of spraint shows fish bones

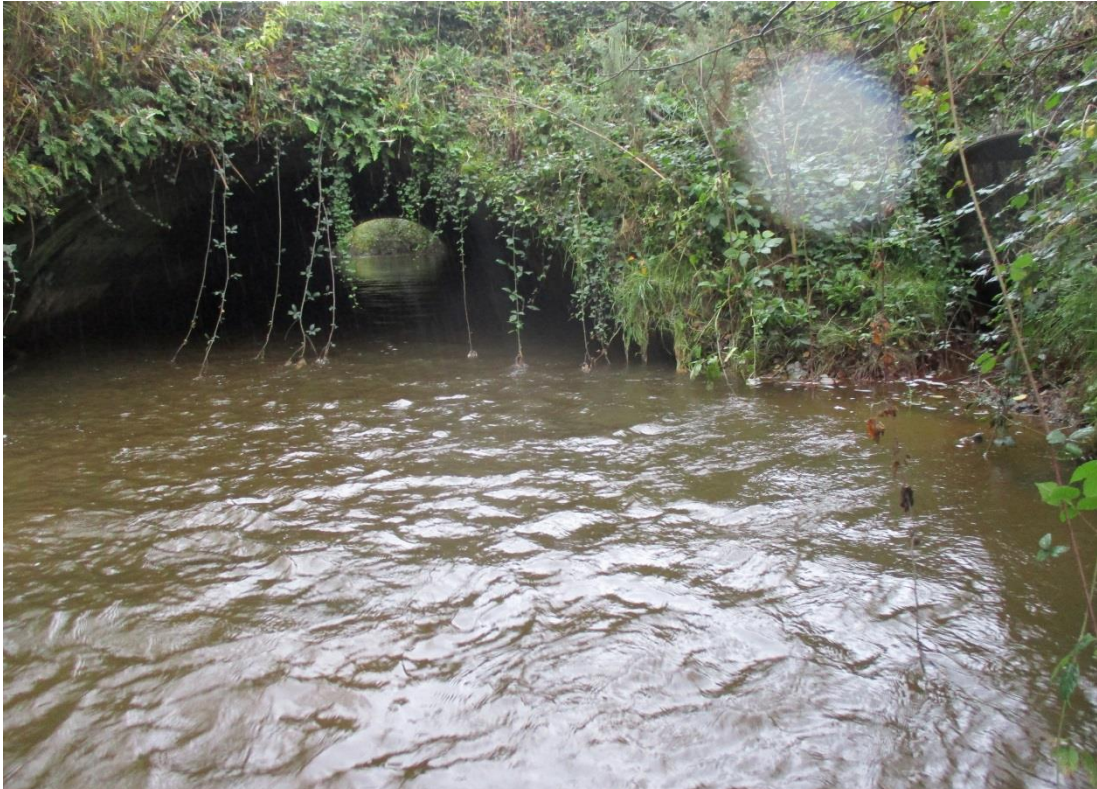
1. Phosphate levels were high but not as high as in October. This is first detected at about the new monitoring point downstream from the STW at SX 04472 58114.

Looking upstream from the new monitoring point at SX 04472 58114. The unexplained outfall is on the right. The known STW outfalls are upstream from the far end of the bridge.

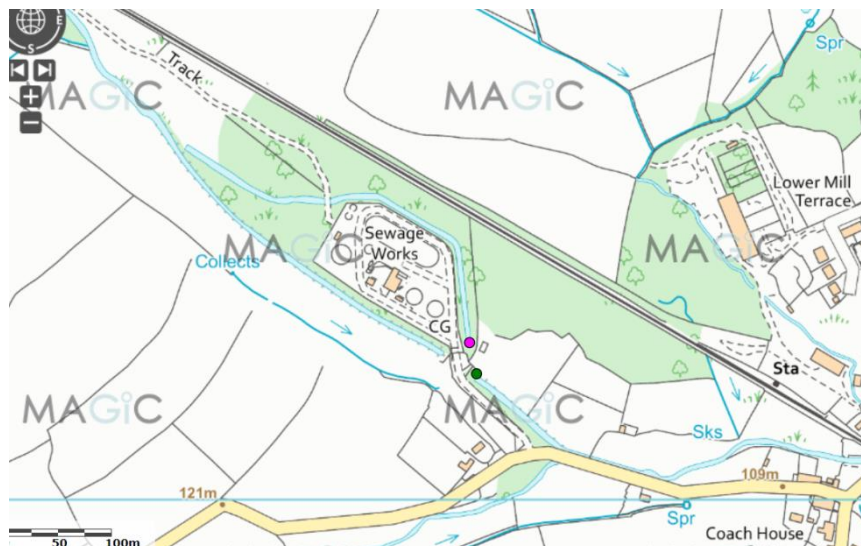
2. Our group awaits the conclusions of the Environment Agency following our report to their hotline last month. The outfall near the new monitoring point was only issuing a trickle this time but its purpose is unexplained. Is it linked to the STW? In the map below, the green dot is the mystery outfall while the purple one shows a watercourse flowing to the north of the STW. The 2 known outfalls are on the southern side of the works.
