MONITORING OF THE PAR RIVER AND ITS TRIBUTARIES

APRIL 2024

TRESKILLING STREAM MONITORING: ARMI RIVERFLY AND CSI SOUTH-EAST OF INNIS FISHERY, NEAR PENWITHICK

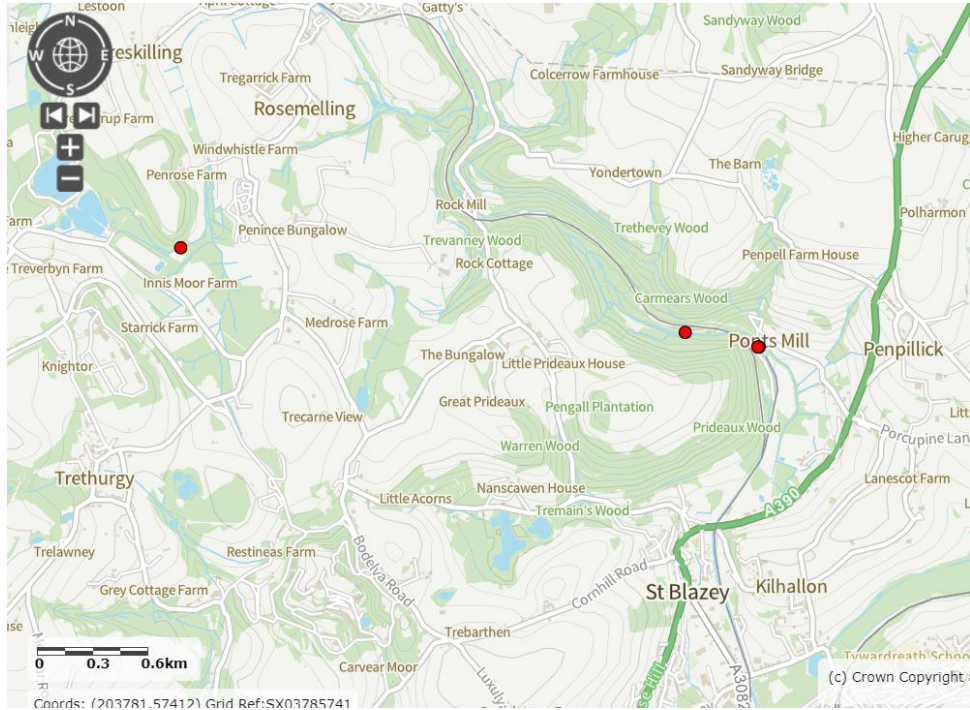
3. MAP

Red dots – definite evidence recorded on ORKS.

Black dots – possible evidence. Not recorded on ORKS.

Green dots – definite evidence but may have been recorded in the previous month, e.g. old spraint.

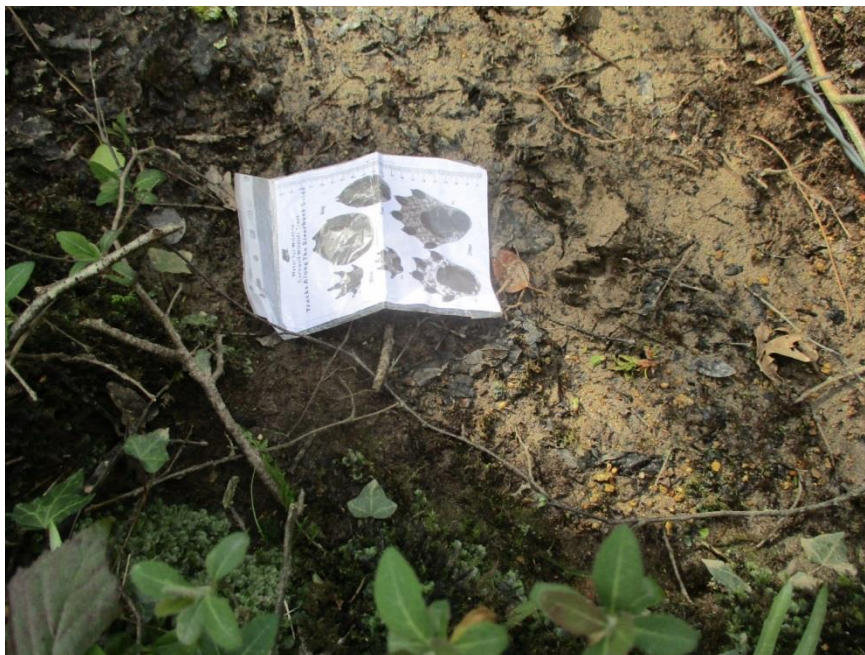
Otter prints near Innis mica dam

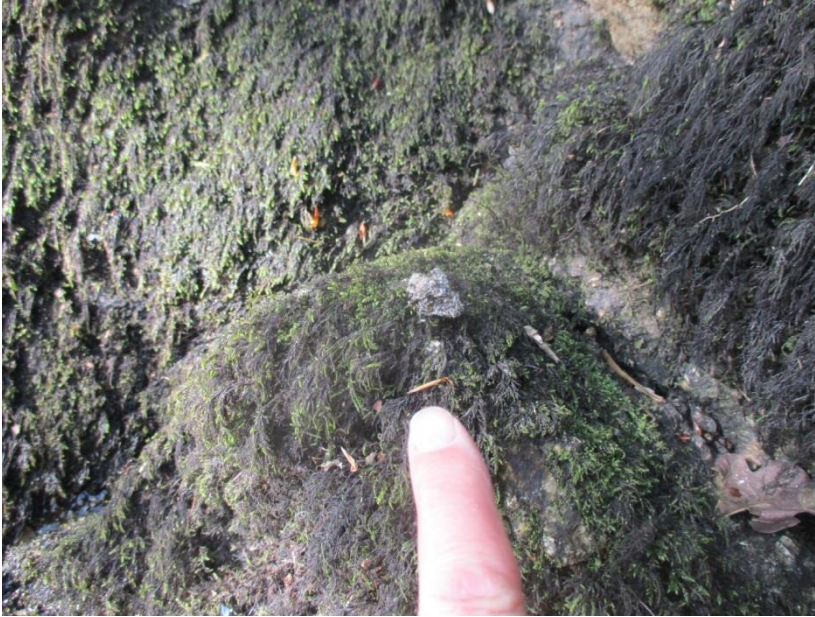
Spraint near Lower Tramway

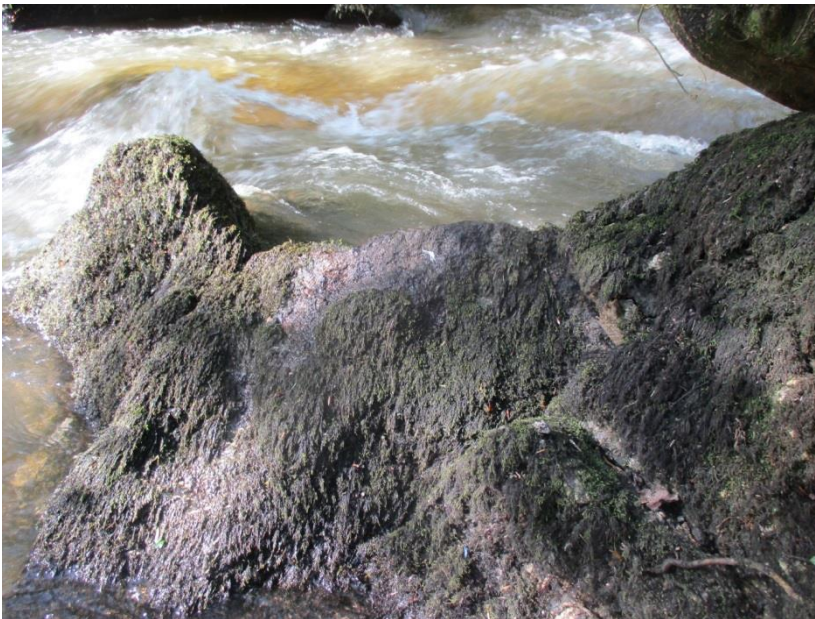
Rock where spraint was found near Lower Tramway, Luxukyan Valley

Evidence was found at two locations in Luxulyan Valley. Unfortunately, the closure of the footbridge downstream from Ponts Mill sluice gates limited the extent of the survey. Otter prints were found on the Treskillling (or Treverbyn) Stream near Innis mica dam (and close to Innis fishing lakes). A fish (roach) was caught during the riverfly survey at the latter site.

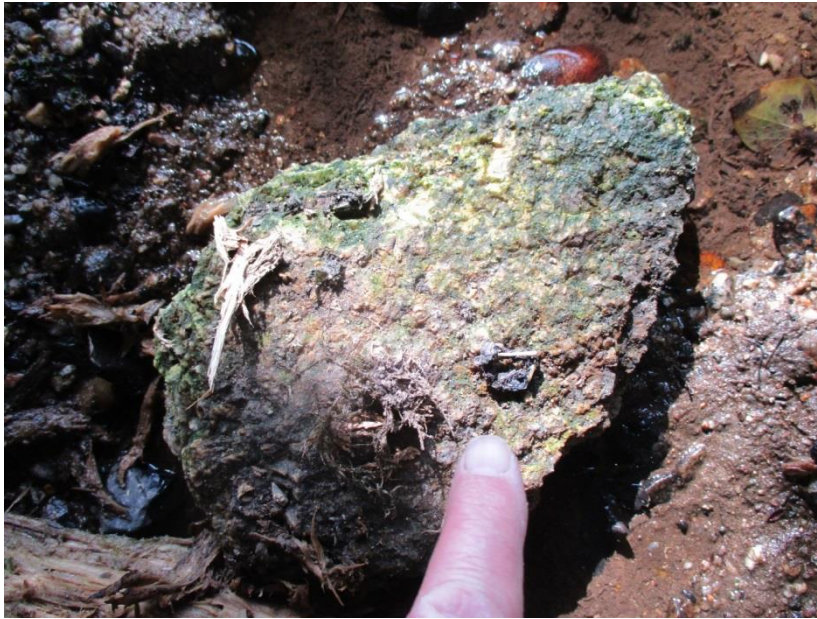
Spraint under Ponts Mill canal bridge

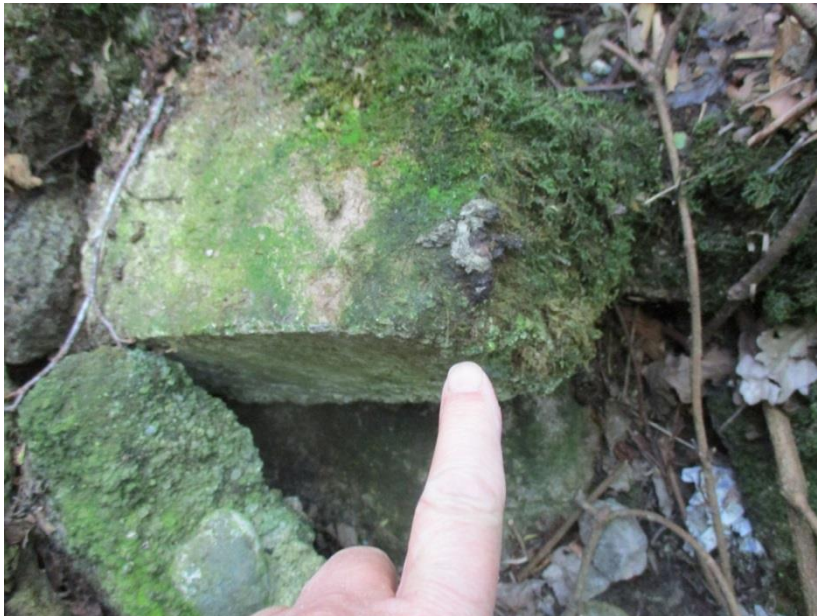
Spraint in gully upstream of Ponts Mill canal bridge

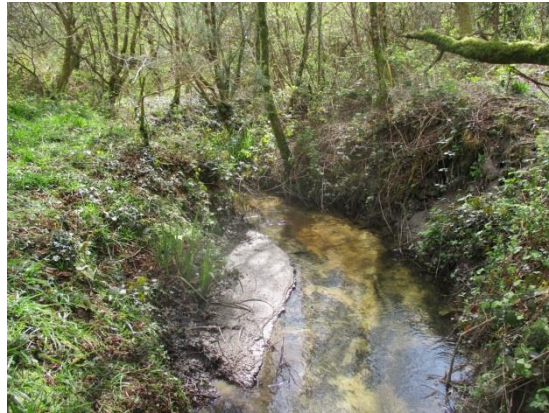
Site 1 Black dot SX 04058 56650: Treverbyn/Treskilling Stream upstream from confluence with Innis Stream.

Monitoring was conducted on the Treverbyn/Treskilling Stream upstream and downstream of the confluence with the Innis Stream, which is ochre-stained as a result of flowing through former tin-streaming ground.

Looking upstream

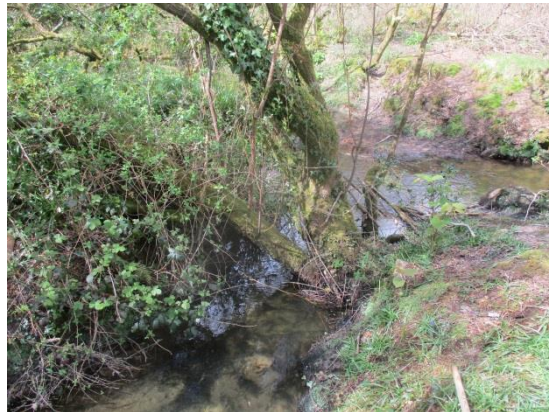
Looking downstream towards confluence with Innis Stream

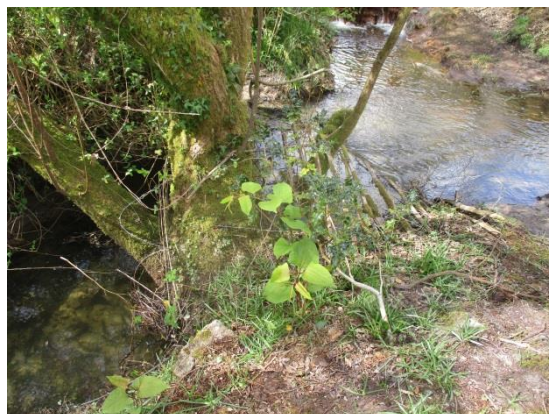
Japanese Knotweed

Our opinion is that the amount of Japanese Knotweed has increased significantly, especially at the downstream site but we can't provide evidence for this.

(b) Japanese Knotweed on the Treskilling Stream near Innis mica dam is a concern.

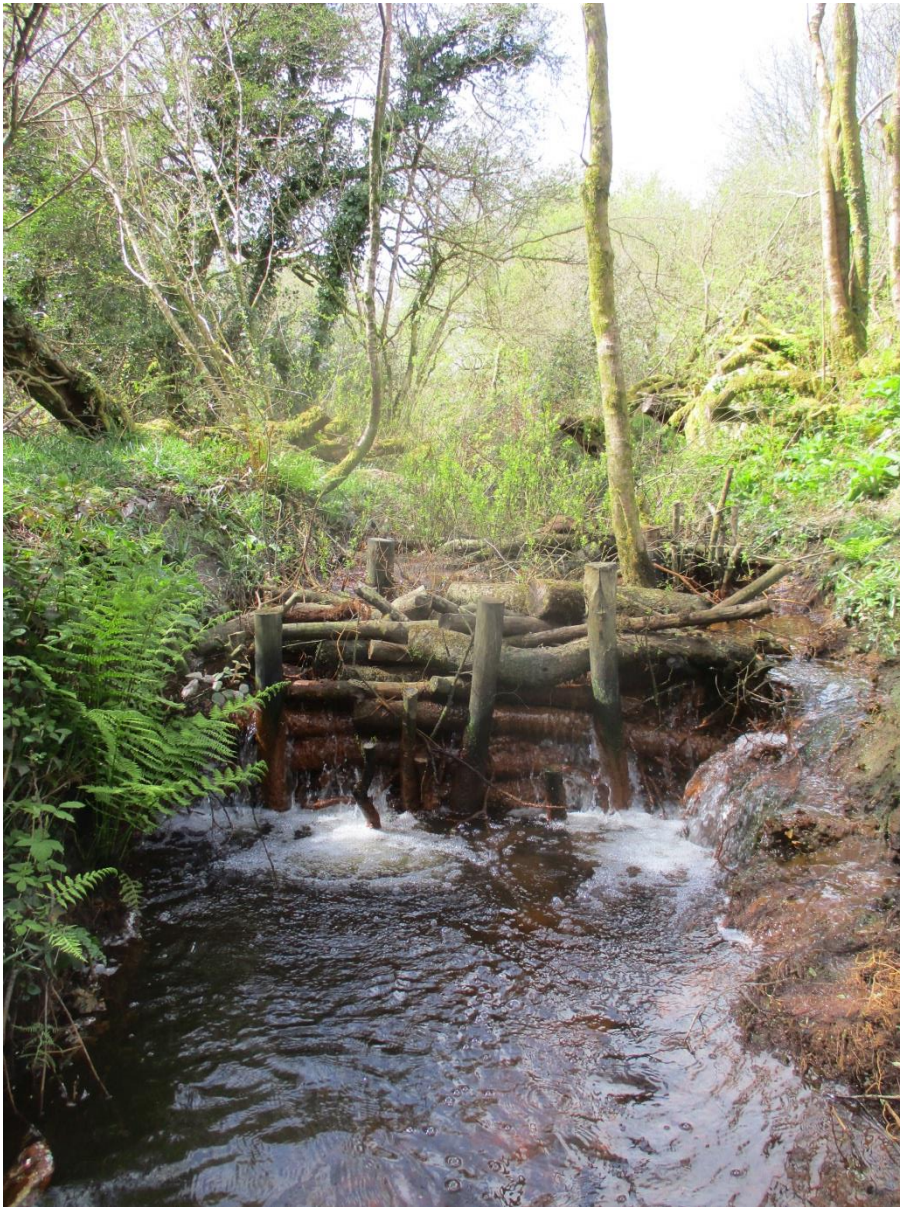
Leaky dam on Innis stream upstream of confluence with the Treskilling Stream

(b) The habitat work carried out on the Treskilling Stream by WRT and the EA, including a leaky dam is creating an impressive, pleasant location on a former industrial site, showing what can be achieved in difficult locations. One sign seems to be a reduction in ochre downstream from the dam.

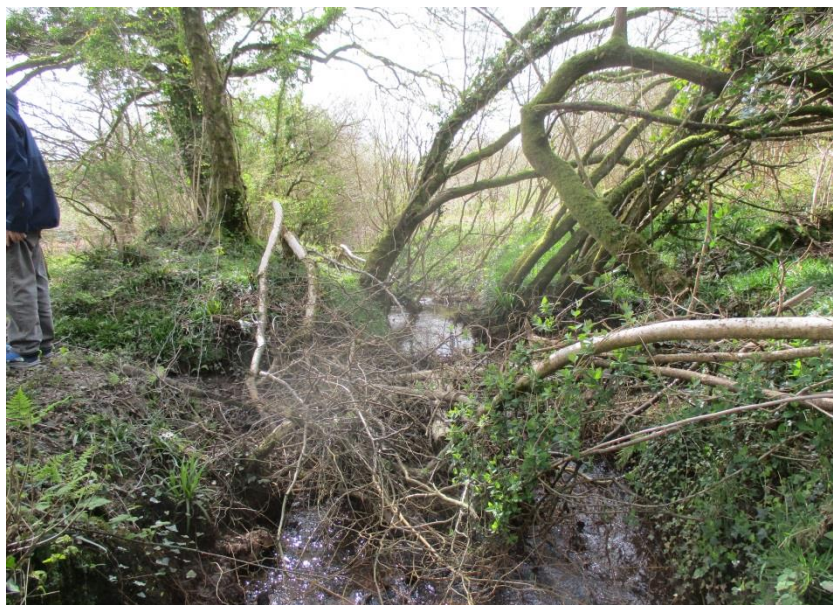
Looking upstream. Note brash placed in stream.

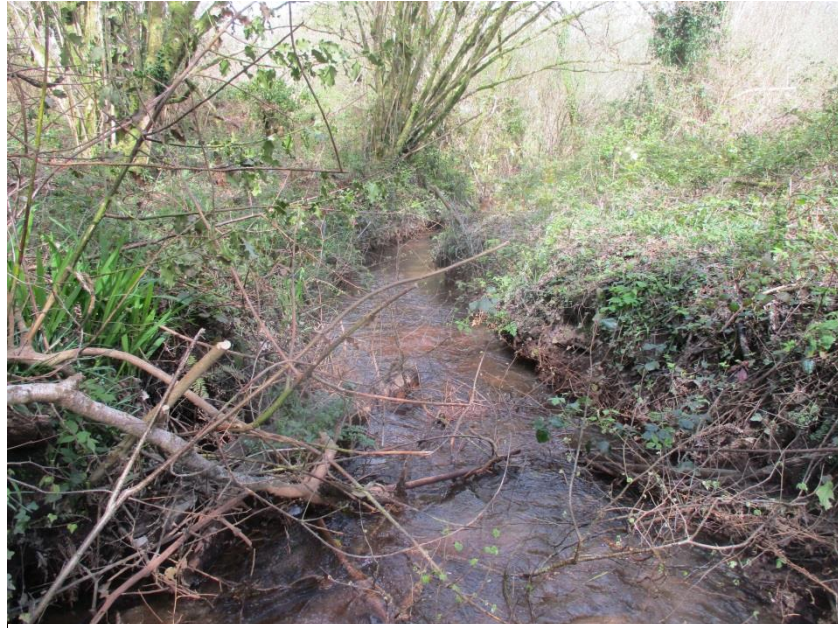
Looking downstream. Note slight tinge of ochre.

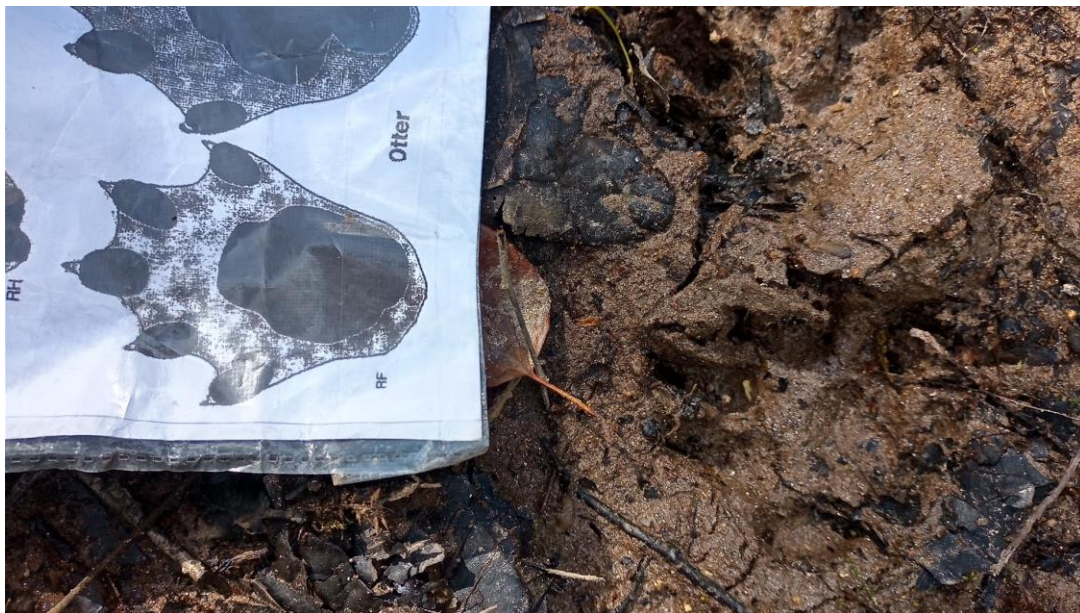
Otter footprint. Photo: Dave Burrell
