MONITORING OF THE PAR RIVER AND ITS TRIBUTARIES

The monitoring group operates under the citizen science scheme run by the Westcountry Rivers Trust. Comments and opinions in this report are those of the authors only.

DECEMBER 2023

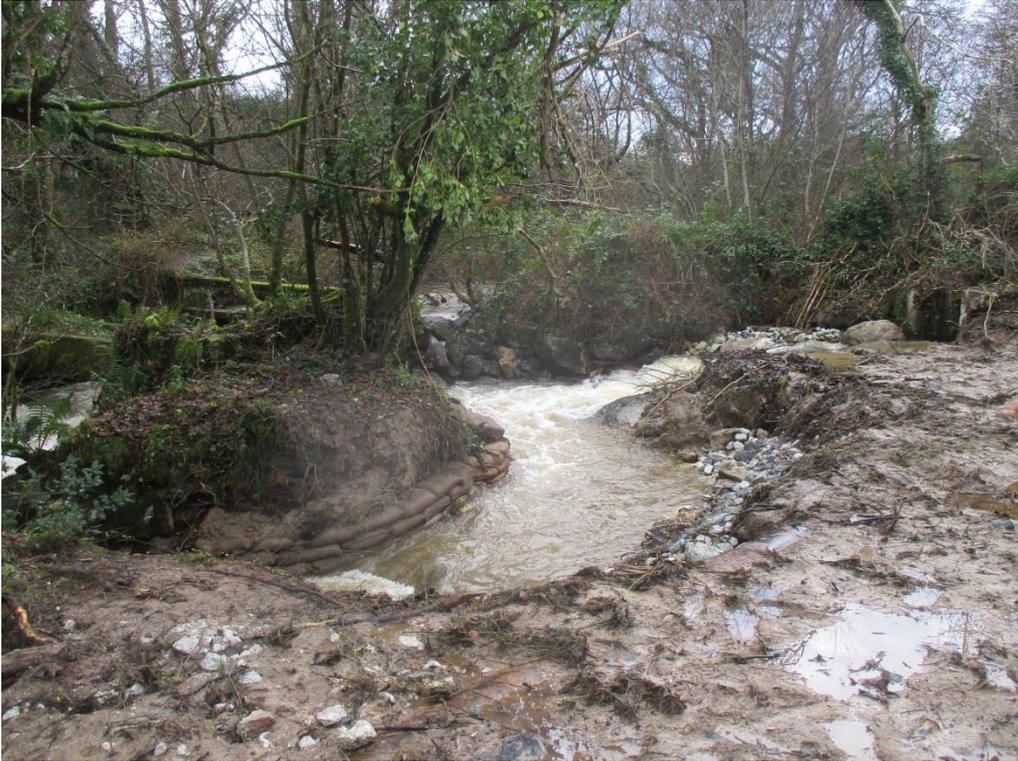
Recently works have been carried out near Cam Bridges weir. It is hoped that the channel to the right will serve as a fish-pass.

(c) Recent work on the bank at Cam Bridges has created a potential fish passage although further work might be required to make it more manageable for fish.

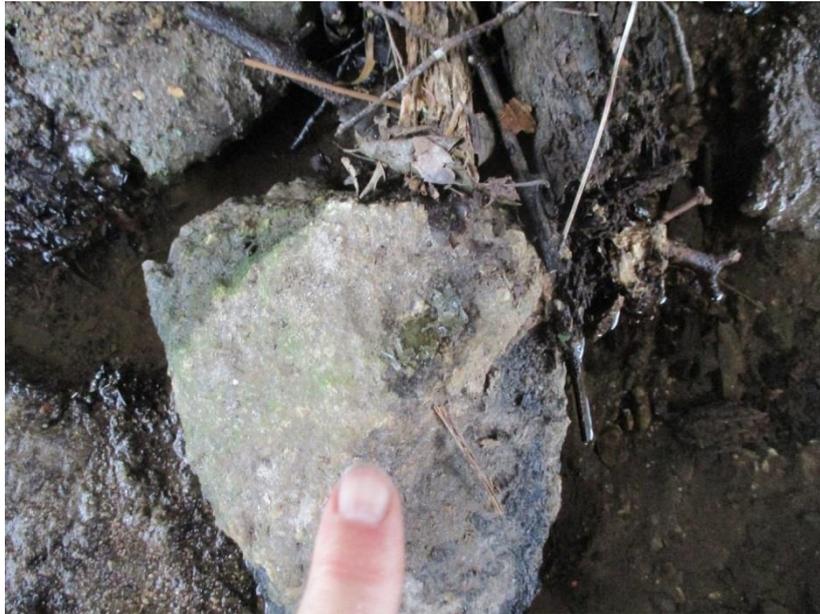
Recent spraint under canal bridge, Potts Mill

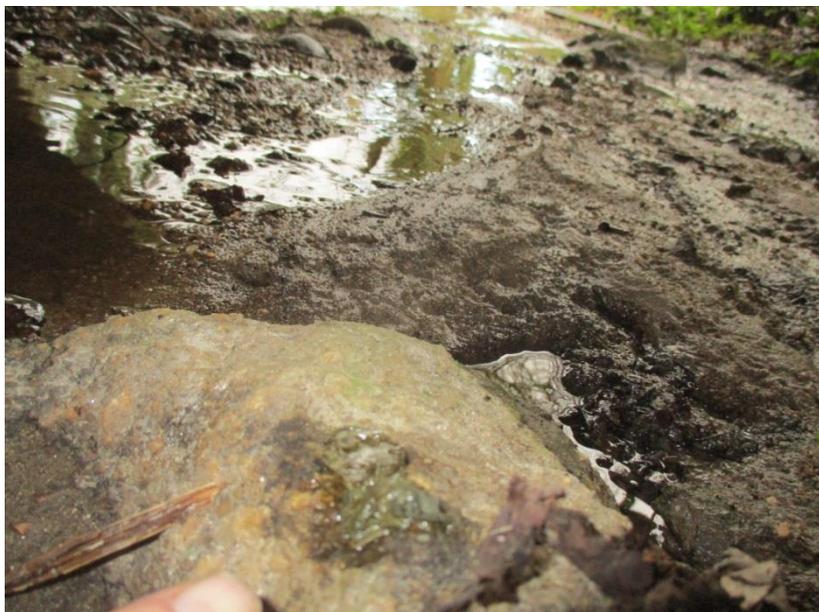
Recent spraint under canal bridge, Potts Mill

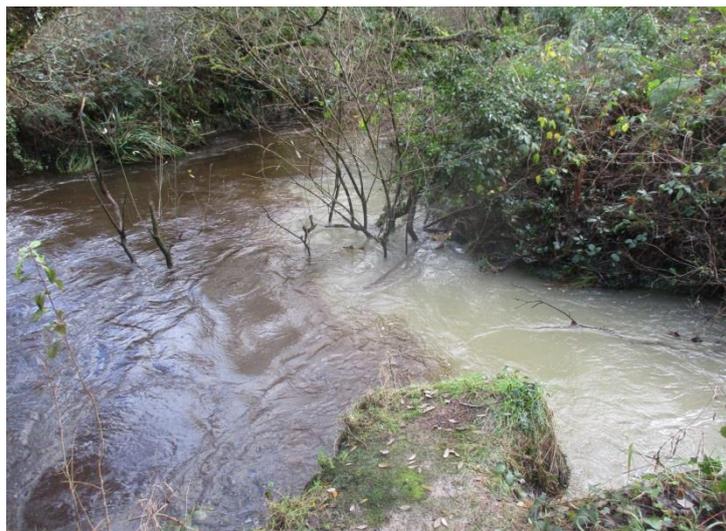
(d) The water on the Carbis Stream was white once again, after several months of being clear. This may have resulted from china clay being washed from the banks by the increased flow following very heavy rain, rather than an increased discharge.

The white Carbis Stream entering the Par River near Higher Menadue.
