MONITORING OF THE PAR RIVER AND ITS TRIBUTARIES

The monitoring group operates under the citizen science scheme run by the Westcountry Rivers Trust. Comments and opinions in this report are those of the authors only.

MAY 2024

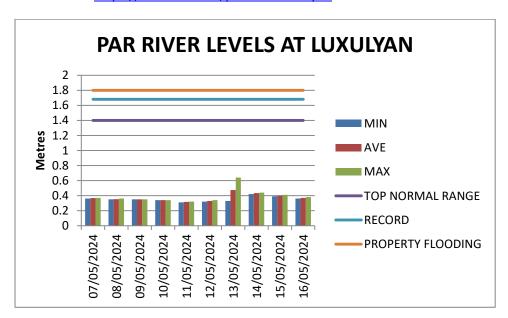
2. Par River levels at Luxulyan preceding and during surveys. These are available here: https://check-for-flooding.service.gov.uk/station/3159). The following graph uses data recorded at this website: https://riverlevels.uk/par-river-luxulyan.

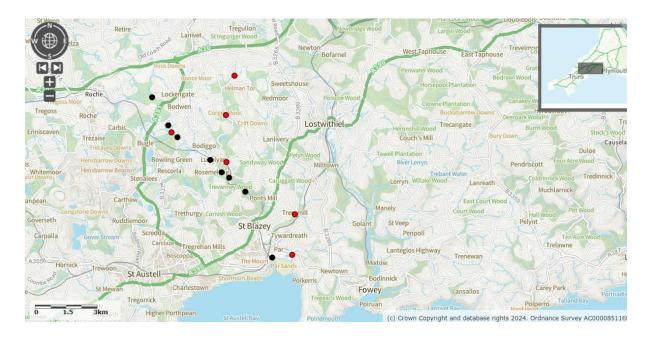
B. MAY 2024 MONITORING POINTS

This month monitoring occurred at 14 locations. Monitoring points along the main Par River are shown in black. Those in red are on tributaries. **Source:** https://magic.defra.gov.uk/MagicMap.aspx

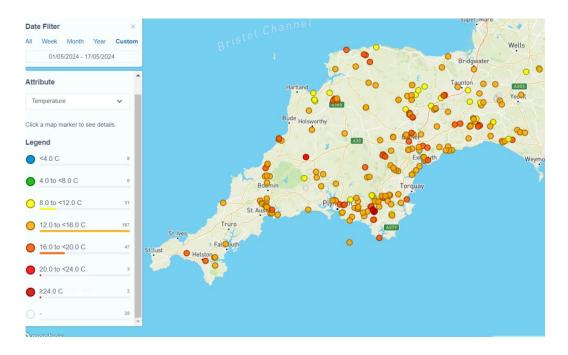
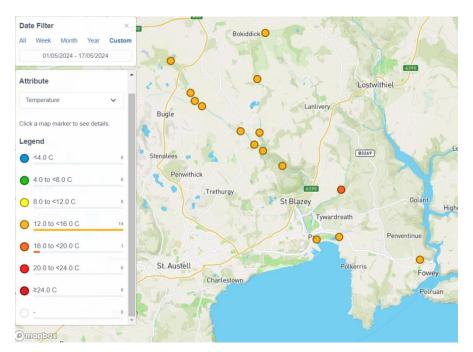
Geographical comparison. Source: Cartographer.

Results above the temperature at which fish and other organisms can function healthily will be shown in red. At present, 18 °Celsius is being used as the upper safe limit for fish and other creatures, although 20° Celsius has recently been suggested by WRT instead. The Yealm Estuary to Moor Project (YEM) in Devon considers that the upper safe level (USL) for temperature is 19.5 °C.

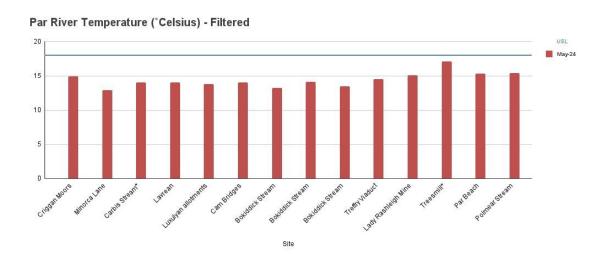
(a) This month

N.B. The third site shown for the Bokiddick Stream should be the first, i.e. at Trebell Green. This is due to a temporary technical insuperability and will be remedied in due course.

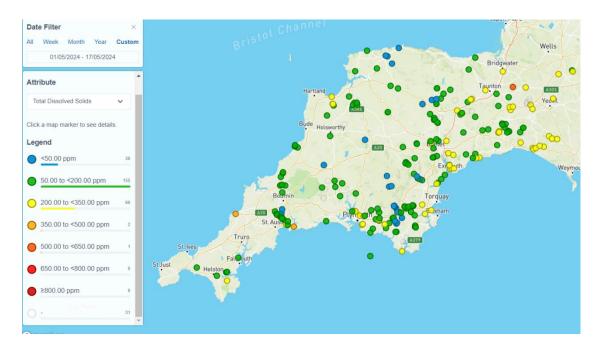
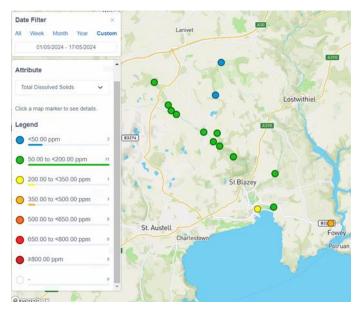
2. Geographical comparison. Source: Cartographer.

Total Dissolved Solids (TDS) is directly related to the conductivity of the water. The more minerals, salts and metals that are dissolved in the water the more conductive it gets. Low levels of dissolved solids in waters such as those on Dartmoor near to the source of the river are a result of very low levels of input from the surrounding landscape. As the river runs down to the sea it

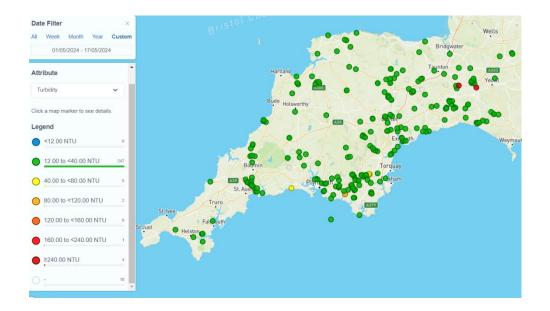
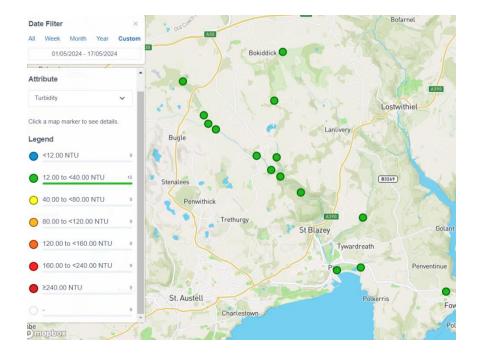
2. **Geographical comparison.** Where scores are shown as 0, it means that the reading using the Secchi tube was <12. Source: Cartographer. Most of our results should have blue dots (<12) but Cartographer shows them as 12 (green dots).

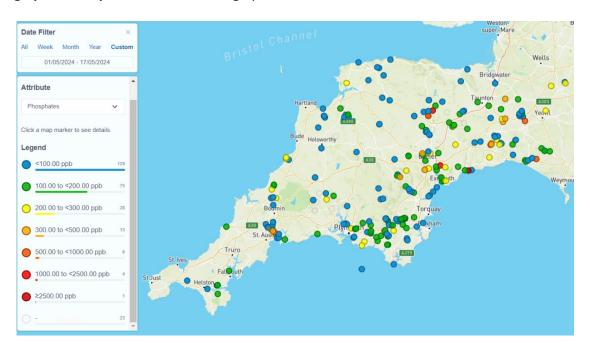
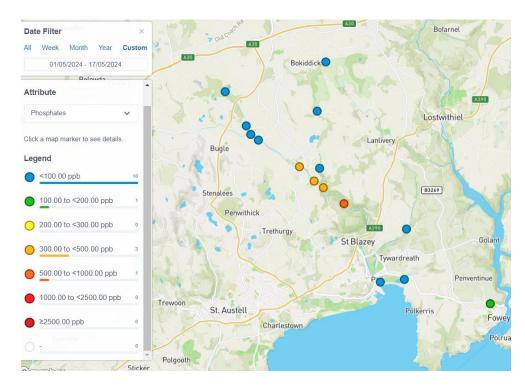
2. Geographical comparison. Source: Cartographer

Results in red show phosphate levels that are 'High'/above the upper safe level. WRT advice is that this is 100 Parts Per Billion (0.1 mg/l).

- (a) Phosphate levels on the Par River remain High and Too High (WRT classifications) downstream from Luxulyan STW.
- **(b)** An unpleasant odour persists near the main river from Cam Bridges downstream through Luxulyan Valley. This has been commented on by knowledgeable local people for a very long time. It is believed this may be related to the presence of sewage in the water but confirmation is needed.
- **(c)** High TDS levels at Par Beach Slipway, and, to a lesser extent on the Polmear and Treesmill Streams, are concerning.

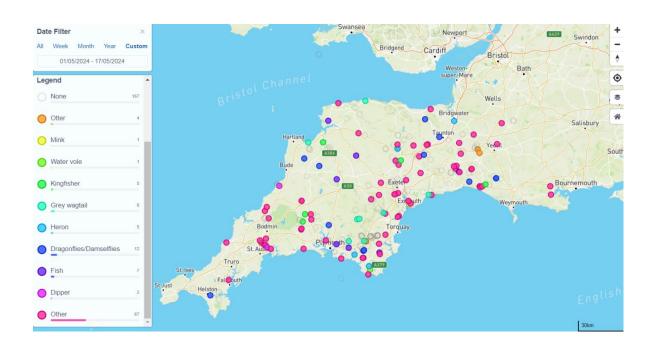
(a) Wildlife maps

Evidence of otters is found nearly every month, but frequently it is not found at our monitoring points and when it is it will be entered under 'Other' because live sightings are extremely rare.

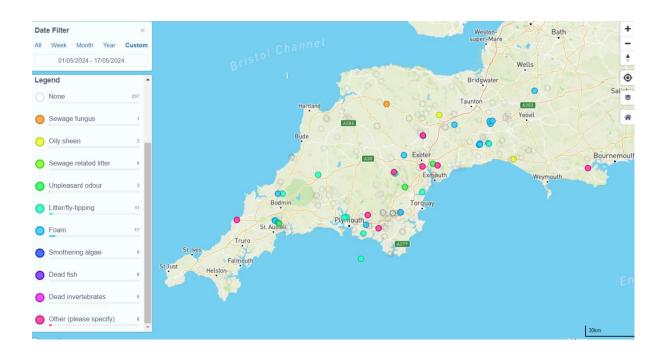
2. Evidence of recent pollution

EVIDENCE	, ,	Dipper, herring gull,	, , ,	Wren, chaffinch,
	robin, blackbird	Canada goose	blackbird	chiffchaff
EVIDENCE OF	Foam, smell	None	China clay	None
POLLUTION

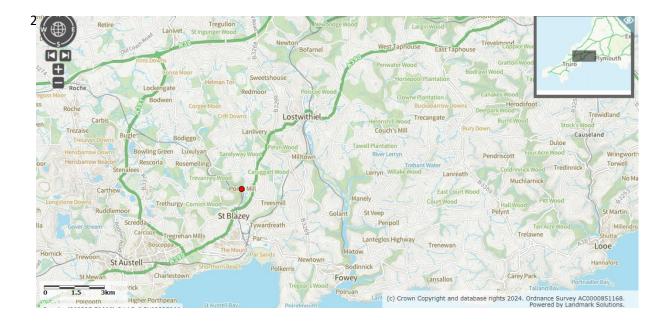
3. MAP

Red dots – definite evidence recorded on ORKS.

Black dots – possible evidence. Not recorded on ORKS.

Green dots – definite evidence but may have been recorded in the previous month, e.g. old spraint.

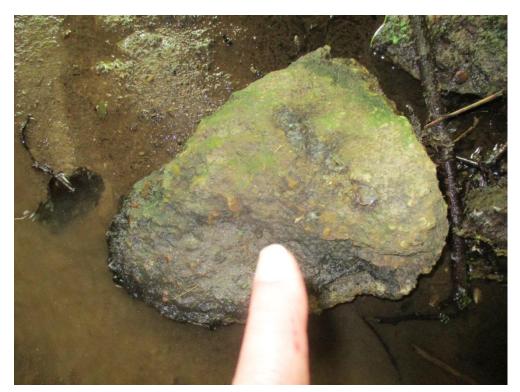
Spraint under the canal bridge at Ponts Mill

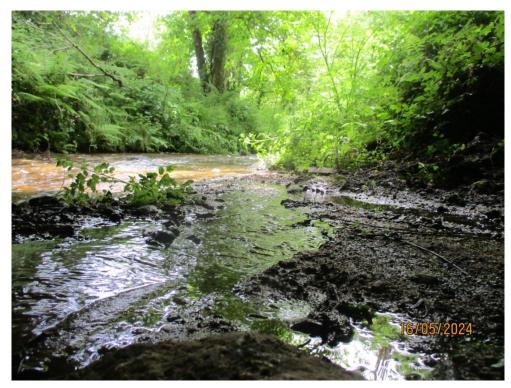
View downstream from Ponts Mill canal bridge at otter-level

Few signs were found, which may be due in part to high river levels following recent rain.

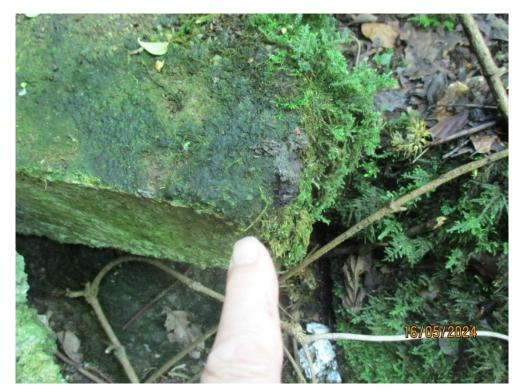
Old spraint in gully upstream of Ponts Mill bridge
