## WESTCOUNTRY RIVERS TRUST CITIZEN SCIENCE

### MONITORING OF THE PAR RIVER AND ITS TRIBUTARIES

**APRIL 2022**

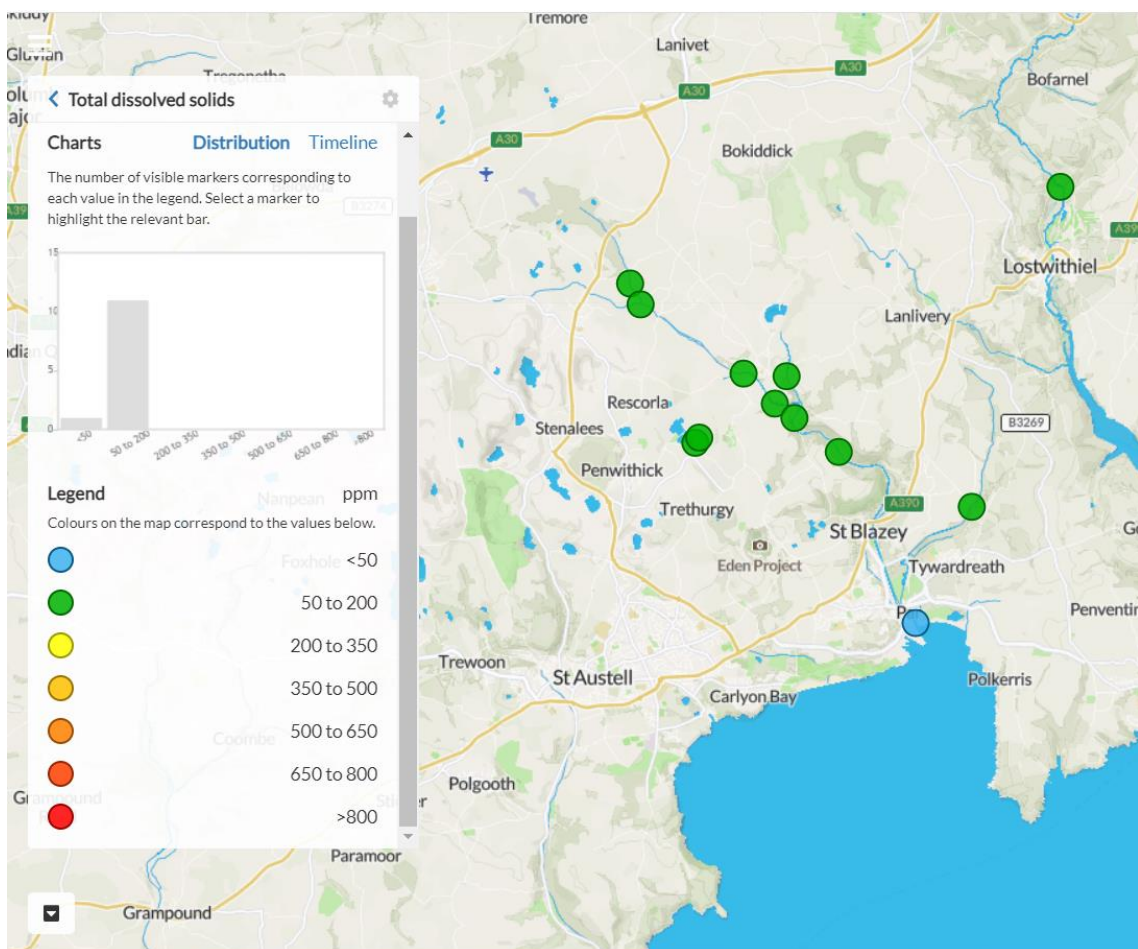
The reading of zero ppm at Par Beach is a surprise but is not the only such result in the region as this map shows:

N.B. The reading for Par Beach is surprising.

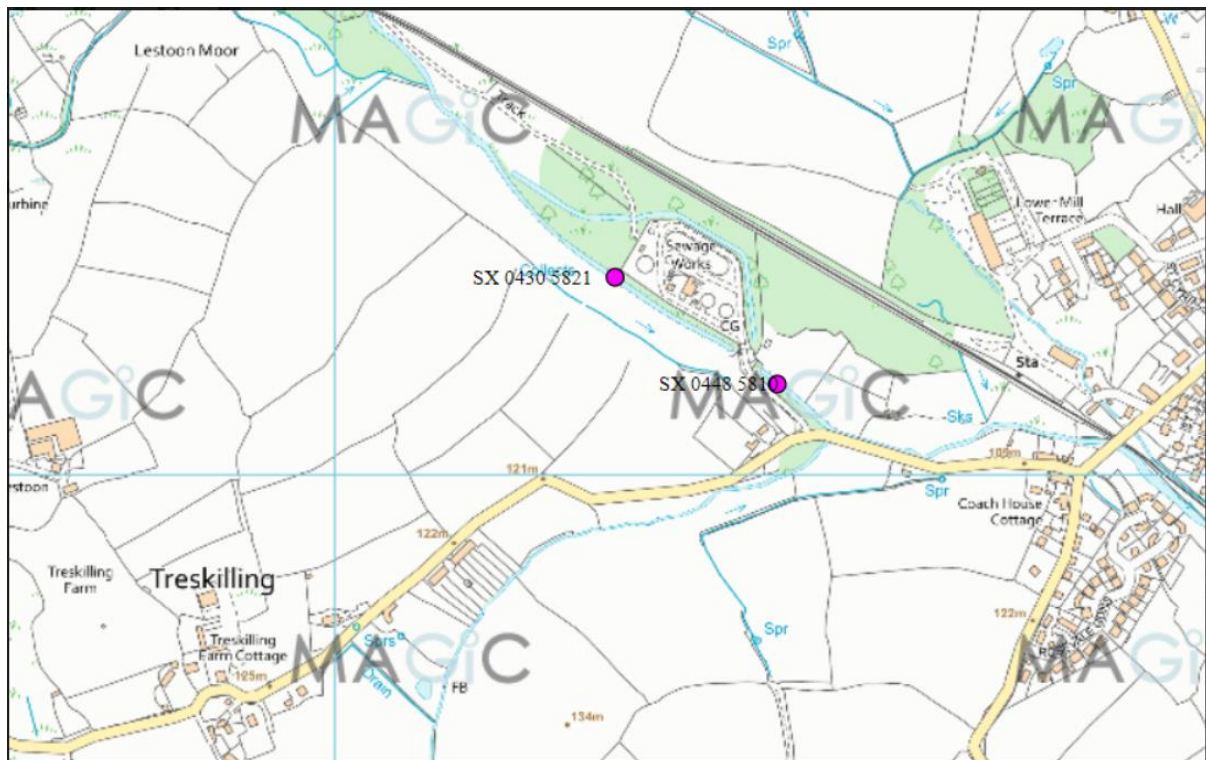
The new Rivers Trust Sewage Map (<https://theriverstrust.org/key-issues/sewage-in-rivers>) shows the 2 outfalls from this facility. Samples were taken upstream and downstream of the works.

I suggest that we seek expert advice, test where we have access about a mile upstream and downstream at our testing site in the allotments, next time.

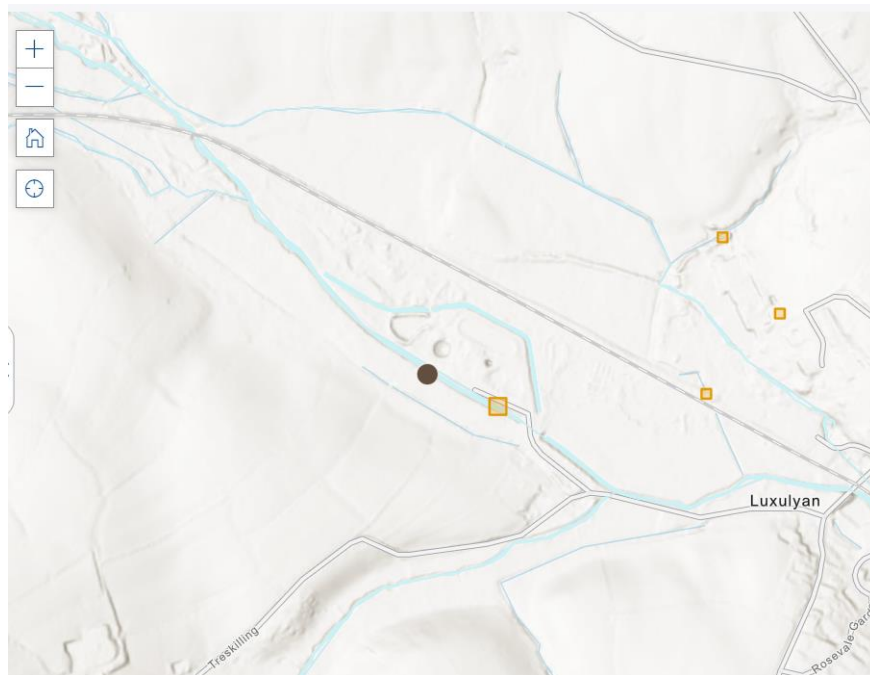
The outfall marked by the brown circle was inactive when the samples were taken. This is what The Rivers Trust has to say about it:
