WESTCOUNTRY RIVERS TRUST CITIZEN SCIENCE

MONITORING OF THE PAR RIVER AND ITS TRIBUTARIES

DECEMBER 2021

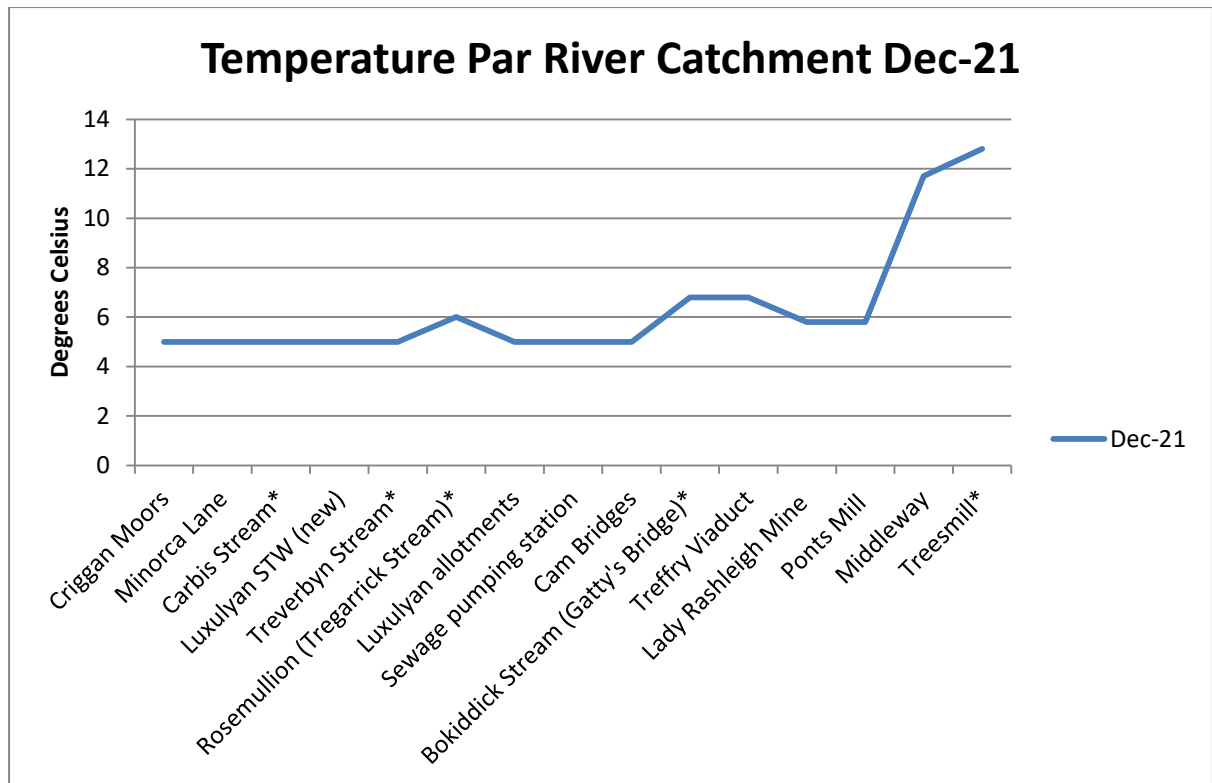
In the recent WRT webinar, Simon Browning emphasised the critical influence of temperature on fish, particularly their spawning, so the relatively high temperatures at Middleway and Treesmill may be noteworthy.

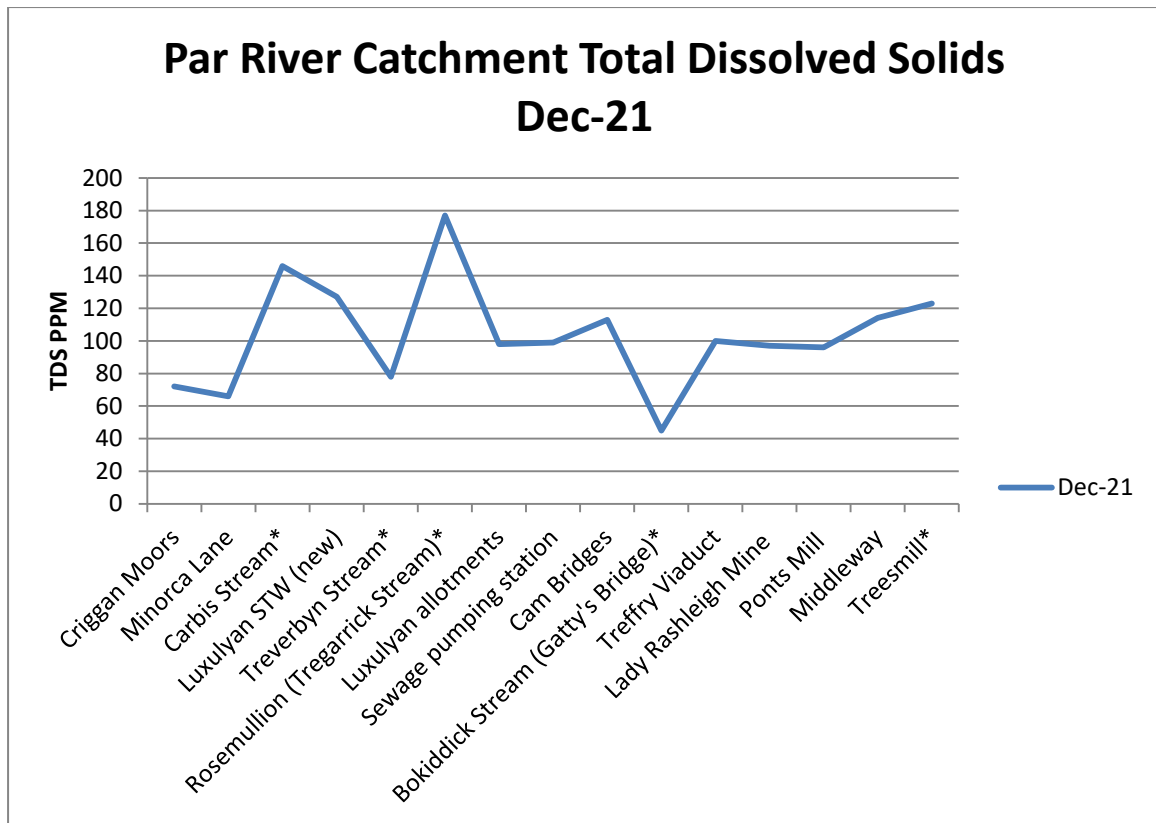
The highest readings were from the Tregarrick Stream at Rosemullion bungalow and the Carbis Stream near Higher Menadue/Lavrean. The former location is a stream containing a thick level of silt believed to have originated from slurry. At the latter, it is quite clearly china clay.

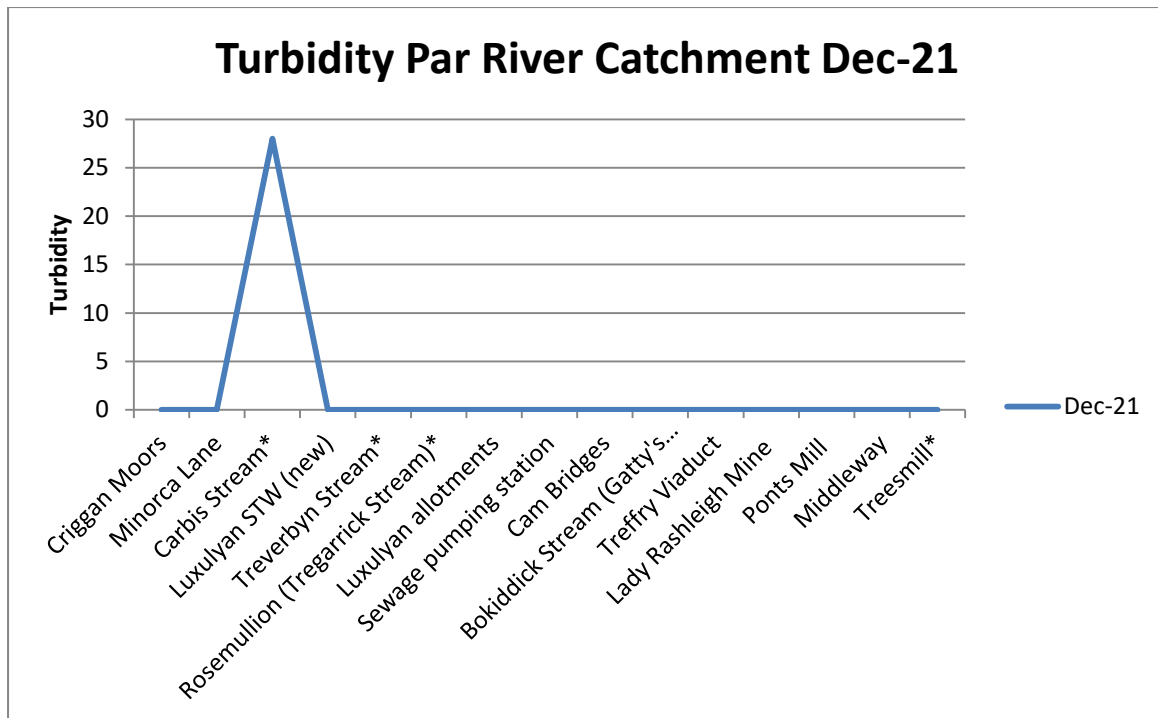
The outlier is the Carbis Stream, which, as shown in the section on Total Dissolved Solids, was running white with china clay.

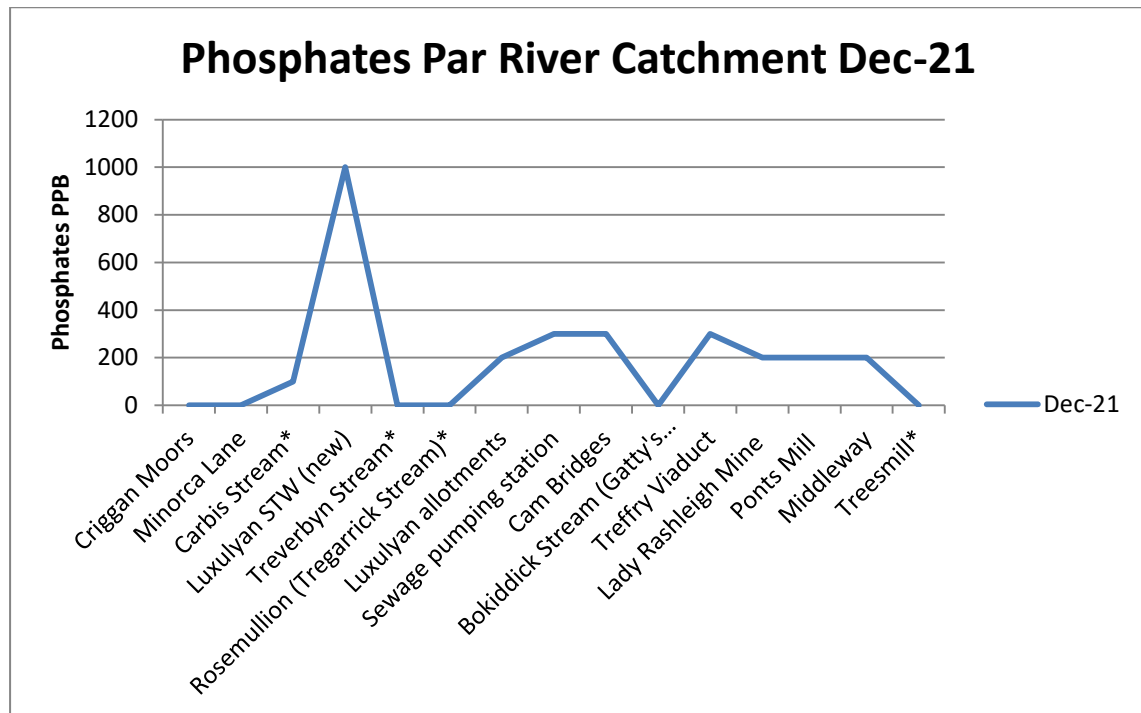
This month's readings were an improvement in that, with the exception of the reading nearest the STW, levels tended to be **High** rather than **Too High** (WRT grading). It isn't known if this was related to higher water levels or not. The Environment Agency has been in touch with South West Water after our group reported very high phosphate levels near the STW on 9th October 2021. Recently, strimming has taken place near our monitoring spot at SX 04472 58114 raising the possibility of activity in the vicinity but this might be irrelevant. Whether this means some sort of action has been taken to limit phosphates coming from the STW it is impossible to say. Our group hopes to learn more about the EA investigation but accepts that it may take some time to complete.

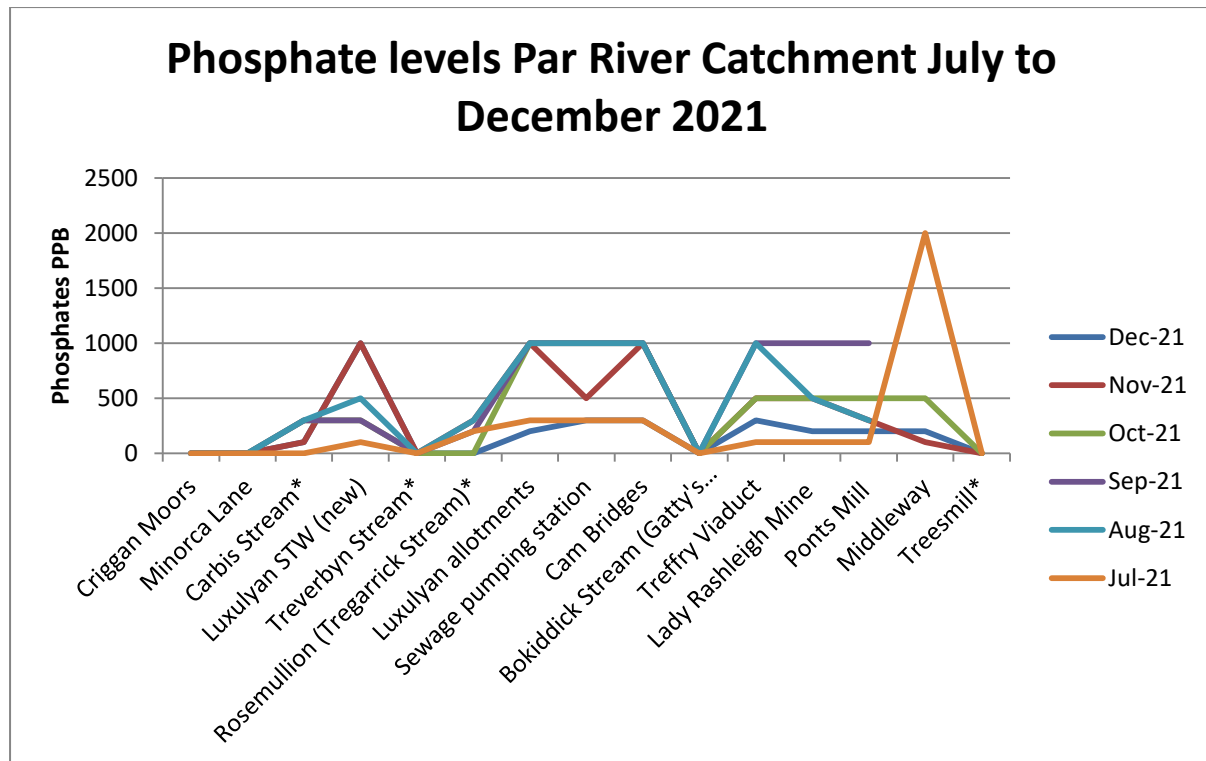
As the following chart shows, elevated phosphate levels in the main river tend to be the norm. Note that from November a slightly different monitoring point was chosen downstream from the STW. This was following our discovery of a phosphate level of 2500 ppb nearby. We believe the new monitoring point is more representative of the phosphate level in the river. The EA seems to have established that the STW is a source of high phosphate levels.

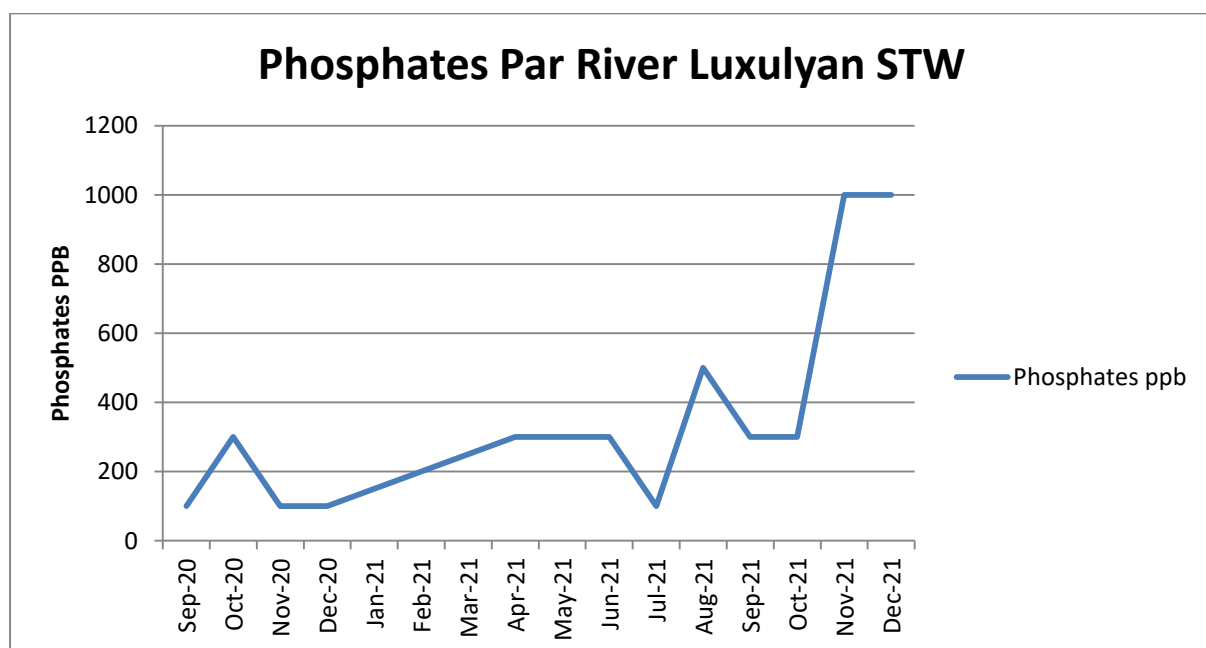
- (a) Luxulyan sewage treatment works measured from November 2021 at SX 04472 58114 (formerly at SX 0455 58114)

Measurements at the old monitoring spot, before November 2021, may have been diluted by the proximity of 2 small outfalls (believed to be land drains).

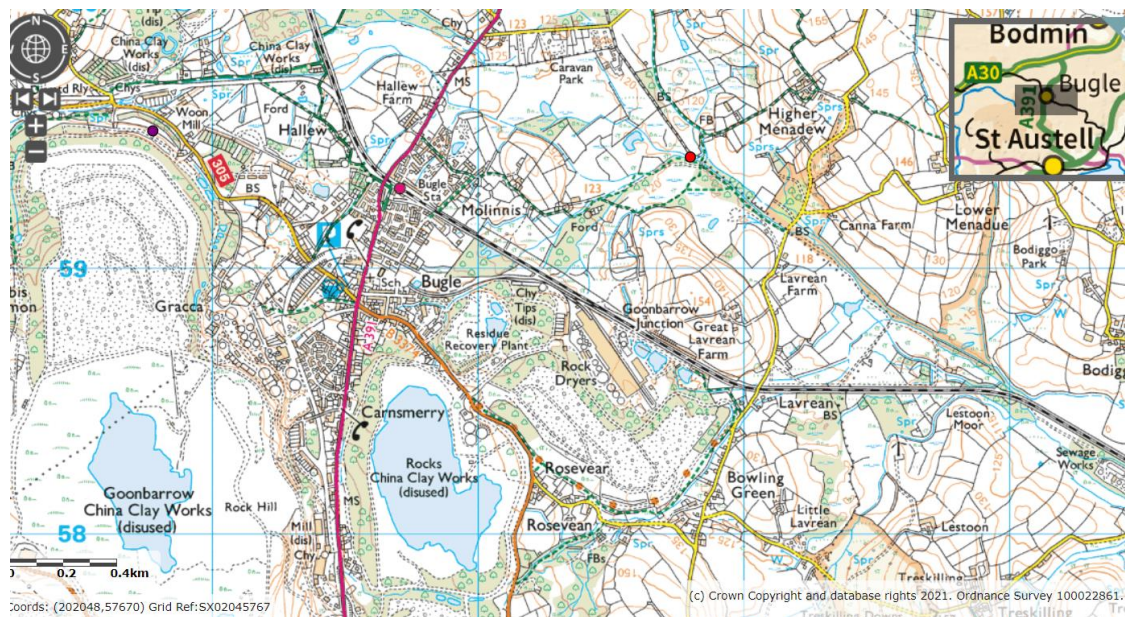
3. The pollution of the Carbis Stream with china clay needs further examination. The source of the china clay could be the banks of the stream, where a higher water level washes previous deposits into the stream, or current discharges, or both. Near the purple dot in the following map, the Carbis Stream can be seen by the road. Often it runs clear; at the monitoring point at SX 02834 59401 (red dot), however, it is more often white than not. This suggests that the clay enters the river closer to Bugle but as the map suggests, there are various watercourses in addition to the Carbis Stream that might act as conduits for pollution. Therefore it cannot yet be said where this china clay is coming from. The impact on fish and other wildlife is unknown.
