WESTCOUNTRY RIVERS TRUST CITIZEN SCIENCE

MONITORING OF THE PAR RIVER AND ITS TRIBUTARIES

FEBRUARY 2022

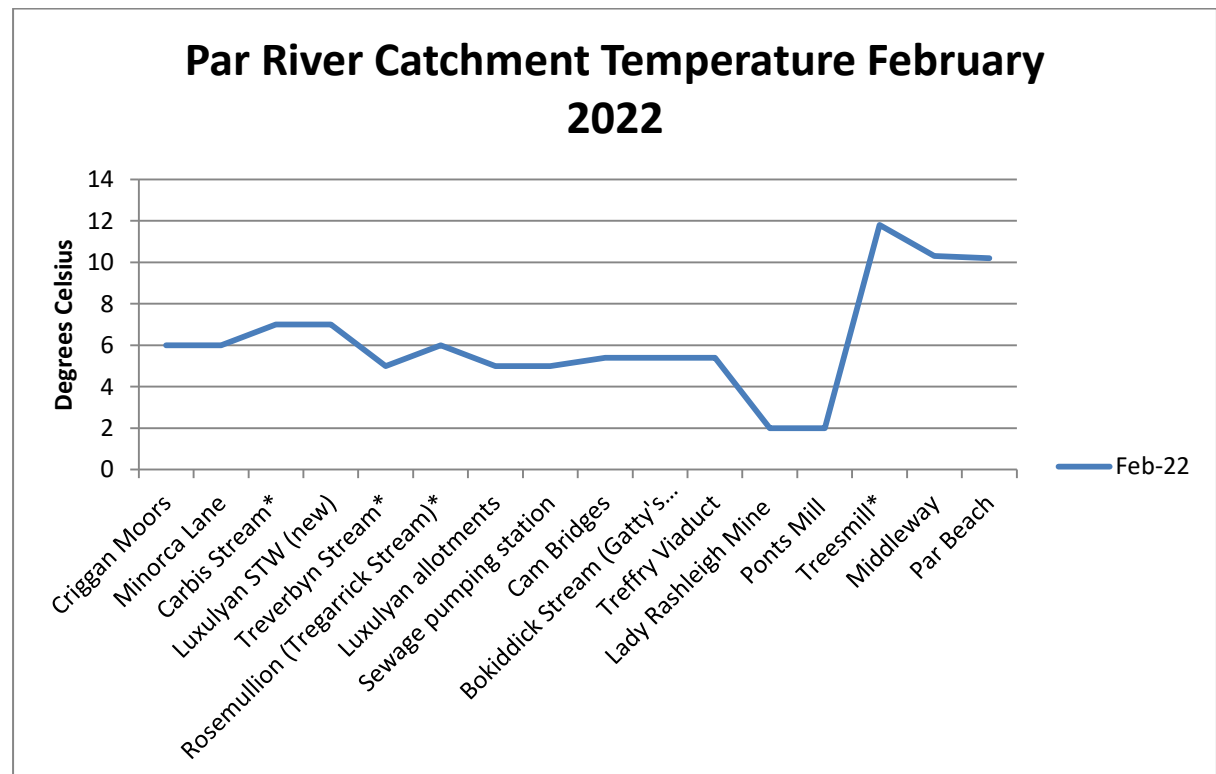
Temperatures from near the source of the Par to Pontoys Mill are consistent (readings at Lady Rashleigh Mine and Pontoys Mill were taken early on a very cold morning). Once again, temperatures at Treemill (shallow tributary), Middleway (former canal fed by the river but shallower than the river upstream) and Par Beach (tidal though monitoring was at low tide) were higher but this may be due to local factors.

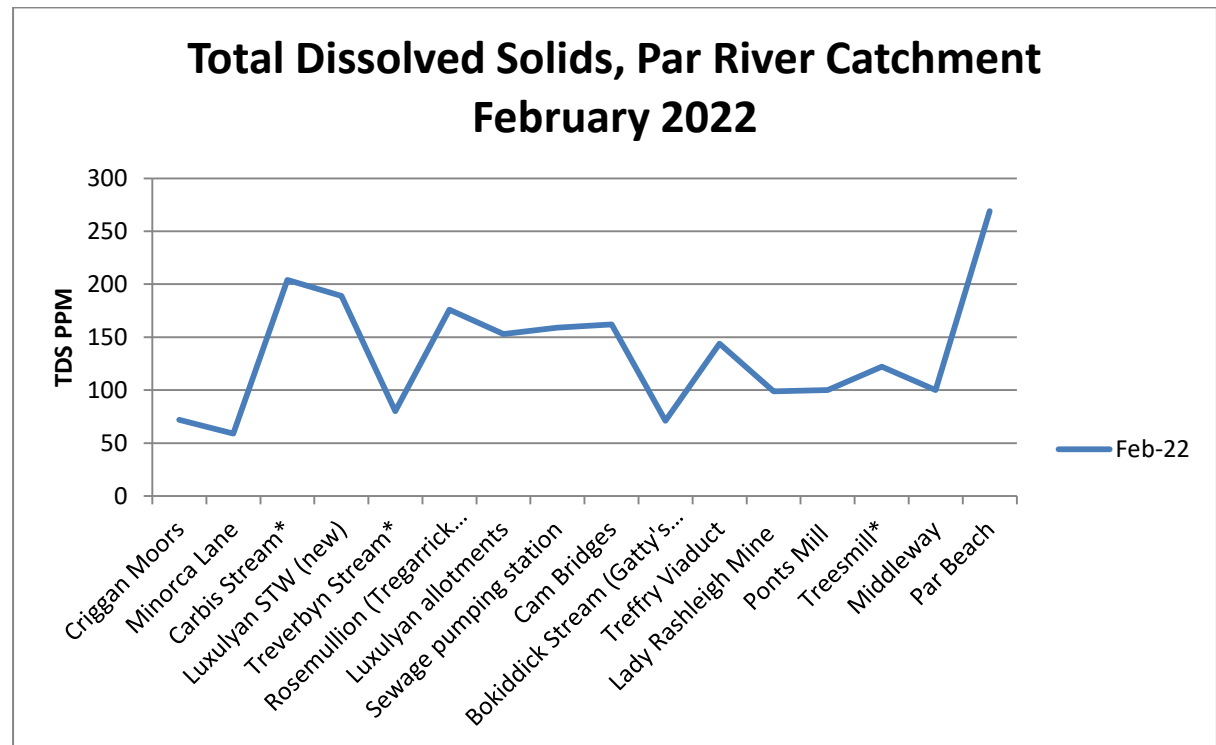
The two highest readings were on the Carbis Stream, where the water was white with china clay, and Par Beach, where, presumably, beach sand had an effect on the reading.

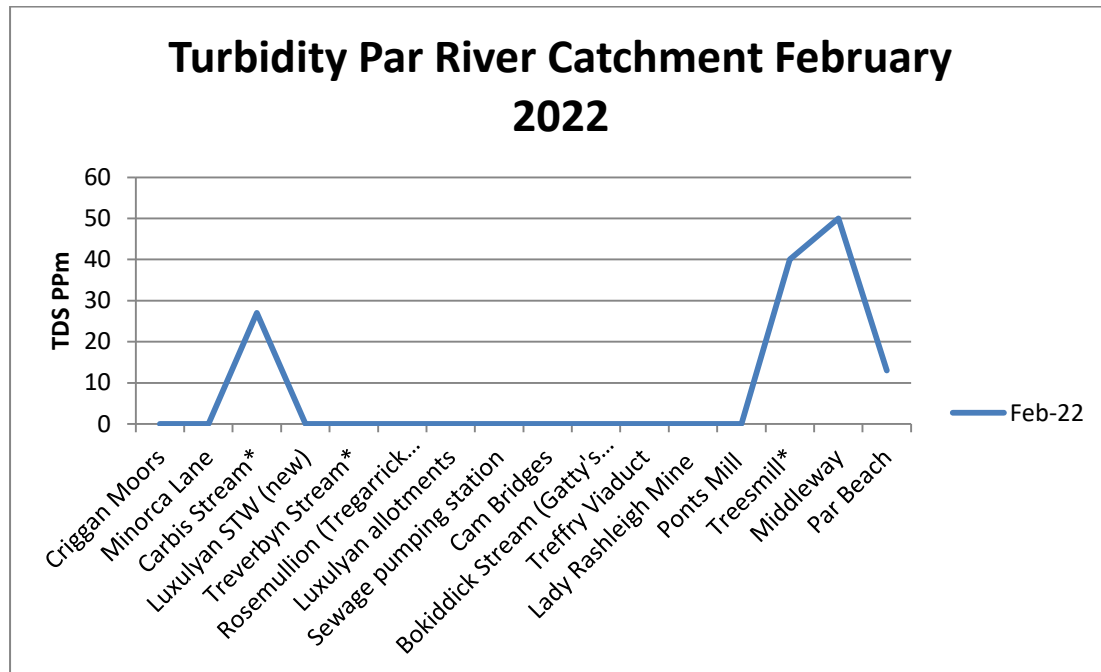
The high figure for Total Dissolved Solids on the Carbis Stream is consistent with the high Turbidity recorded. Those at Treesmill and Middleway (photo below) may be explained by the heavy rain that preceded monitoring.

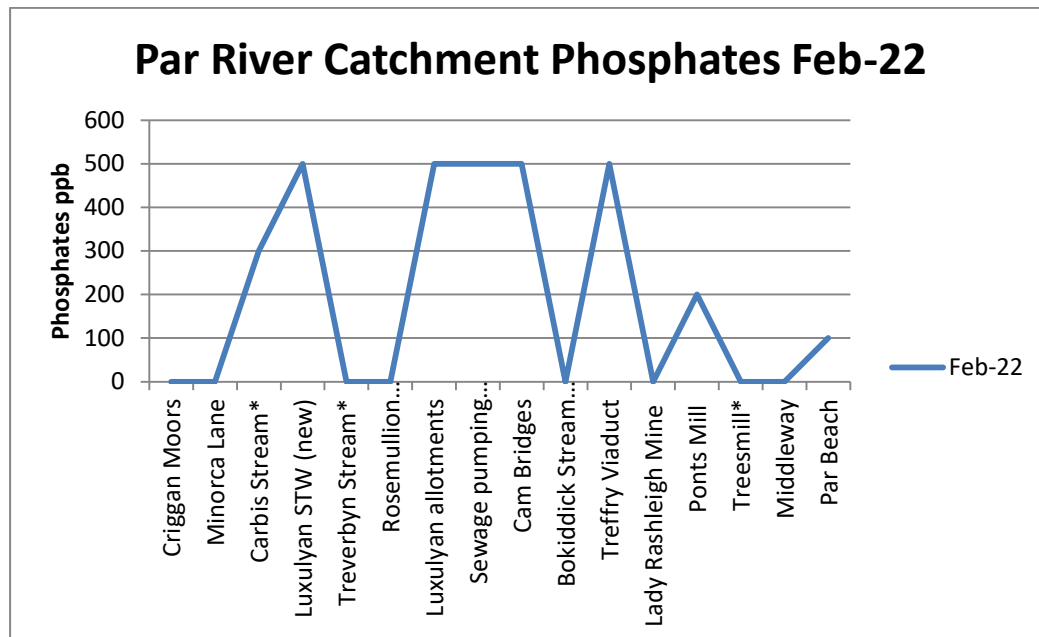
Phosphate levels were relatively low for the second month running. Levels at all sites monitored were OK according to the WRT guidance. Maximum scores of 2500 PPB have been recorded at some sites but these precede the date range in the historical graphs. They have been recorded on Cartographer.
