WESTCOUNTRY RIVERS TRUST CITIZEN SCIENCE

MONITORING OF THE PAR RIVER AND ITS TRIBUTARIES

JULY 2022

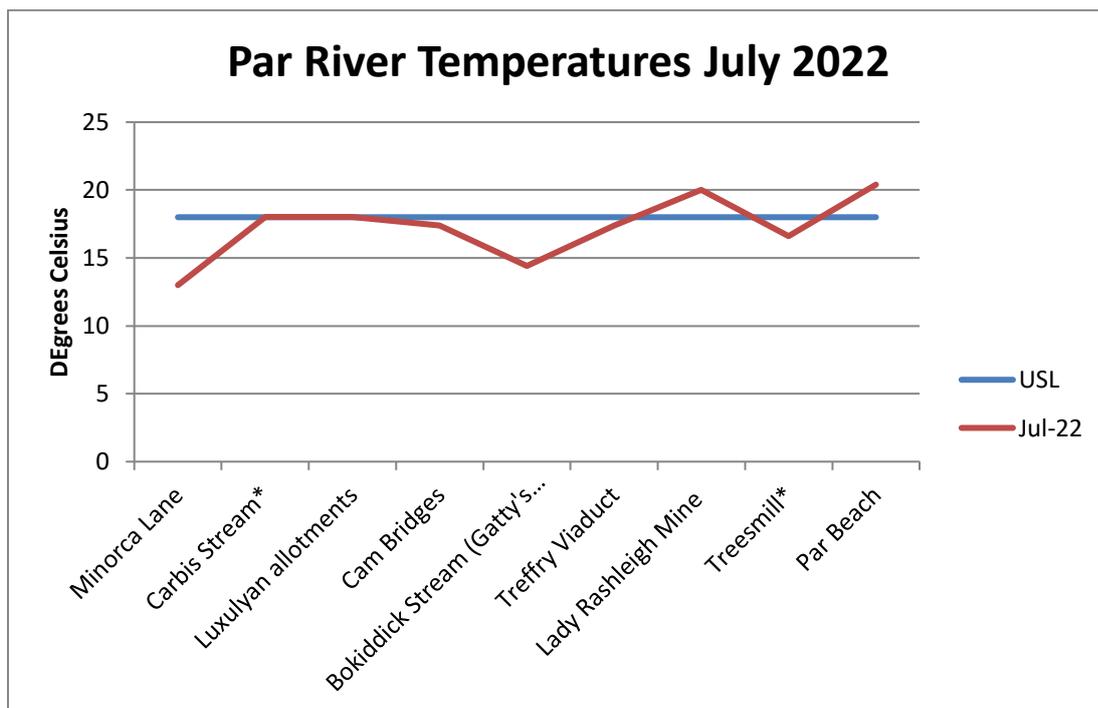
*indicates a tributary of the Par River.

USL – Upper Safe Limit. Our assumption (based on anecdotal evidence) is that 18° Celsius is the upper safe limit for fish. This may be a simplification but hopefully is a useful rule of thumb.

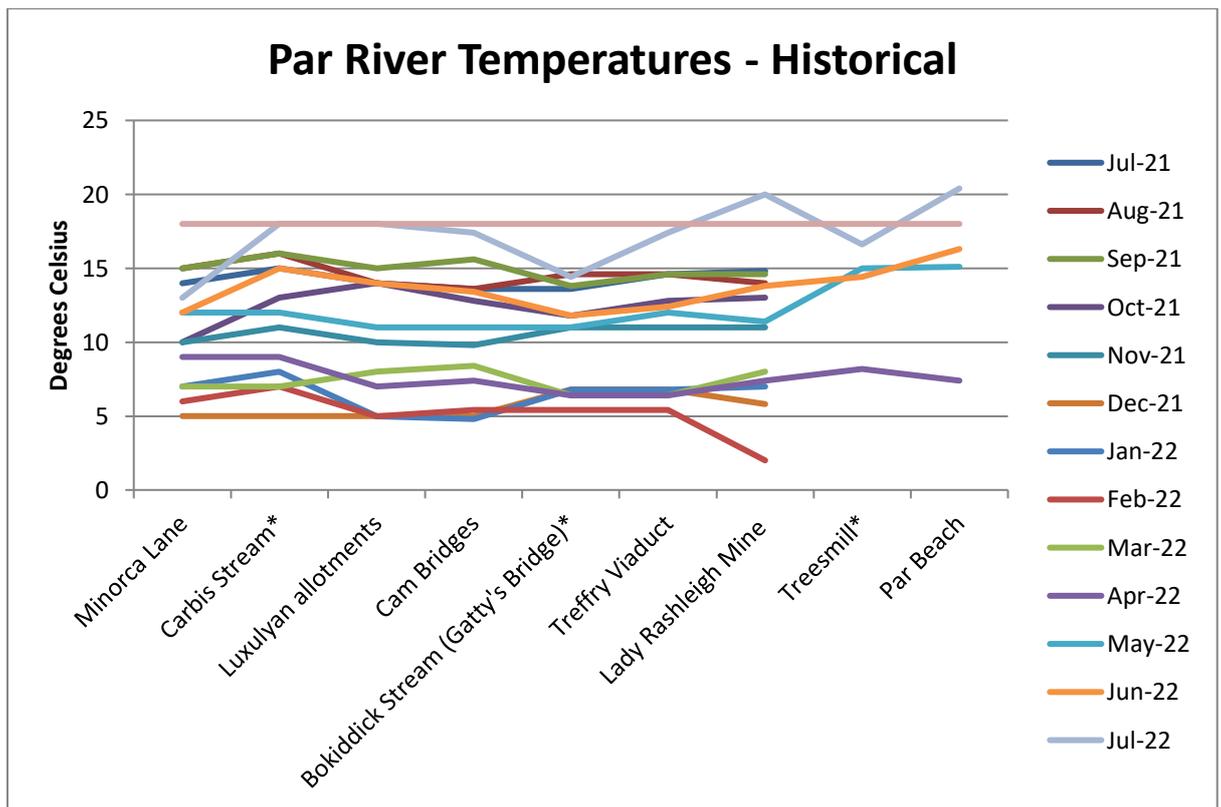
Nothing should be inferred from this because the database is tiny but this is the first occasion that our surveys have recorded river temperatures above 18°.

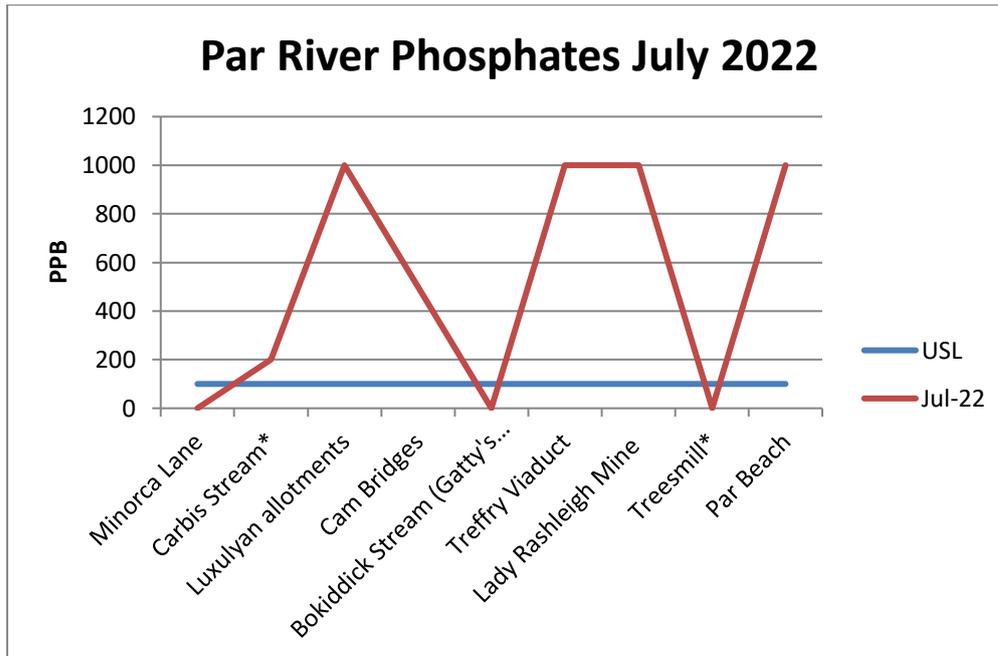
*indicates a tributary of the Par River. USL is 100 Parts Per Billion which, according to WRT, is the Upper Safe Level.

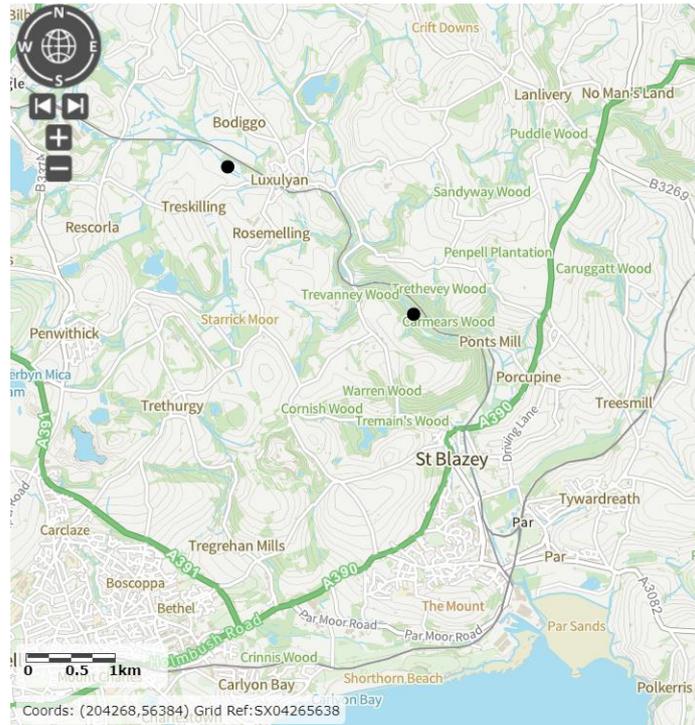
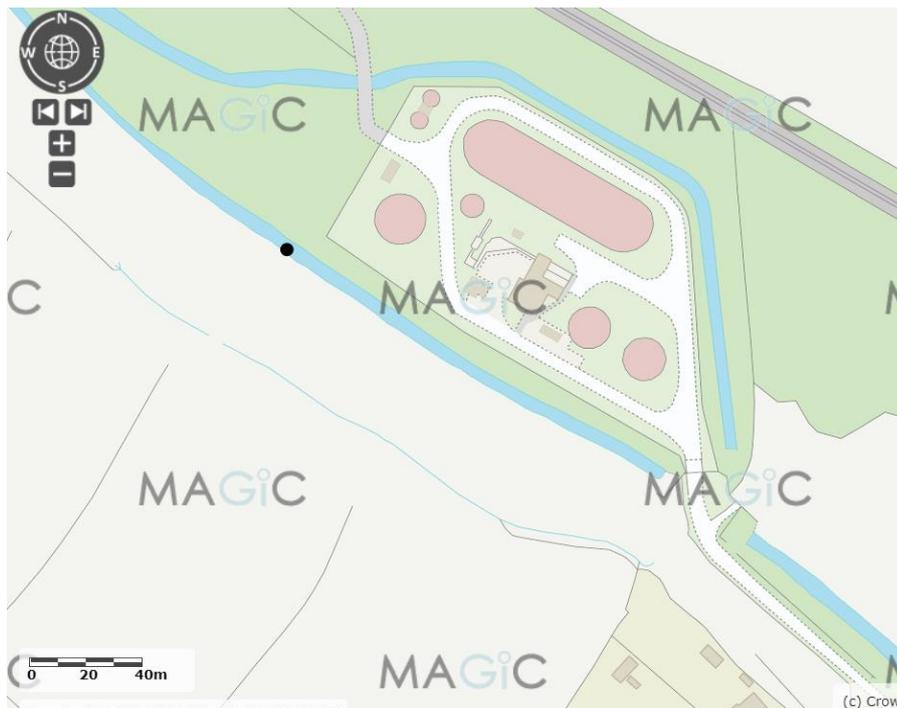
The sample was taken upstream from the STW and so would not have been affected by the two outfalls, one of which is a Combined Sewer Overflow, and was not discharging, and the main one, which was (see photo).

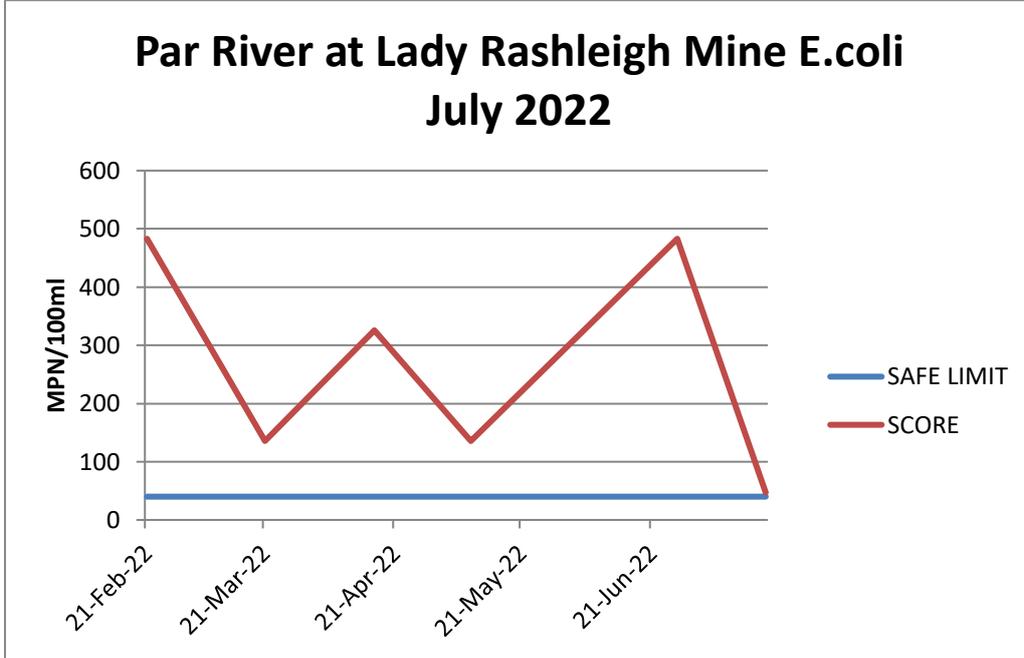
- (i) E.coli was 47 MPN/100 ml, which is considered to be **Low Risk/Possibly Safe**.

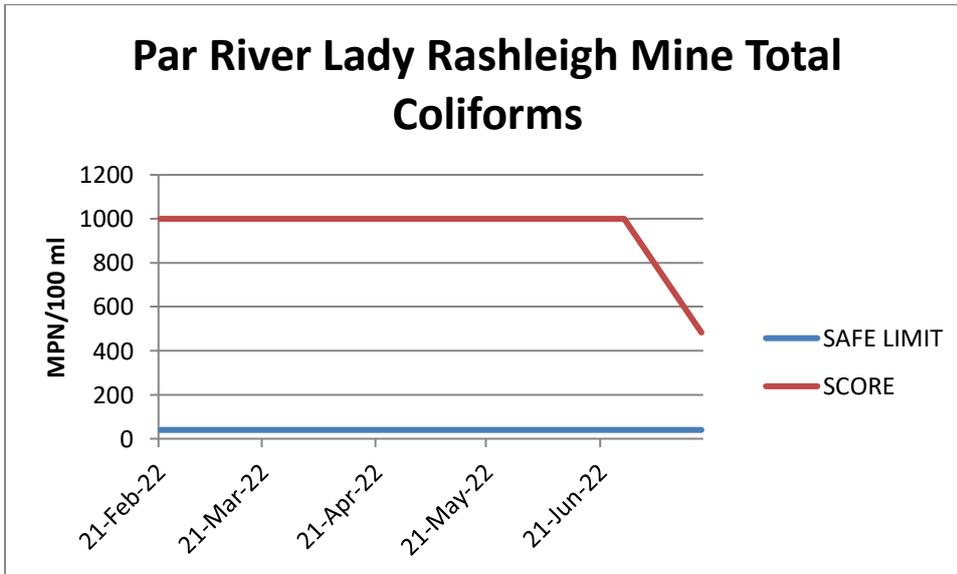
The reading was 483: **Very High Risk/Unsafe**.
