WESTCOUNTRY RIVERS TRUST CITIZEN SCIENCE

MONITORING OF THE PAR RIVER AND ITS TRIBUTARIES

NOVEMBER 2021

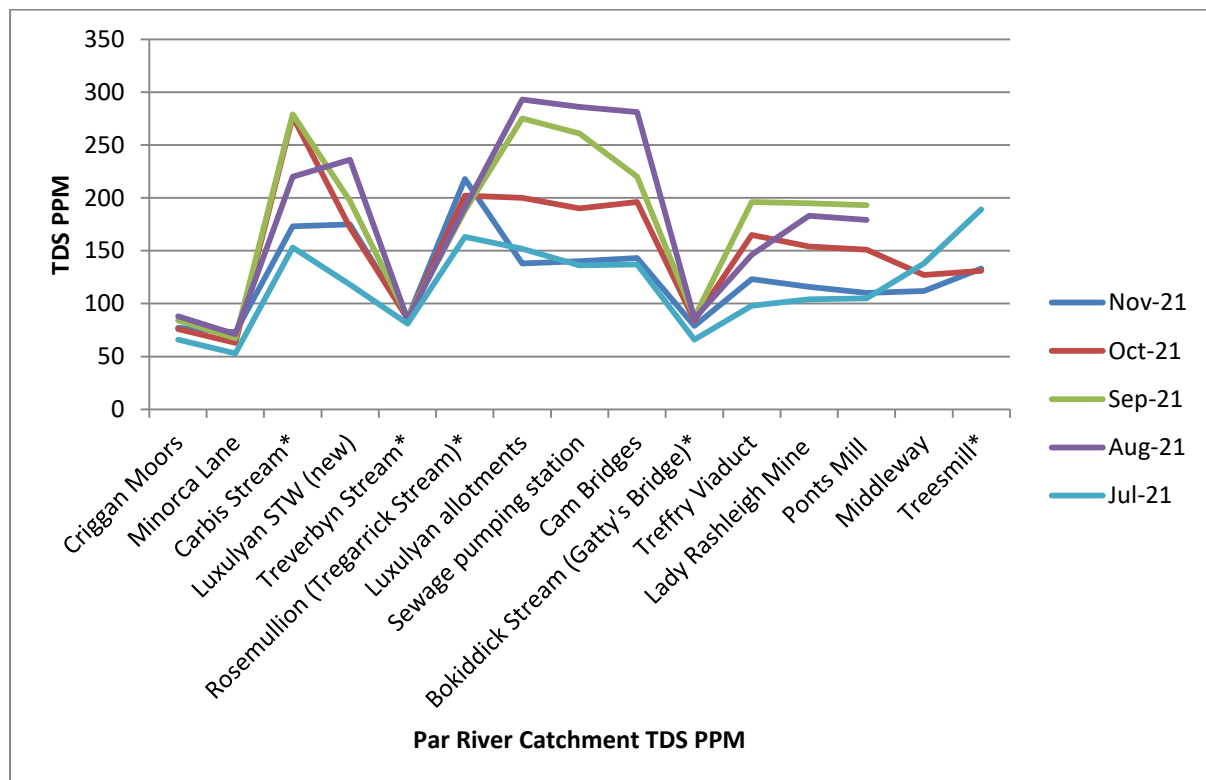
Tributaries seem to have lower TDS than the main river, with the exception of the Carbis Stream.

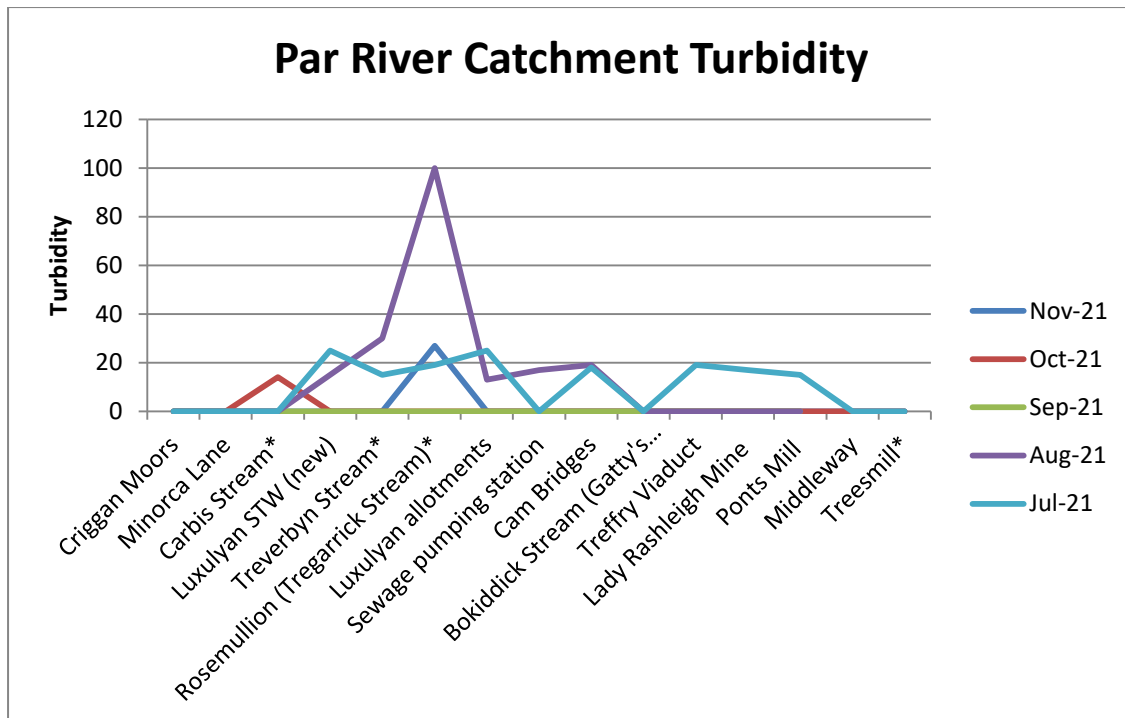
Although the reading on the Carbis Stream was just <12, it can be seen that the silt-laden water in the tiny Tregarrick Stream is an outlier. This is not unusual, as the following graph shows:

The turbidity in the Carbis stream may be the result of china clay pollution. Turbidity scores for most locations since monitoring began in 2020 are usually <12 (recorded on Excel as 0 for convenience). The Carbis and Tregarrick Streams have been outliers (the latter as a result of thick silt in the stream) although high rainfall preceding readings has sometimes raised levels elsewhere.

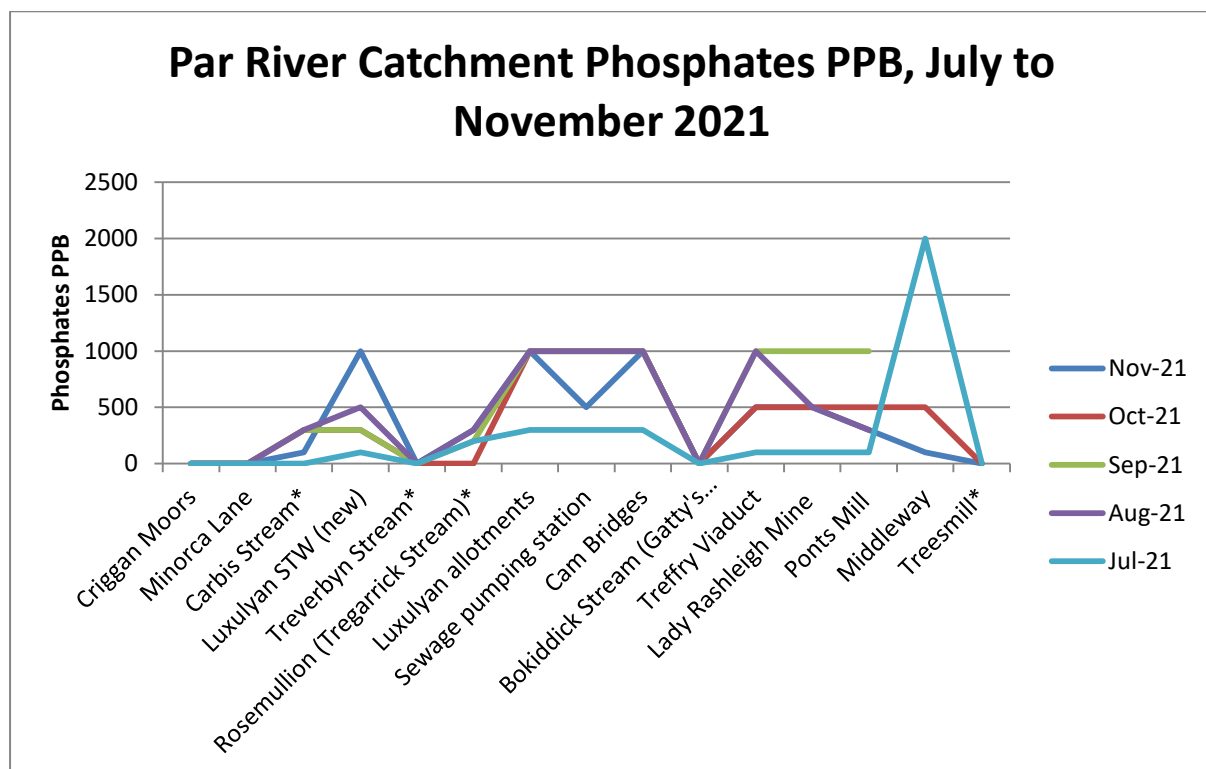
It would seem that the selection of a new monitoring point, downstream from the Luxulyan STW, on the opposite bank, and a few metres from the unexplained outfall, is indicating the point where phosphate levels become elevated. This does not prove that the SWW treatment works is the cause but it will be interesting to see what the EA investigations initiated in October 2021 reveal.

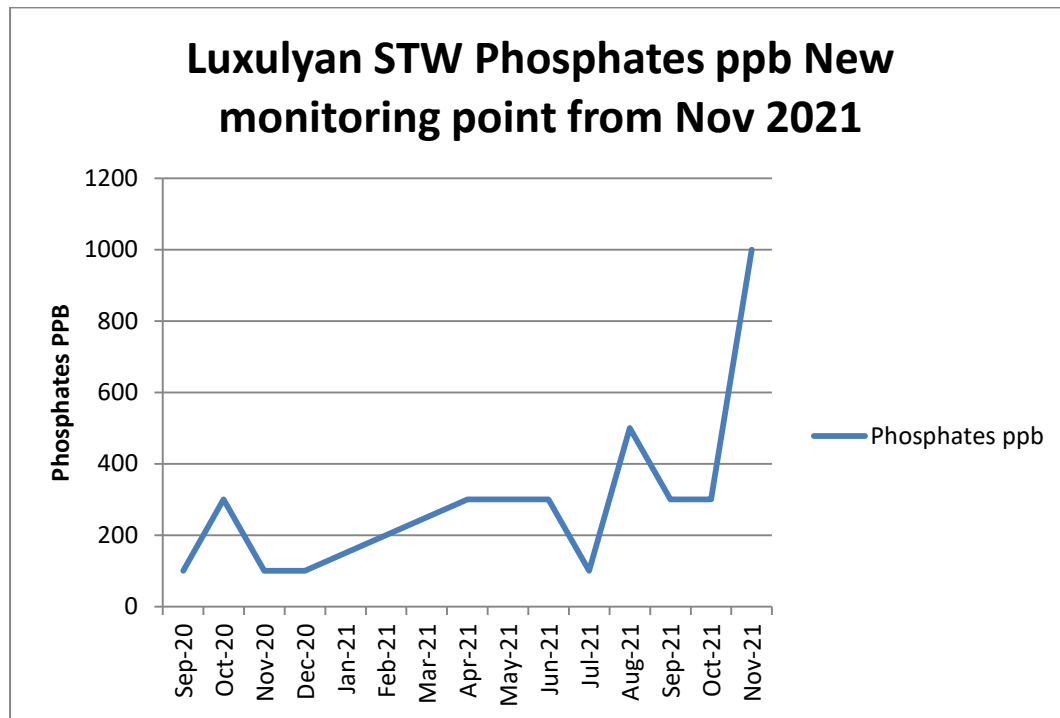
- (a) Luxulyan sewage treatment works measured from November 2021 at SX 04472 58114 (formerly at SX 0455 58114)

The new monitoring point was selected after very high phosphate levels were detected in October 2021. Two small outfalls from field drains next to the previous monitoring point were thought to have been diluting readings. Two outfalls from the STW are known. An EA investigation has confirmed high phosphate readings in this vicinity. Ammonia levels were recorded but our group does not know if these were significant. The purpose of the outfall at SX 0447 5811 is unknown. On this occasion only a trickle was emerging, yet the red-stained deposit was still evident (see photo on page 1).

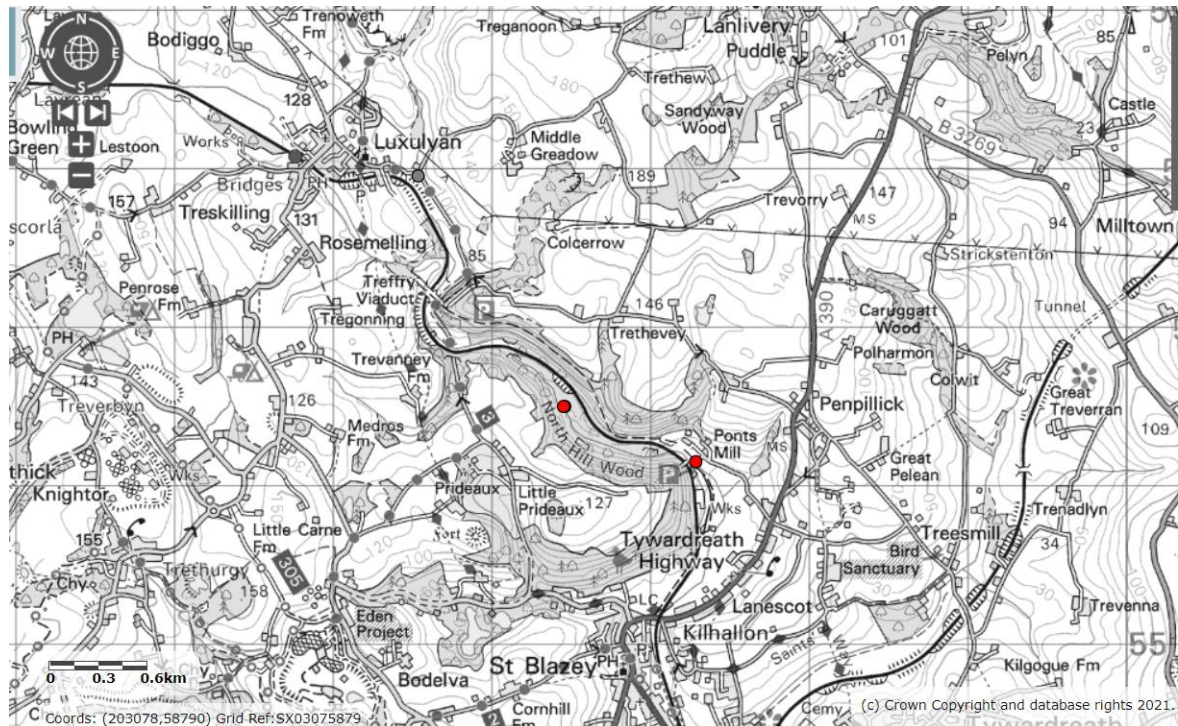
Red dots – definite evidence of otters. Recorded on ORKS database.

Grey dots – possible evidence. Not recorded on ORKS database

EVIDENCE	SEEN/ ORKS*	LOCATION	NOTES
Spraint - fresh	✓	SX 06456 56498 Lady Rashleigh Mine – boulder in river	Also, on a boulder and a tree trunk an unidentified odourless deposit.
Spraint – recent	✓	SX 07312 56164 Gully on north side (west bank) of canal bridge at Ponto Mill	
Spraint - old			
Anal jelly			
Sign heap			
Staining			
Tracks	?	SX 0553 5795 Scratch marks on sand in bankside hollow near Gatty's Bridge	Besides the scratch marks there was a strong smell reminiscent of spraint but none could be found. The sand had been scraped up into a small pile.
Path			
Slide			
Holt			
Hover			
Couch			
Live sighting			
Corpse
