## WESTCOUNTRY RIVERS TRUST CITIZEN SCIENCE

### MONITORING OF THE PAR RIVER AND ITS TRIBUTARIES

OCTOBER 2021

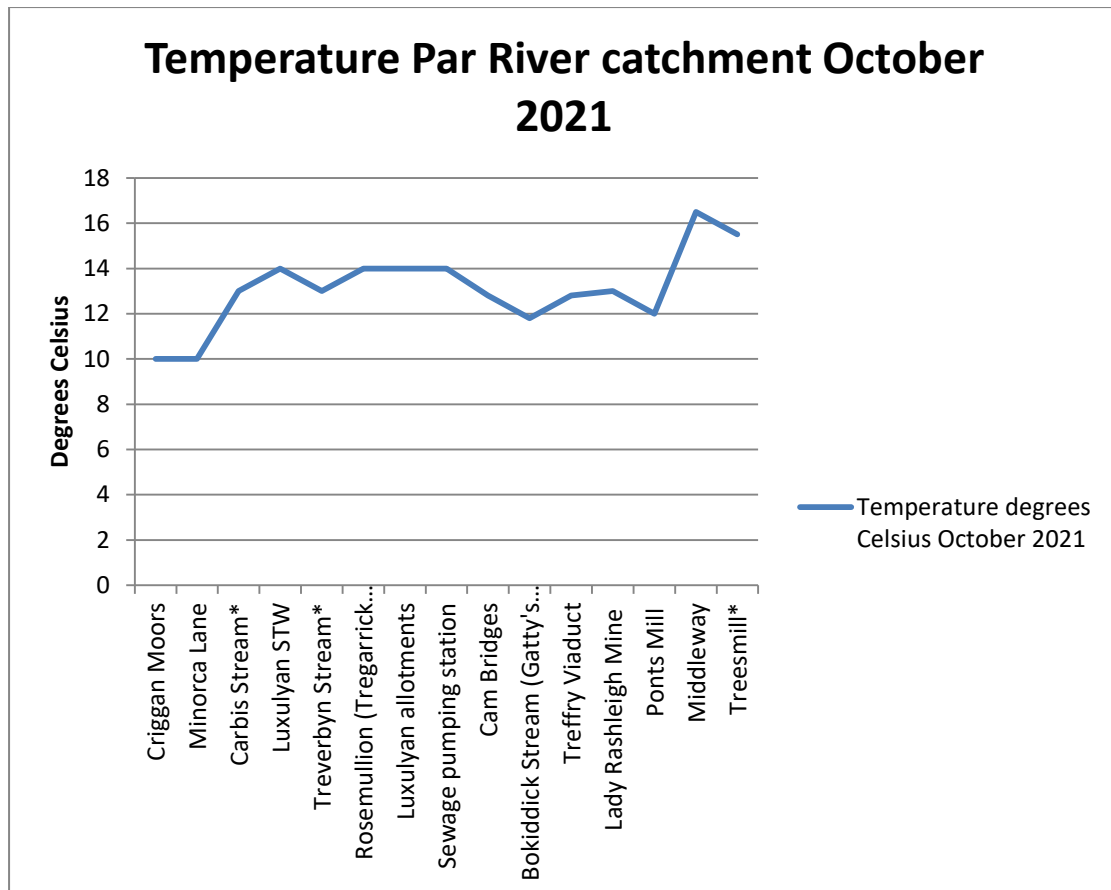
These temperatures are arranged, broadly speaking, from north (upstream) to south (downstream), and in order of flow. The last 2 readings are significantly higher. This may be partly due to the weather, which had been unseasonably warm, the amount of tree cover and the volume of water at those points. It should be pointed out that Middleway is the former Par Canal, rather than the river, although it is fed by the river upstream. It does mean that the water is split between two water-courses so that the lower volumes in each might be warmed more quickly.

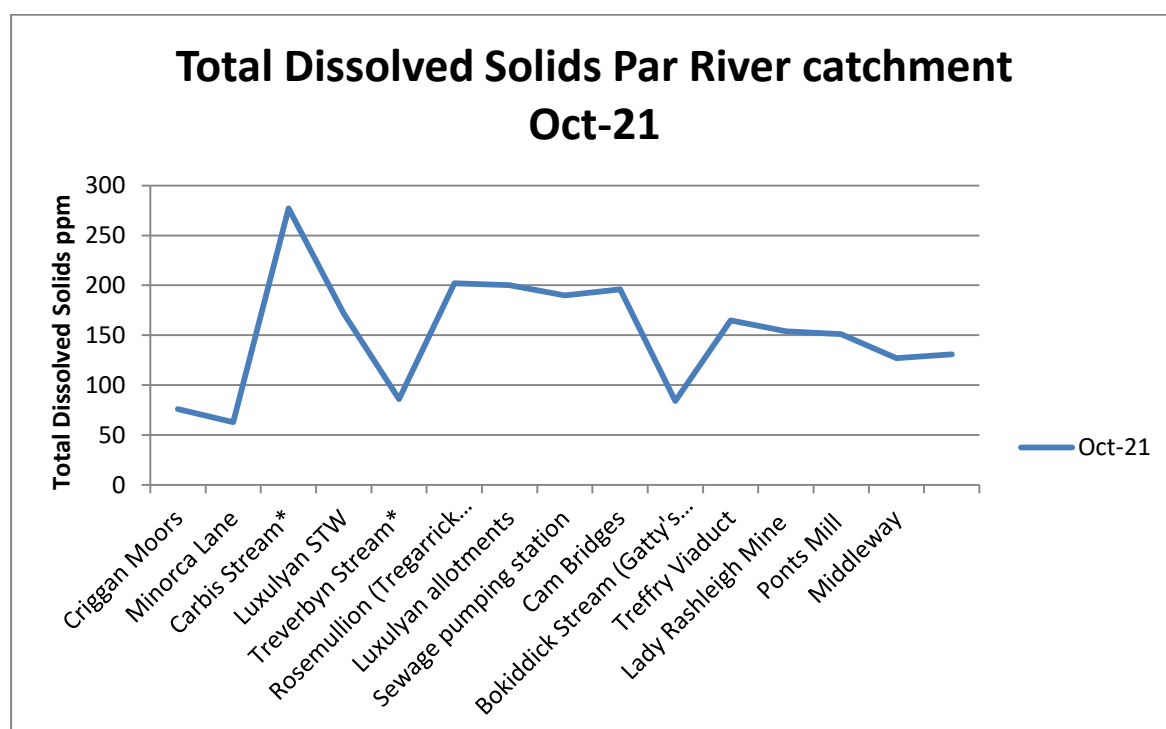
Once again, the relatively high score on the Carbis Stream may reflect china clay in the stream, which was slightly milky in appearance (unfortunately there are no photos because my camera battery ran out). It has been assumed that this is the result of erosion from the banks, rather than

current discharges from working plants but perhaps this should be investigated. Other rivers in the St Austell area do carry china clay from operating works. Otherwise, the usual observation can be repeated: TDS levels on the main Par River seem to be greater from the STW downstream, if tributaries are ignored. Tributaries seem to have lower TDS than the main river, with the exception of the Carbis Stream.

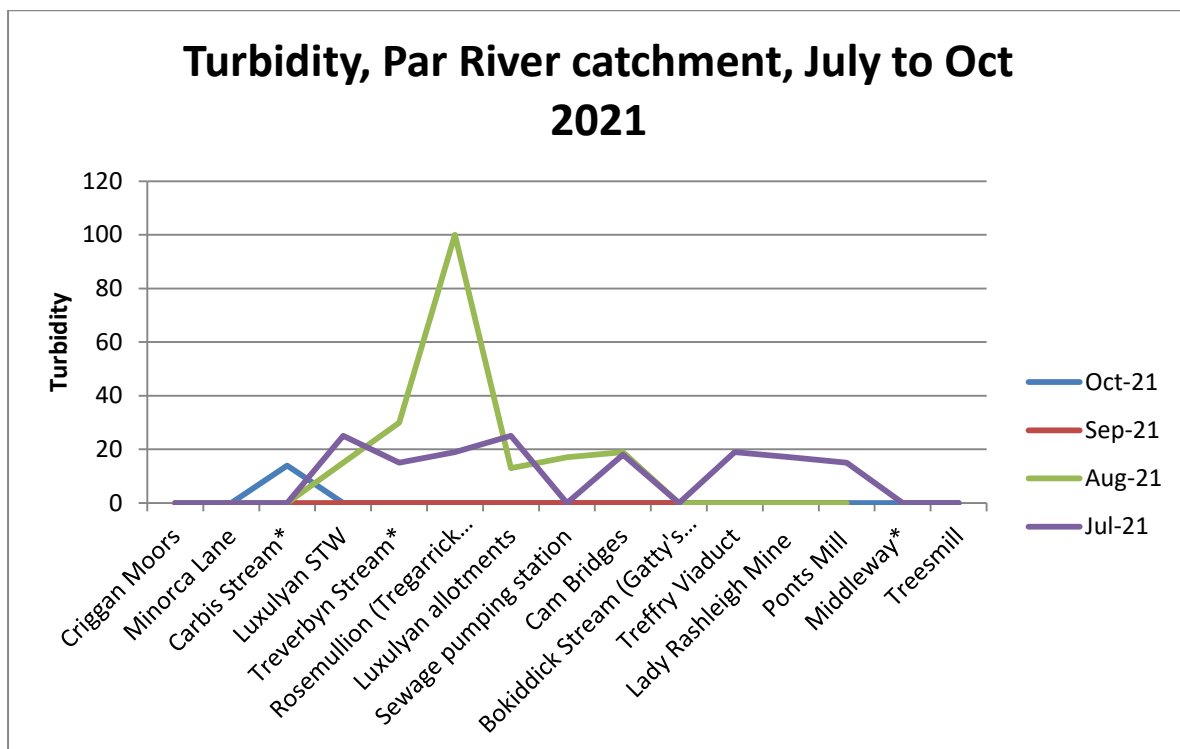
The turbidity in the Carbis stream may be the result of china clay pollution. Turbidity scores for most locations since monitoring began in 2020 are usually <12 (recorded on Excel as 0 for convenience). The Carbis and Tregarrick Streams have been outliers (the latter as a result of thick silt in the stream) although high rainfall preceding readings has sometimes raised levels elsewhere.

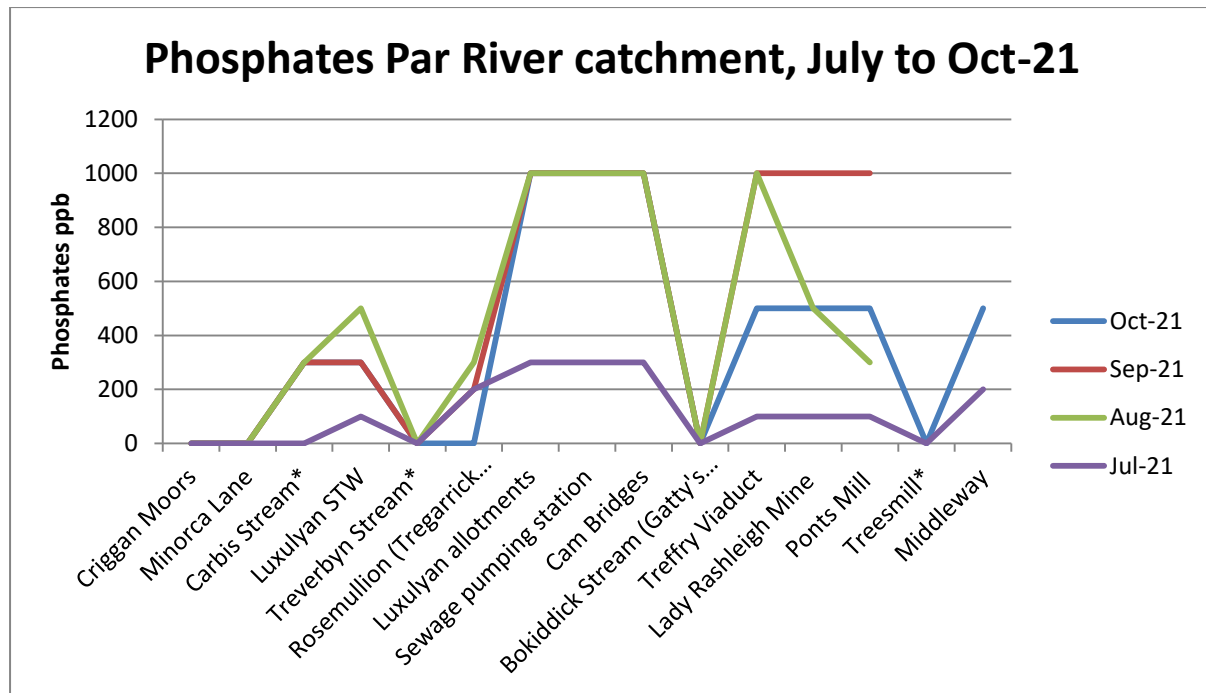
The pattern is consistent. Ignoring the dips, which represent phosphate-free tributaries (with the exception of the Carbis Stream), levels rise from acceptable levels in most of the Upper Par to the *Too High* category (WRT guidance) shortly after the STW, remaining at *Too High* or *High* levels thereafter. The report to the Environment Agency hotline on 9<sup>th</sup> October 2021 and observations in relation to phosphates in the vicinity of the Luxulyan STW are covered more fully in **Section I Discussion**.

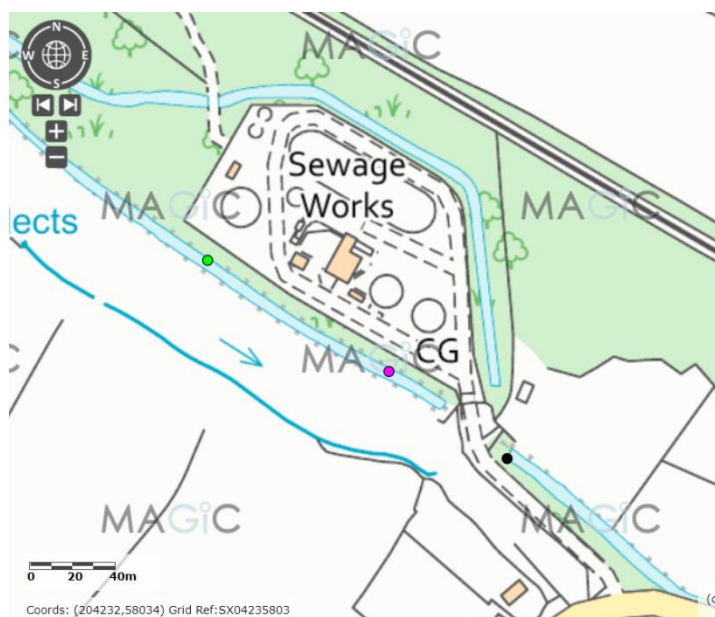
2. Our group has noticed that phosphate levels only become seriously elevated downstream from the STW, yet at the usual monitoring point readings have never been of great concern (see graph in 4 (a) page 21 above); however, levels between there and the allotments have been markedly higher. Last month we became aware of two outfalls from the STW:

**Green dot** Storm Effluent discharge point (Outlet 2 at SX 0432 5820). This should not be operational in dry weather.

**Purple dot** normal Final Effluent discharge point (Outlet 1 at SX 0440 5815)

**Black dot** WRT CSI usual monitoring point (SX 0455 58114)

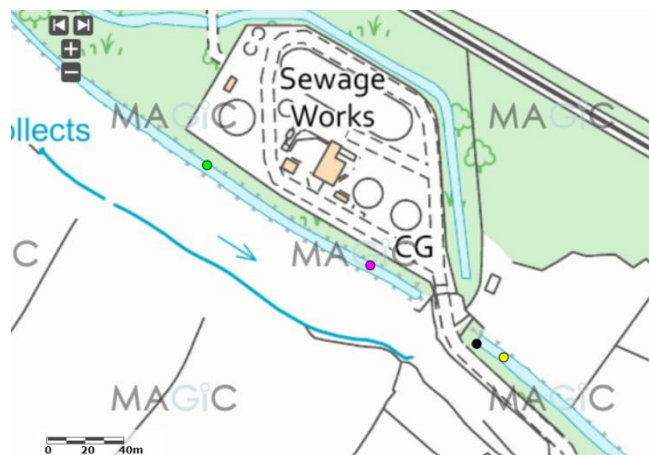
5. After recording 300 ppb at the usual monitoring spot at SX 0455 58114 (black dot in above map) it was decided to take a reading from water taken mid-river about 10 metres downstream. This is shown approximately by the yellow dot in the next map:

This time the maximum possible reading using our kit was made: 2500 ppb. The next photo is looking from the usual monitoring spot in the direction of the place where the mid-river sample was taken. No tributaries enter in this stretch. On one side is a field and on the other a belt of bushes and trees. In other words, there was no obvious source of contamination.

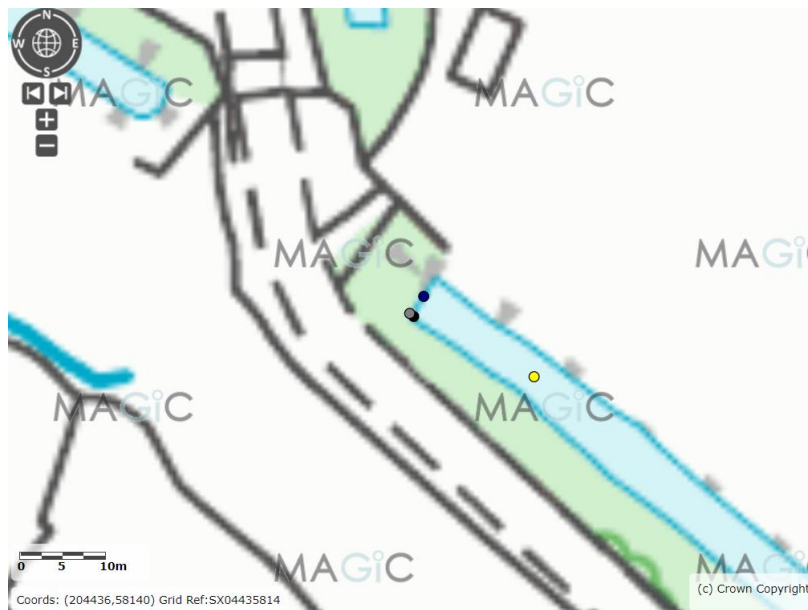
To test this idea we sampled river upstream of the twin outfall, and usual monitoring position, under the downstream side of the bridge (see blue dot in next map). This gave a reading of 500 ppb.

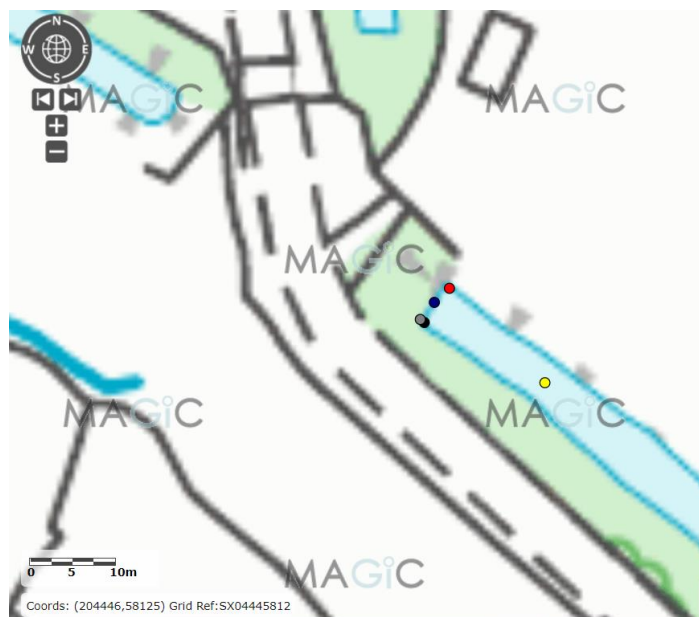
7. Something downstream of the bridge had to be the cause of the 2500 ppb reading. The only visible candidate was the large outfall (red dot in map below) which has been a mystery to us ever since we began monitoring in this location.

This outfall has a metal hinged flap that is permanently open. We have never observed large volumes of water emerging from it, although sometimes, as was the case on this occasion, small amounts of foam and a reddish tinged liquid emerges. We don't know its purpose but its position suggests it is the outfall from a water channel that flows around the northern perimeter of the STW (see map in section 5 above).

8. It seemed as if the high phosphate level was the result of something emerging from the large, unexplained outfall at SX 0447 5811. Given the very high levels the Environment Agency hotline was contacted later on Saturday 9<sup>th</sup> October. Information was also sent by email. Shortly after a very helpful conversation with the official manning the hotline someone from the Cornwall section EA rang me. On Monday 11<sup>th</sup> October the following message was received from the EA:

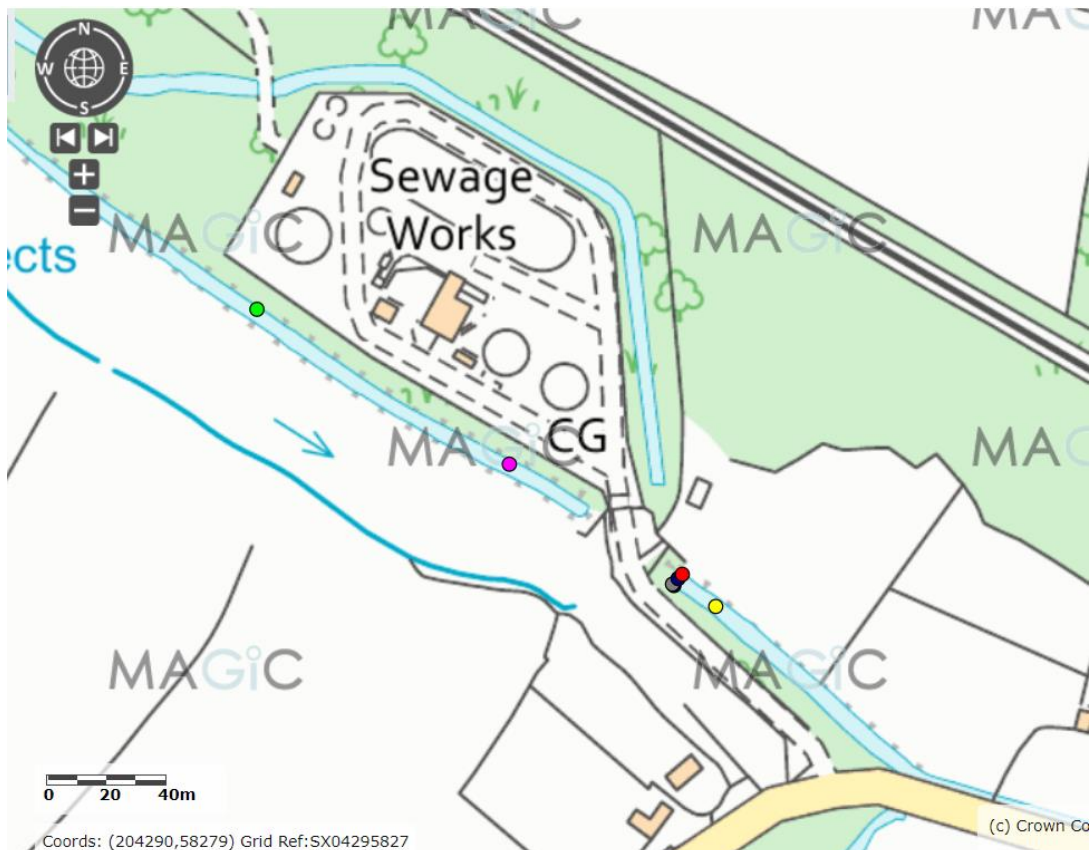
This map shows the distance between the bridge near the STW and Luxulyan allotments. Readings from the allotments downstream made on 9<sup>th</sup> and 10<sup>th</sup> October was a minimum of 500 ppb (Too High – WRT guidelines).
